# Engineering lessons not learnt from 2002 Diglipur earthquake – A review after 2004 Sumatra earthquake

Durgesh C. Rai\* and C. V. R. Murty

**Keywords:** A&N Islands, bridge, buildings, earthquake, jetty.

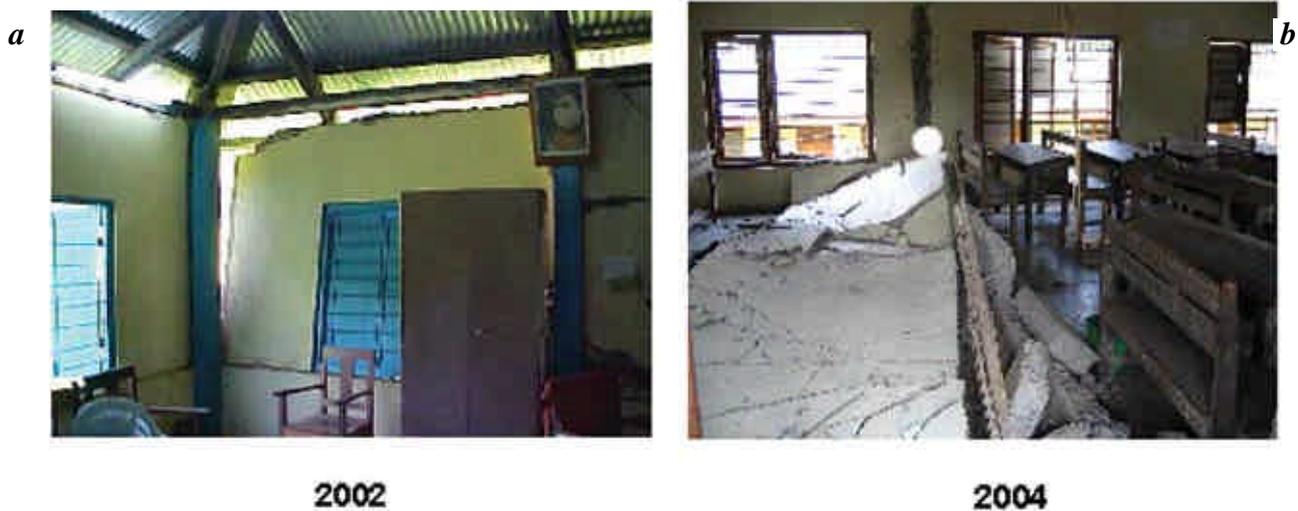
In the A&N Islands, many private dwellings and community buildings, such as school and health centres, are built in masonry-load-bearing walls and light roof (steel pipe/timber truss clad with corrugated galvanized iron sheets). Often, these walls are not tied together to create the box-action required to improve lateral resistance. Also, positive connection is not provided between walls and roof trusses resting on them. An example of such a structure is shown in Figure 2: the masonry wall collapsed out-of-plane when the flexible roof consisting of poorly jointed wooden truss members moved by large amounts. Similar damages were observed on a much larger scale in most school buildings, wherein long slender partition walls separating two classrooms were either severely damaged or collapsed due to out-of-plane instability.

**Figure 2.** Slender masonry walls dislodged due to out-of-plane instability and poor or no connection to the surrounding structural elements.

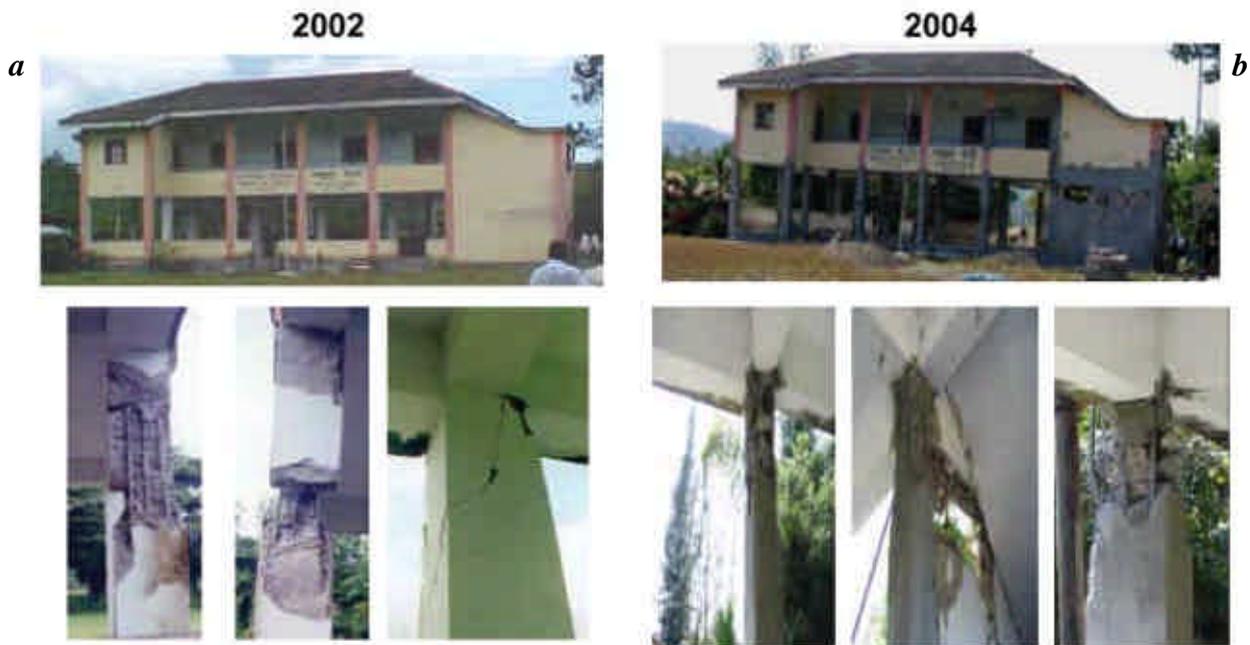
**Figure 3.** *a*, Severe cracking and damage to soft first storey columns of Nabagram Panchayat Bhavan building primarily due to ‘missing’ ties in the 2002 earthquake. *b*, More severe damage in the 2004 earthquake to the same columns which were ‘retrofitted’.

In many instances, the masonry walls in the ground storey were discontinued at the sill level instead of being raised to the full storey height. This created the short column effect, an additional abnormality that was also not accounted for in the design. An example of such a structure is the Panchayat Bhavan building at Nabagram, about 25 km south of Diglipur (Figure 1). The ground storey columns of this building suffered extensive damage in the 2002 earthquake. Many columns were severely cracked and damaged near beam-column joints and at mid-heights (Figure 3). First, a close inspection revealed that no transverse

stirrups (ties) were present over a length greater than 350 mm of the columns in the ground storey from the soffit of the beam. The code (IS 13920 : 1993) for detailing of earthquake-resistant RC frame requires the stirrup spacing<sup>5</sup> in such locations to be no more than 75 mm. Even if such a building is located in the lowest seismic zone II, the code (IS 456 : 2000) requirement for these 200 mm wide columns would be no more than 200 mm for the spacing of stirrups<sup>6</sup>. This is a construction error: the ties were not securely held in place during concreting, slipped from their position, and three ties stacked one on top of the other.

Secondly, the building was made susceptible to poor seismic performance by creating the open ground storey. Thirdly, the infills of partial height created short columns effect. Fourthly, the RC columns were not designed for earthquake forces and required ductility, particularly in the ground storey, where it was most needed. As a consequence, even a low intensity (VI on MSK scale) ground shaking was sufficient to seriously damage the structure and undermine its safety. The severely damaged columns of the building were simply repaired after the 2002 earthquake: the fine cracks were filled with mortar and the crushed concrete was replaced with hand-placed new concrete. No attempt was made to evaluate and remedy its overall seismic deficiencies; this left the building especially vulnerable to future earthquake shaking. And, during the 2004 earthquake, the building was again severely damaged and many columns in the ground storey were damaged. Further, the portion of the building close to the stiff stairwell was heavily damaged.

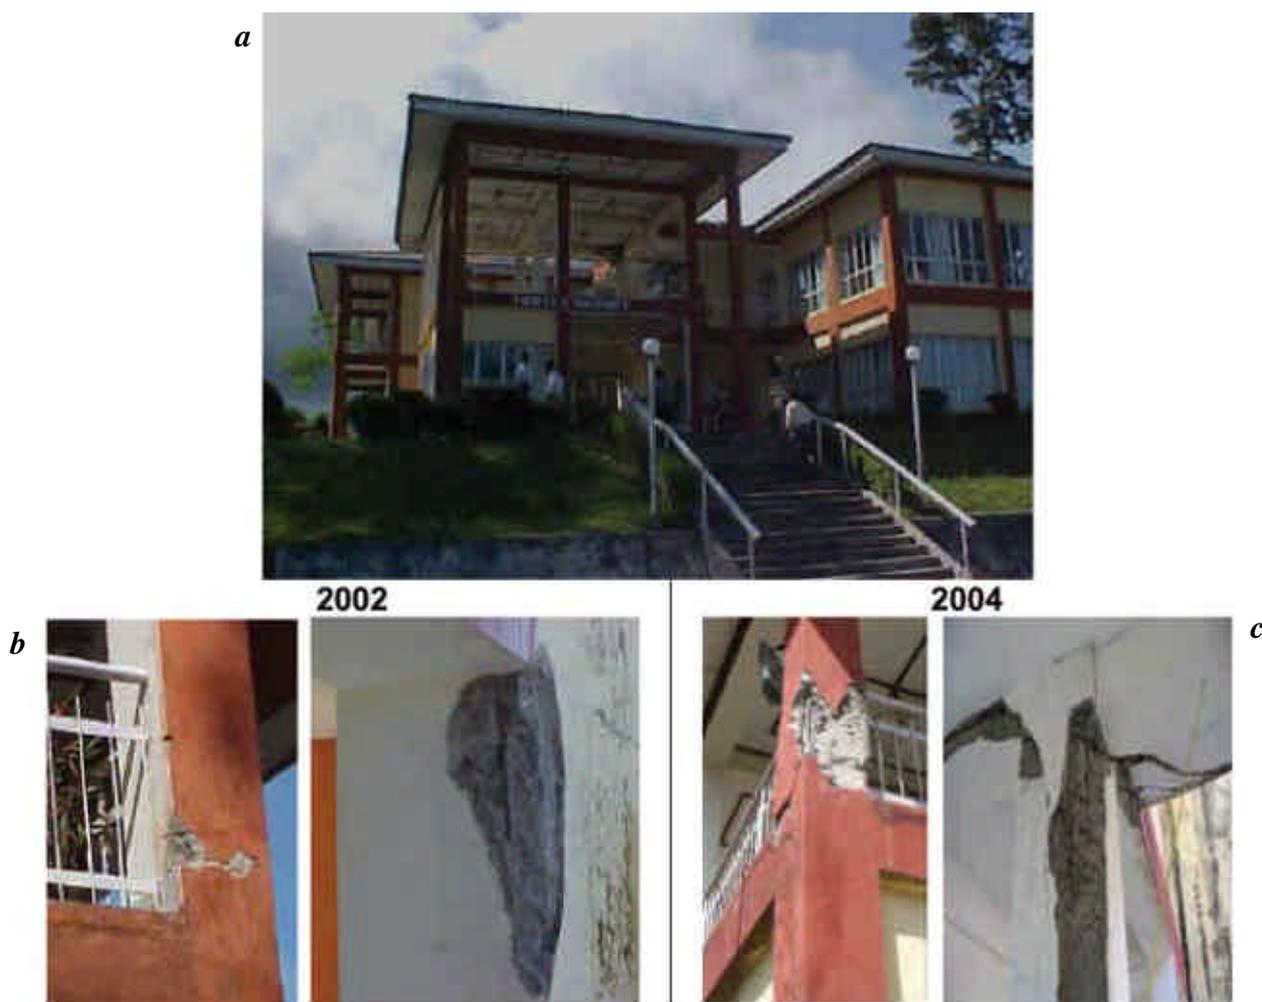
**Figure 4.** *a*, Turtle Resort building and highly irregular and asymmetric arrangement of structural members. *b*, Damage to columns which reveals absence of transverse ties over a length of about 450 mm from the beam soffit. This omission during construction compounded with poor structural configuration resulted in significant damage in less than moderate shaking of the 2002 earthquake. *c*, Repeat damage to columns in the 2004 earthquake, as no attempt was made to remedy the underlying structural deficiencies.

Similar serious errors were committed while conceiving the architectural layout, deciding the structural frame of structures in high seismic zones, and drafting reinforcement detailing in the Turtle Resort building at Shibpur, near Diglipur (Figure 1). One portion of this two-storey building has RC frame with concrete block masonry infills, and the other has load-bearing masonry with RC slab. This building is highly irregular not only in plan, but also in elevation; floors are at different levels, interconnected through lobbies and walkways (Figure 4). In the 2002 earthquake, the building sustained cracks in columns and in a large number of partition and load-bearing walls. Cracks at the top ends of the columns were primarily caused by the absence of transverse stirrups over a length greater than twice the column width. The high damage despite low intensity of shaking was primarily due to poor structural layout resulting in additional torsion-induced forces, irregularities in strength and stiffness, discontinuities in load path and absence of column ties. Even though the 2002

earthquake vividly illustrated the seismic vulnerability of this building to future shaking, no effort was made to remedy its seismic deficiencies; the damaged portions were simply ‘repaired’ after the 2002 earthquake. And, in the 2004 earthquake, the story was repeated.

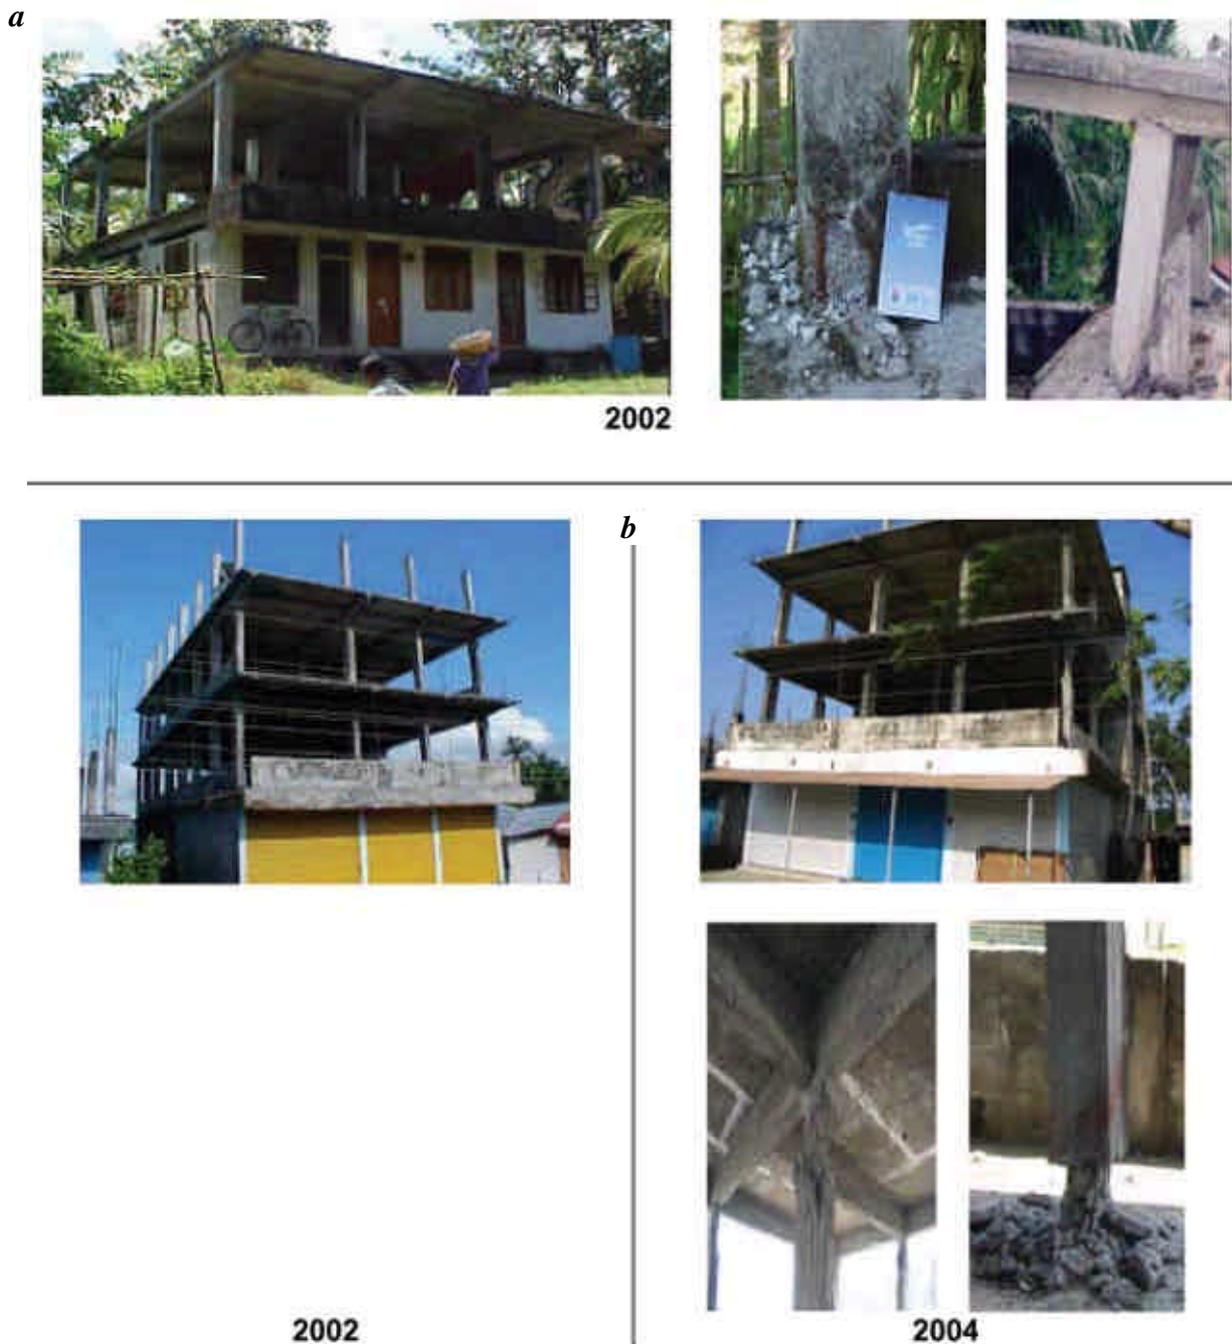
**Figure 5.** Weak RC columns cannot safely resist even less than design level earthquake forces. *a*, Unfinished residential building in Keralapuram damaged in the 2002 earthquake developing ‘plastic-hinges’ at the base of second story column due to inadequate strength. *b*, Unfinished three-storey building in Diglipur market which escaped damage in the 2002 earthquake, had severe damage to most of its columns in the second storey in the 2004 earthquake.

umns that is likely if columns are not provided adequate lateral strength and confinement at their ends, in Keralapuram, near Diglipur on the way to Aerial Bay jetty. As shown in Figure 5 *a*, the top storey (in the absence of masonry walls) acted as a vertical ‘cantilever’ and could not respond satisfactorily to the seismic moments and shears produced during the earthquake for the roof slab alone. Flexural crack-

ing (due to formation of plastic hinges) was noticed at the base of most columns of the upper storey. Clearly, the prevalent practice in the A&N Islands of providing 90° hooks in column ties at 150 mm centres in all building columns does not guarantee the confinement required for ensuring stable and ductile behaviour under strong seismic shaking expected in the region. Similar reinforcement detailing led to the failure of staircase columns at mid-height, and to the subsequent collapse of the slab supported over the staircase. Another building with similar details which escaped major damage in the 2002 earthquake (Figure 5 *b*), was badly damaged in the 2004 earthquake, in the same fashion with plastic hinges formed at one or both ends of most columns. Clearly, the RC columns designed only for gravity forces can be easily overwhelmed by lateral

forces even under moderate shaking, and could collapse if masonry infills are absent.

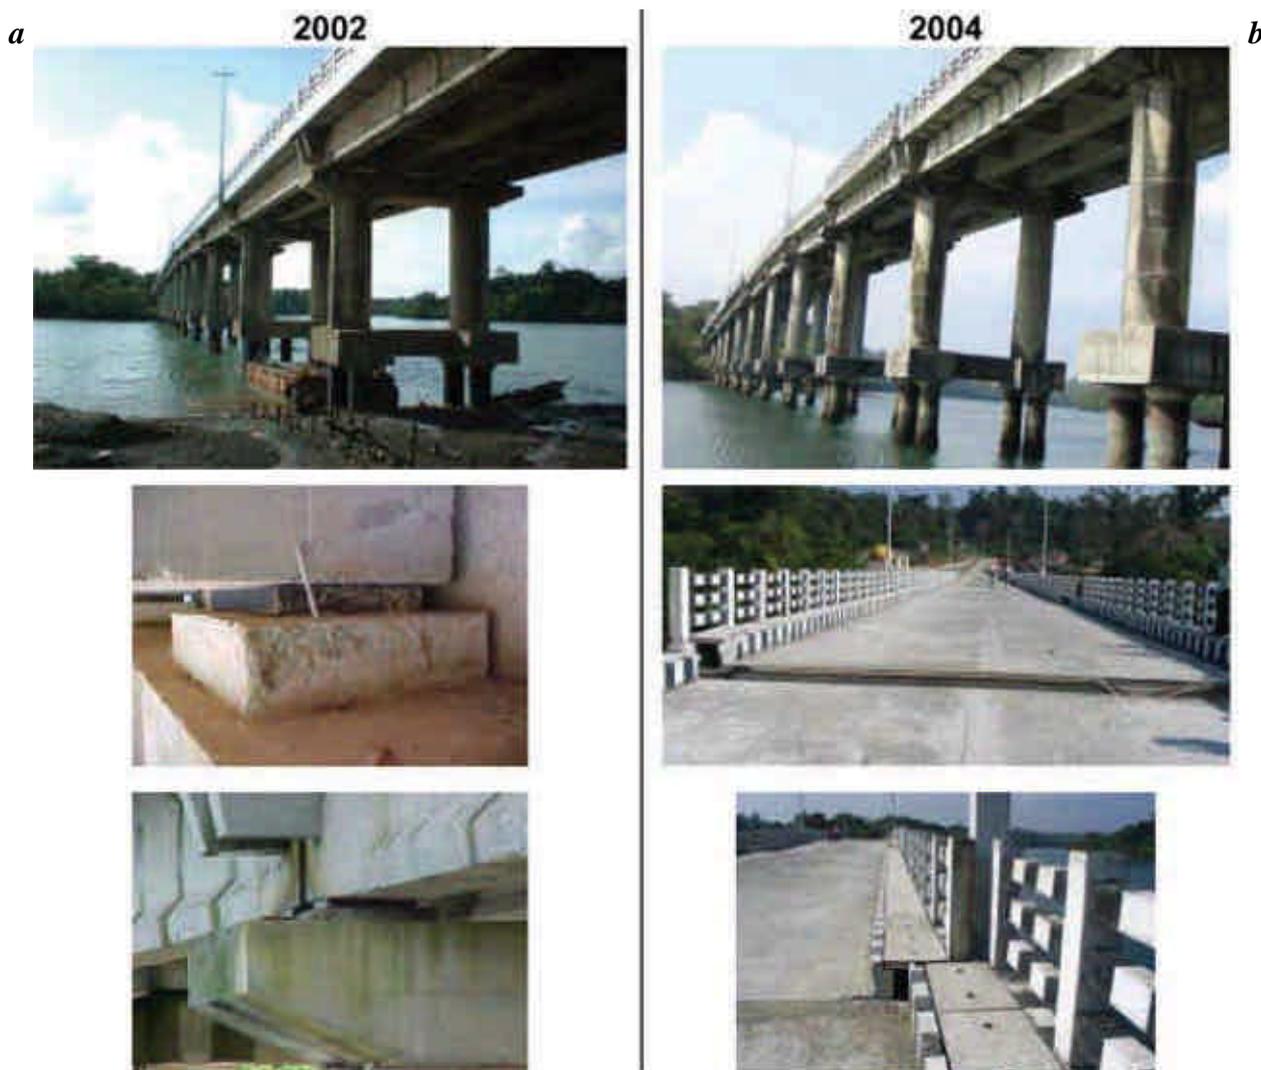
**Figure 6.** Newly constructed Chengappa RC bridge at the Austen Strait on ATR connecting North and Middle Andaman Islands. *a*, Bridge after 2002 earthquake where inadequate seating for bridge deck and absence of restrainers had raised concern for unseating of deck during probable strong motion at the site. *b*, Decks of three middle spans fell off the bearing, got displaced laterally about 700 mm and closed for even light vehicles.

The newly constructed bridge over the Austen Strait near Mayabunder that connects the Middle Andaman Island to the North Andaman Island along the Andaman Trunk Route (ATR), was not open to traffic at the time of the 2002 earthquake (Figure 6). This 268 m long RC bridge is simply supported over 13 cast-in-place piers. The bridge deck is 9.3 m wide and is made of pre-cast girders and cast *in situ* slab. The superstructure merely rested on elastomeric bearings placed on the pier caps, with no fastening between any of

them. No damage was noticed to the bridge structure in the 2002 earthquake; however, in their reconnaissance report, the authors had expressed concerns about this bridge as follows<sup>3</sup>:

'Inadequate seating of bridge deck over piers and abutments is a serious concern for its safety during a stronger earthquake in future. The bearings are simple neoprene pads which

are far from satisfactory for a bridge located in seismic zone V. Bridge deck restrainers are the minimum that need to be provided to ensure that the spans are not dislodged from the piers in future earthquakes.'

In the 2004 earthquake, the sixth, seventh and eighth spans from Mayabunder side abutment were displaced horizontally by about 700 mm and vertically by about 220 mm from their

original positions and were off-seated from their bearings. Also, the second, third, fourth, fifth, ninth and tenth spans from Mayabunder side abutment moved horizontally by about 20–150 mm. As a result, the bridge had to be closed even for light vehicles after the 2004 event, particularly when it was needed most for facilitating post-earthquake emergency services across the islands. The bridge could have been easily retrofitted in the intervening period of two years, which would have prevented unseating in this and the future earthquakes.

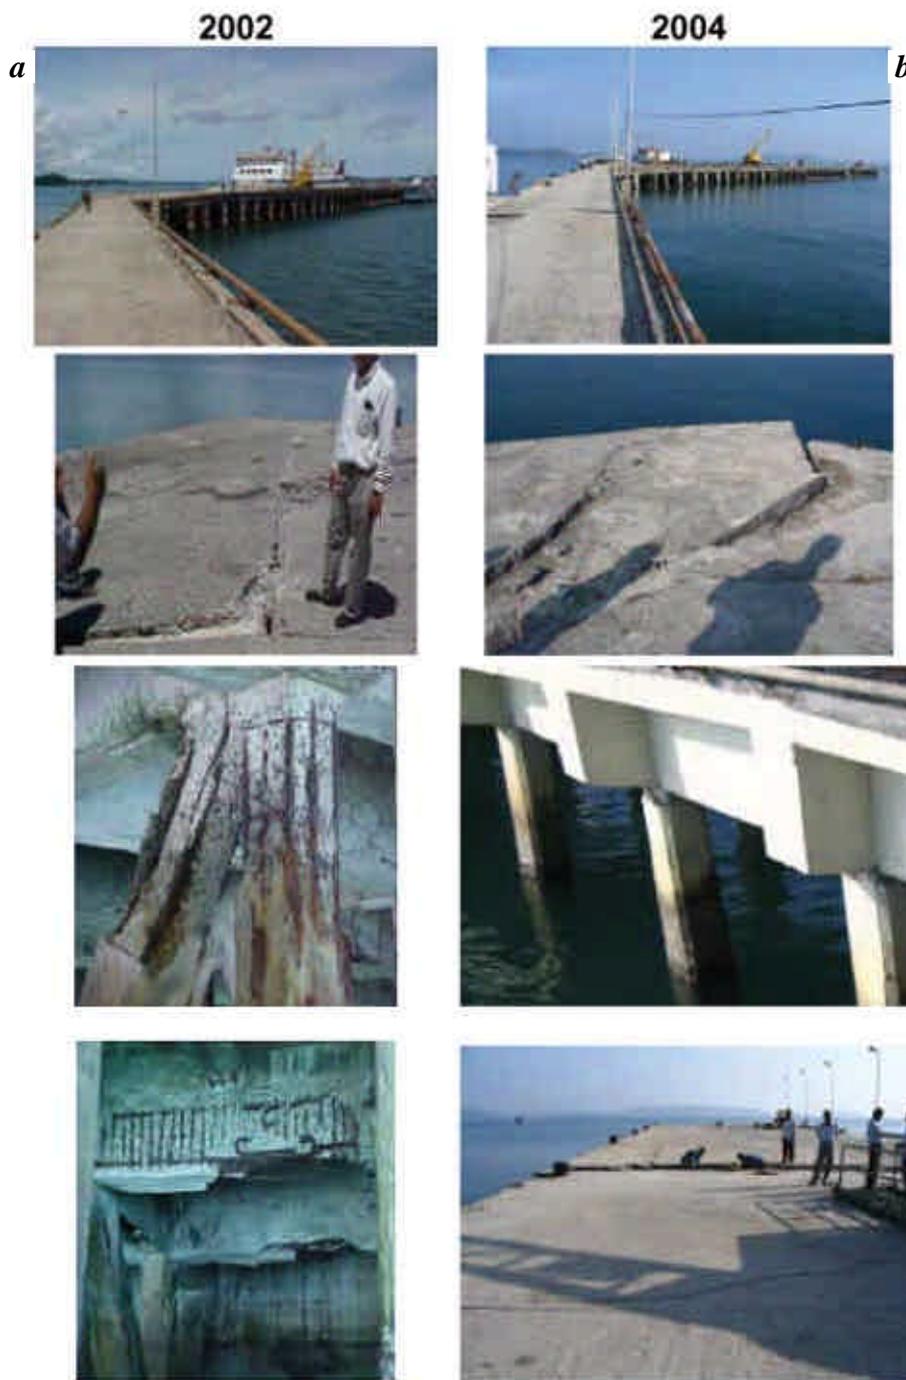
**Figure 7.** *a*, Approach jetty meeting an angle with the main berthing jetty at Diglipur harbour and pounding damage to jetty slab was concentrated at the intersection in the 2002 earthquake. Severe corrosion of reinforcing bars and spalling of cover concrete from beams, columns and batters. *b*, Besides pounding damage of slabs, the old berthing jetty 'sank' and cracked as piles at top failed in shear in the 2004 earthquake.

The Aerial Bay jetty structure consists of an approach segment meeting the main berthing structure at 120° angle (Figure 7). The berthing structure was originally constructed in 1968 and extended in 1999. The approach and berthing structures are supported by 400 mm square RC piles connected at the top by a box-type pier cap made of beams, columns, braces and slabs. In the 2002 earthquake, pounding damage was observed at the junction of the approach segment and main berthing structure; the wearing coat was broken. The piles suffered significant spalling of cover concrete at their top ends, and the reinforcements there were exposed. After the 2002 earthquake, these damaged top ends of the piles of the approach jetty were simply covered with micro-concrete for the lost reinforcement and cover; no assessment was made of the ability of the structure to resist strong seismic shaking in future. And, in the 2004 earthquake, besides the pounding damage at junctions, damage was noticed at the same top ends of piles of the approach jetty, which were covered up. However, piles of the older section of the berthing jetty failed in shear at the top ends and these were not addressed after the 2002 earthquake. This led to the sinking and cracking of the jetty slab, which is not easy to repair and is currently not being used.
