Effects of $M9$ Sumatra earthquake and tsunami of 26 December 2004

This communication is based on a study organized by IIT Kanpur, in which a total of 13 investigators, divided into six groups carried out a reconnaissance investigation on the Indian Mainland coast and islands of Andaman and Nicobar during 1–13 January 2005.

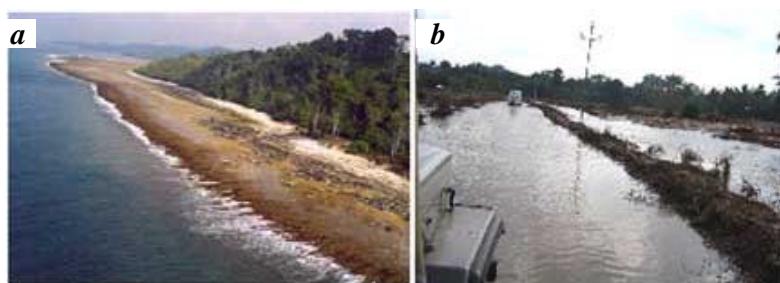
Figure 1. *a*, Up-throw of coral beds and rock strata due to uplift on the western coast of middle Andaman Island near Flat Island (Photo: Javed Malik). *b*, Seawater flooded Andaman Trunk Road at Sipi Ghat area near Port Blair during high tide, suggesting subsidence of the landmass. (Photo: Goutam Mondal).

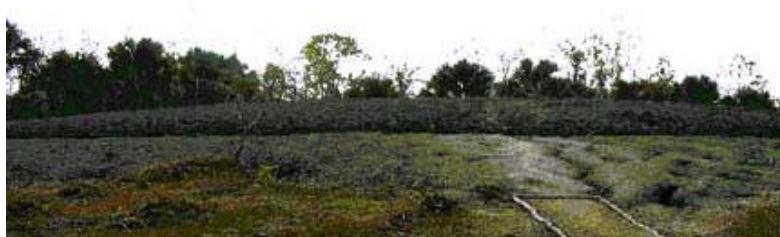
The earthquake occurred along the plate boundary marked by subduction zone between the Indian plate and the Burmese micro-plate. The subduction zone is characterized by NNW–SSE arcuate trench running parallel to the western side of the Sumatra and the Andaman–Nicobar Islands. As a result of this movement of tectonic plates, the Andaman and Nicobar Islands have experienced uplift and subsidence at different places as seen from the field evidence. At Port Blair, the sea water level has risen by about one meter, suggesting a subsidence of the landmass, whereas in Middle Andaman Islands emergence of new shallow coral beaches suggests uplift (Figure 1). The implications of rise in water level by 1 m with respect to the land are rather severe: the buildings and roads at lower elevations and the dry docks are being flooded during high tide, making them non-functional and disrupting normal activities even weeks after the event. In Middle Andaman Islands, at Baratang an older mud volcano became active again after the earthquake and also several new small mud volcanoes erupted

Figure 2. Eruption of a mud volcano near Jarawa Creek at Baratang Island in Middle Andaman, 105 km north of Port Blair (Photo: Durgesh C. Rai).

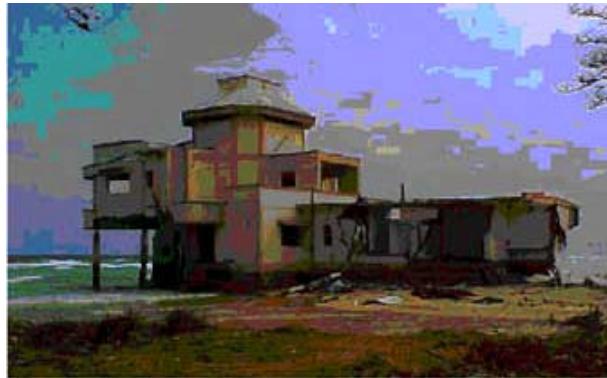
along with large ground deformation (Figure 2). Damages to buildings and other structures were primarily due to tsunami (as against due to ground shaking) on the mainland India, and in Little Andaman and other islands south of it (Figure 3); structural damage in islands north of Little Andaman was primarily due to ground shaking.

Tsunami created giant waves as high as 10–12 m; in several instances, objects were found on top of the trees after the tsunami. In the islands of Great Nicobar, Car Nicobar and Little Andaman, buildings constructed on the coast were washed away by the great waves, while those located on high grounds survived. When a number of rows of buildings existed on the coast, buildings in the first row from the sea suffered extensive damage, those in the rear rows did better due to the shielding provided by the front row. In general, constructions circular in plan (e.g., circular water tanks, light house) did better under the onslaught of tsunamis as the water could easily flow around such objects. At Car Nicobar about 100 personnel of air-

Figure 3. RC frame building (MES Inspection Bungalow) now stands in waters at the Military Residential Colony south of Malacca on the east coast of Car Nicobar Island. (Photo: C. V. R. Murty).

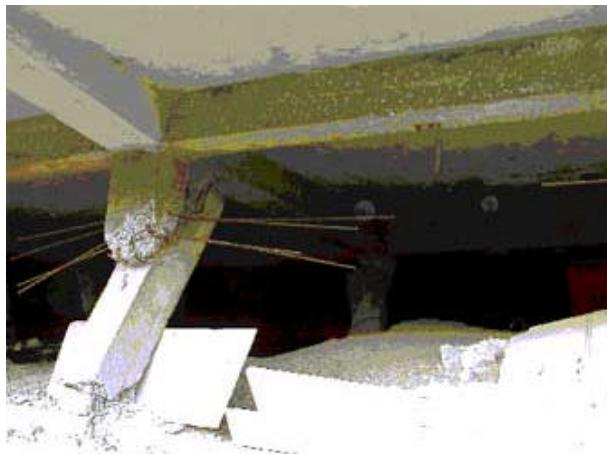
Due to the ground shaking, the wooden buildings suffered less damage compared to the more modern RC frame and concrete block masonry buildings. The latter sustained extensive damage when the seismic codes were not complied with. For instance, the Passenger Terminal Building at the Phoenix Bay in Port Blair was recently constructed but did not comply with the seismic codes. This rather expensive building has been irreparably damaged. A number of houses built by local people using reinforced concrete but without proper engineering supervision and seismic detailing collapsed. A three-storey apartment building in Port Blair on stilt columns, not complying with the codal requirements, collapsed (Figure 4). Similar damages were also observed in Rangat, and Mayabandar in northern islands as well.

Figure 4. Collapse of a three-storey reinforced concrete frame building at Port Blair (Photo: Sudhir K. Jain).

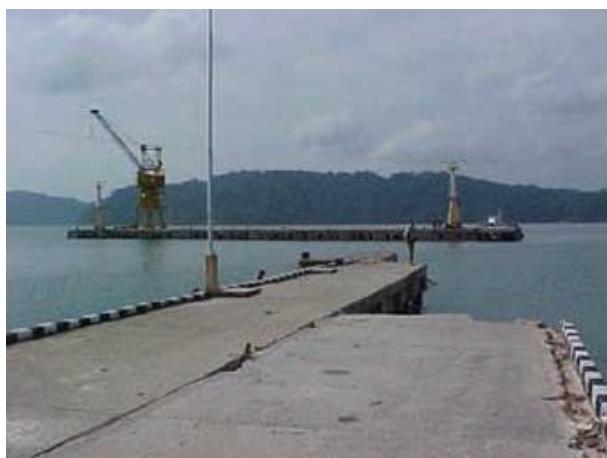
A number of jetties collapsed or were severely damaged in a number of islands

which severely affected the sea traffic and hence the relief operations (Figure 5). A new 268 m long bridge between North Andaman and Middle Andaman at Asten Strait had to be closed to even the light vehicles. The superstructure has moved on the substructure by a substantial amount and middle three spans fell off from the bearing (Figure 6a). Two of the authors had visited this region two years back after a moderate $M 6.5$ earthquake on 14 September 2002 and in their published report¹ had expressed concerns about this very bridge as follows:

Figure 5. Collapse of the 80 m segment of approach in Great Nicobar Island jetty at Campbell Bay. This has adversely affected the relief work. (Photo: C. V. R. Murty).

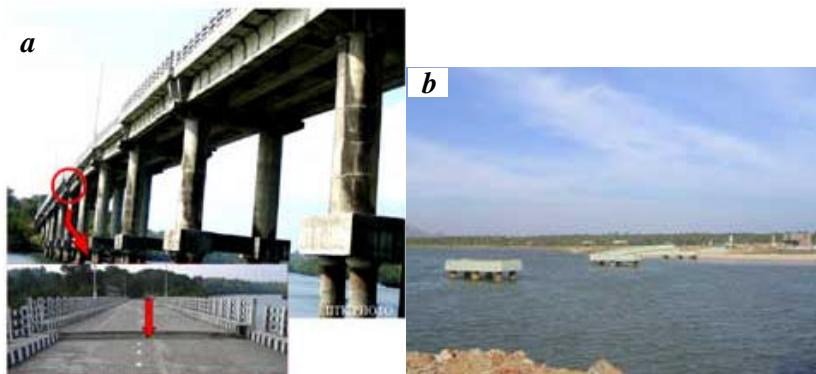
Inadequate seating of bridge deck over piers and abutments is a serious concern for its safety during a stronger earthquake in future. The bearings are simple neoprene pads which are far from satisfactory for a bridge located in seismic zone V. Bridge deck restrainers are the minimum that need to be provided to ensure that the spans are not dislodged from the piers in future earthquakes. (available at http://www.nicee.org/EQ_Reports/Andaman/Andaman_report.htm).

Figure 6. *a*, Three middle spans of Chengappa Bridge over Austen Strait connecting Middle Andaman and North Andaman Islands, 230 km north of Port Blair fell off from the bearing due to ground shaking. (Photo: Durgesh C. Rai). *b*, Complete loss of spans of the four-span RC bridge at Melmannakudi due to tsunami. (Photo: Alpa Sheth).
