North Kashmir earthquake — Reconnaissance survey

Civil Engineering faculty members of IIT Kanpur, Prof. Durgesh C. Rai and C.V.R. Murty undertook a reconnaissance survey of the earthquake affected regions in Kashmir during October 14 to 19, 2005 and visited worst affected major Indian towns Uri, Kupwara and Baramulla.

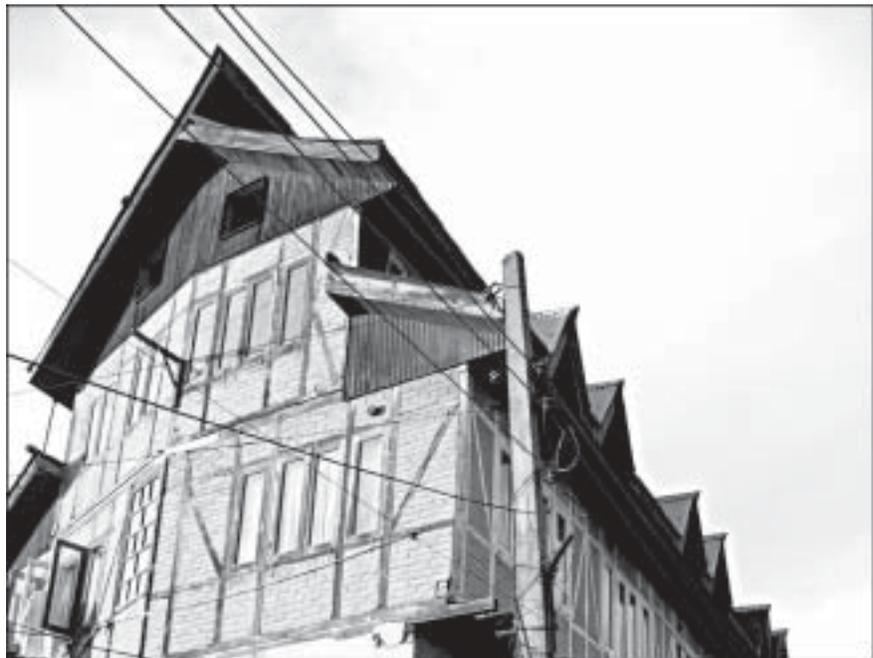
In Kashmir, traditional timber-brick masonry construction consists of burnt clay bricks filled in a framework of timber to create a patchwork of masonry. The resulting masonry referred as *Dhajji-dewari* (meaning patch quilt wall)

Fig 1 *Dhajji-dewari* system of timber-laced masonry for confining masonry in small panels withstood the earthquake without serious damage

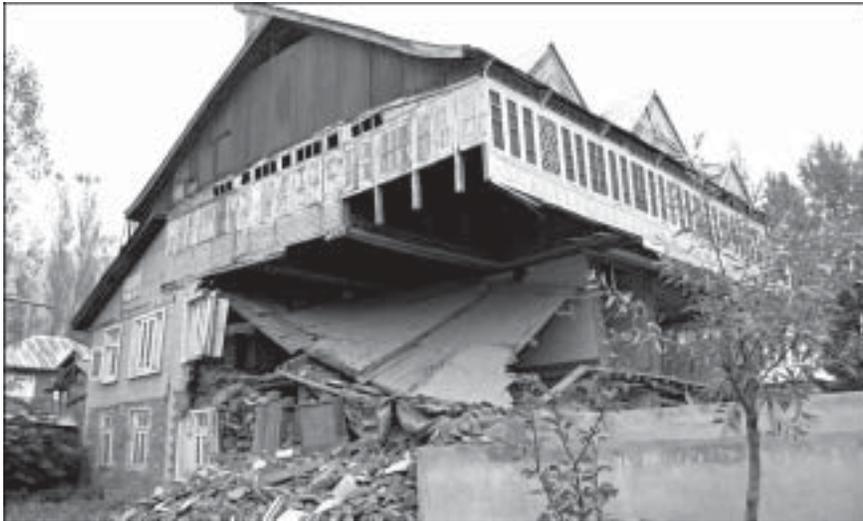
Fig 2 Timber frame and timber-laced masonry held on as stone masonry walls in lower storeys collapsed

age even when the walls in bottom storeys have collapsed, *Fig 2*.

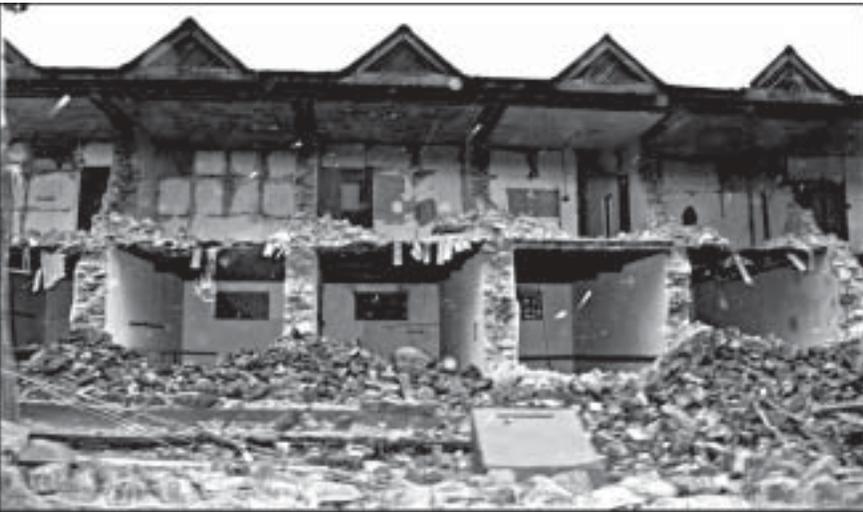
Fig 3 Collapse of stone masonry walls

Undressed random rubble type masonry was responsible for the majority of the deaths and injuries. Most of government buildings, hospitals, schools, jails, etc., built in random rubble masonry without any seismic features suffered heavy damage, especially when the structure was old, *Fig 3*. This was primarily due to the fact that the walls could not maintain their integrity during the shaking.

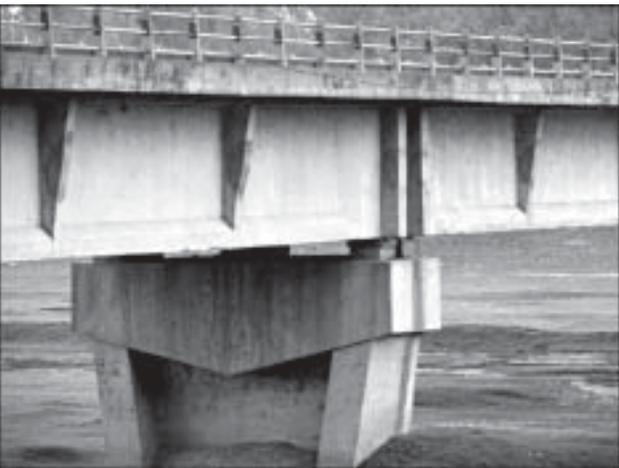
Fig 4 Prestressed concrete girder bridge lacks restrainers to prevent unseating during earthquakes at this bridge in zone V

The affected region has a number of major bridges which are extremely vulnerable due to inadequate seating and absence of other provisions to prevent unseating, *Fig 4*. Roads closer to epicentral area in the mountainous region suffered extensive landslides which resulted in the closure of traffic for many days. The road to Tangadhar from Kupwara was not open even a week after the quake. Pipelines for drinking water supply broke at several places causing severe hardships.
