## Need for earthquake-resistant design of harbour structures in India in view of their performance during the 2004 Sumatra earthquake

GOUTAM MONDAL  
DURGESH C. RAI\*

Department of Civil Engineering,  
Indian Institute of Technology,  
Kanpur 208 016, India  
\*For correspondence.  
e-mail: dcrai@iitk.ac.in

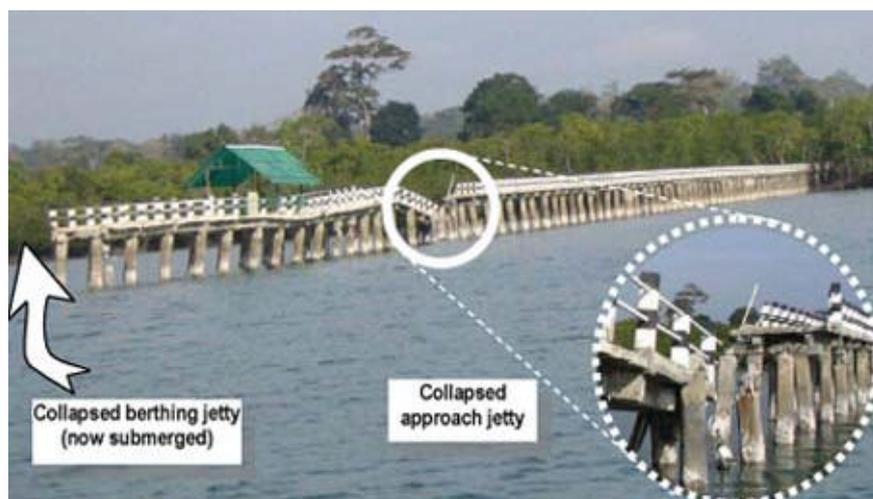
Based on the reconnaissance study conducted by the authors immediately after the earthquake, damages to harbour structures located north of Port Blair are described here along with their possible causes and remedies. Jetties at Rangat Bay and Mayabandar Harbours in the Middle Andaman Islands, and at Diglipur and Gandhinagar in the North Andaman Islands were severely affected, while Kalighat Jetty in North Andaman and Uttara Jetty in Middle Andaman sustained only minor damages (Figure 1). Berthing jetty and a portion of the approach jetty at Sagar Dweep totally collapsed during this earthquake and the jetty was not operational for post-earthquake relief operation (Figure 2).

Figure 2. Gandhinagar Jetty in North Andaman: Total collapse of berthing jetty and partial collapse of approach jetty.

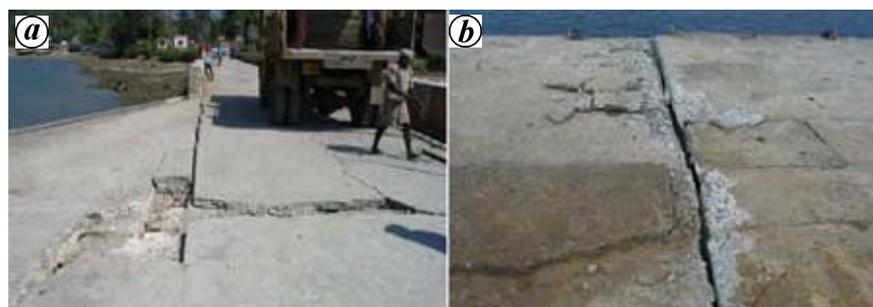
The most common damages of jetties resulted from the pounding at the construction joint of two portions of the jetties supported by piles. Pounding can occur between two adjoining structures due to

out-of-phase horizontal vibrations during earthquake shaking, if sufficient spacing is not provided to accommodate the lateral displacements. Such damages were observed between two portions of berthing jetties of Mayabandar Harbour, Diglipur Harbour and at the junction of the approach jetty and berthing jetty of Mayabandar, Rangat and Diglipur harbours and Sagar Dweep Jetty (Figure 3). Similar pounding damage was noticed at the Diglipur Harbour during the 2002 Diglipur earthquake<sup>4,5</sup>. Pounding damages could have been prevented or minimized by providing sufficient gap at the location of construction joints of the jetties. It appears that the structures were not designed for earthquake-induced lateral displacement and forces.

Figure 3. Pounding damage to jetties in Middle Andaman (a) at the junction of solid jetty and RC piled approach jetty at Rangat and (b) in the berthing jetty at Mayabandar.

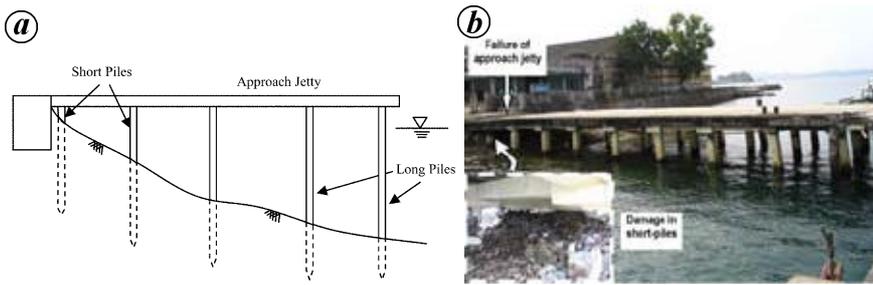
Generally berthing jetties are constructed away from the shoreline inside the sea to get sufficient water depth for anchorage of ships. These are connected to the shore by approach jetties supported by piles, which generally are embedded in the sloping ground and therefore, the unsupported length of the piles varies along the length of the approach jetty (Figure 4 a). The piles mostly affected by this earthquake were those having comparatively shorter unsupported length (short piles) towards the shoreline. These comparatively stiffer, short piles attract more shear forces during earthquakes than those with relatively longer unsupported length and hence more flexible. Such damages were observed in the piles of the approach jetty of Mayabandar where the approach slab fell-off from the ends due to damages to the short piles (Figure 4 b), while little or no damage was found in the relatively longer piles. Therefore, either proper dredging of seabed should be done to increase the unsupported length of the shorter piles or the shorter piles should be designed to withstand large amount of shear forces to prevent short-column failure during an earthquake.

**Figure 4.** *a*, Pile-supported approach jetty. *b*, Damage in short piles of the approach jetty at Mayabandar Harbour in Middle Andaman Islands.

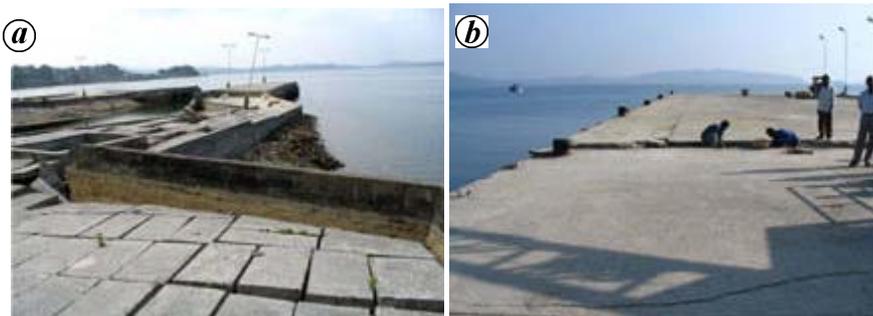
Poor performance of several ports during the past earthquakes throughout the world has been primarily due to liquefaction of the soil<sup>6</sup>. During the Sumatra earthquake, the approach pavement and seawall around the slipway at Mayabandar Harbour were severely damaged due to liquefaction of soil (Figure 5 a). Some soil improvement technique, e.g. vibro-flotation, dynamic compaction can be used to overcome the problem of soil liquefaction. Further, installation of compaction piles also can reduce the possibility of soil liquefaction.

seismic zone map)<sup>2</sup>. This inadequate detailing of transverse reinforcement may lead to shear failure at the top of the piles of the approach jetty at Diglipur Harbour. These piles were also affected during the 2002 Diglipur earthquake<sup>4,5</sup> and some cosmetic retrofitting was done with 10 to 15 cm thick micro concrete. No assessment was made of the ability of the structure to resist strong earthquake shaking in future. A part of the berthing jetty at Diglipur Harbour sunk due to pile failure underneath (Figure 5 b).

**Figure 5.** *a*, Damaged side bund of slipway at Mayabandar Harbour in Middle Andaman due to liquefaction of soil. *b*, A portion of the berthing jetty at Diglipur Harbour sunk due to failure of piles. This portion of the jetty cannot be approached by the vehicle for loading/unloading of goods.

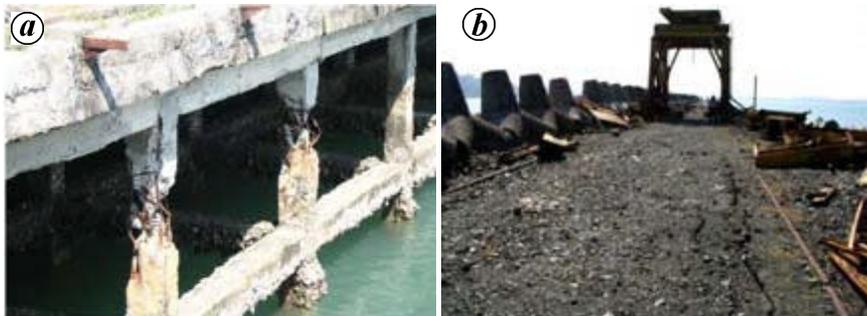
for the severe damages. Jetty structures are continuously in contact with severe and very severe coastal environment (IS 456: 2000)<sup>7</sup>, which led to the deterioration of concrete and steel reinforcement by chemical, electrochemical and mechanical processes. The common deterioration mechanisms are corrosion of steel reinforcement, alkali-aggregate reaction (AAR), carbonation, abrasion, scour and cracking. Steel corrosion is caused by electrochemical processes, AAR and carbonation result from the chemical reaction between the marine environment and concrete, and the rest are mechanical processes. Corrosion of steel reinforcement is prevalent in the splash and tidal zones where alternate wetting and drying takes place. It deteriorates the cover concrete, exposing the reinforcement of piles and deck slabs. Corrosion of the exposed reinforcement in some piles at Rangat Bay Jetty was so severe that the transverse ties were practically missing, which led to the failure of these piles during the earthquake (Figure 6a). Use of galvanized or plastic-coated reinforcing bar along with periodic maintenance of these piles may reduce the risk of such damages. Carbonation and AAR are common in submerge and tidal zones. In the tidal and splash zone, abrasion of concrete piles takes place by the repetitive impact of waves, and the water-borne sands and floating debris which destroy the concrete cover and expose the steel reinforcement. Wave action also increases strain in the piles and thereby causes cracks, which in turn accelerate corrosion of the steel reinforcement by permitting the ingress of chloride, water and oxygen. High performance epoxy-coating materials may be used to protect concrete and steel from such mechanical attack in marine environments.

Apart from jetties, other harbour structures that were affected are breakwater, slipway, passenger hall, etc. The Breakwater at Rangat Bay consists of 100 m long RC-pile trestle followed by rubble mound portion (length 375 m) which was covered with four-legged ‘tetrapods’ of 4 to 10 tons capacity each, to protect rubble from rough sea waves. Several piles of the reinforced concrete trestle were damaged exposing the steel reinforcement, while the deck slab of the trestle was not damaged. Some tetrapods on the sea side of the breakwater were dislocated due to the tsunami. Longitudinal cracks were developed at the centre at different places

along the length of the rubble mound portion of the breakwater (Figure 6b). Typical failure mode of such breakwaters during earthquakes is ‘settlement associated with significant foundation deformation beneath the rubble mound’<sup>8</sup>. Stability against horizontal forces, e.g. sea waves, earthquake loading, etc. is maintained by shear resistance of the rubble, resistance to overturning and bearing-capacity failure.

**Figure 6.** *a*, Severe corrosion led to damage of columns of approach jetty at Rangat Bay Harbour in Middle Andaman. *b*, Rangat Bay Harbour in Middle Andaman, longitudinal cracks on top of the breakwater.
