## Need for earthquake-resistant design of harbour structures in India in view of their performance during the 2004 Sumatra earthquake

GOUTAM MONDAL  
DURGESH C. RAI\*

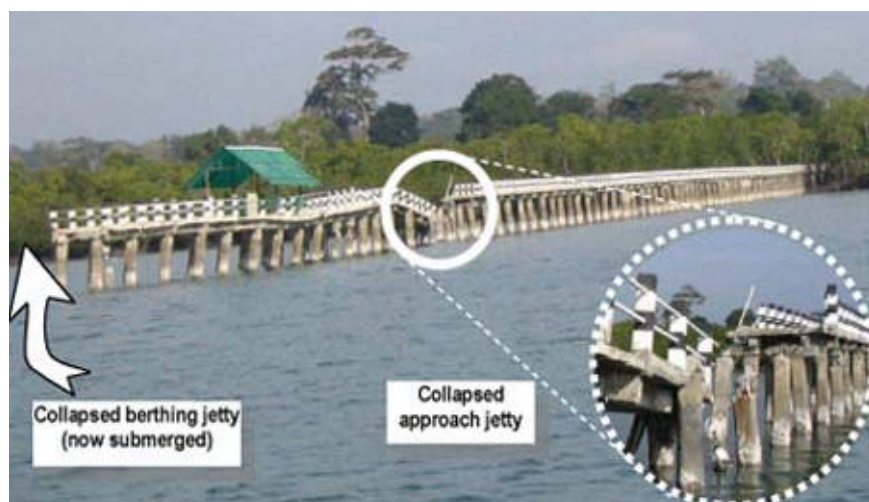
Based on the reconnaissance study conducted by the authors immediately after the earthquake, damages to harbour structures located north of Port Blair are described here along with their possible causes and remedies. Jetties at Rangat Bay and Mayabandar Harbours in the Middle Andaman Islands, and at Diglipur and Gandhinagar in the North Andaman Islands were severely affected, while Kalighat Jetty in North Andaman and Uttara Jetty in Middle Andaman sustained only minor damages (Figure 1). Berthing jetty and a portion of the approach jetty at Sagar Dweep totally collapsed during this earthquake and the jetty was not operational for post-earthquake relief operation (Figure 2).

Figure 2. Gandhinagar Jetty in North Andaman: Total collapse of berthing jetty and partial collapse of approach jetty.

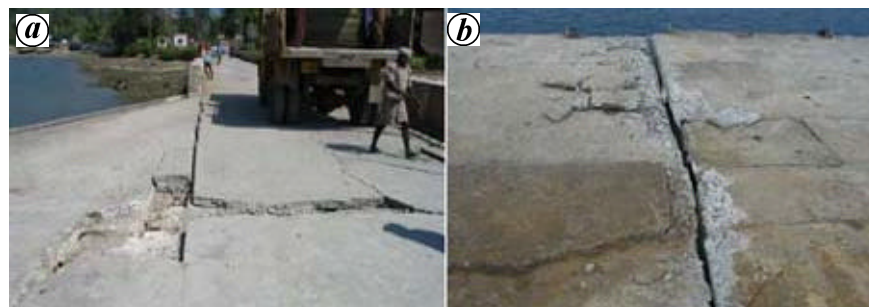
The most common damages of jetties resulted from the pounding at the construction joint of two portions of the jetties supported by piles. Pounding can occur between two adjoining structures due to

out-of-phase horizontal vibrations during earthquake shaking, if sufficient spacing is not provided to accommodate the lateral displacements. Such damages were observed between two portions of berthing jetties of Mayabandar Harbour, Diglipur Harbour and at the junction of the approach jetty and berthing jetty of Mayabandar, Rangat and Diglipur harbours and Sagar Dweep Jetty (Figure 3). Similar pounding damage was noticed at the Diglipur Harbour during the 2002 Diglipur earthquake<sup>4,5</sup>. Pounding damages could have been prevented or minimized by providing sufficient gap at the location of construction joints of the jetties. It appears that the structures were not designed for earthquake-induced lateral displacement and forces.

Figure 3. Pounding damage to jetties in Middle Andaman (a) at the junction of solid jetty and RC piled approach jetty at Rangat and (b) in the berthing jetty at Mayabandar.

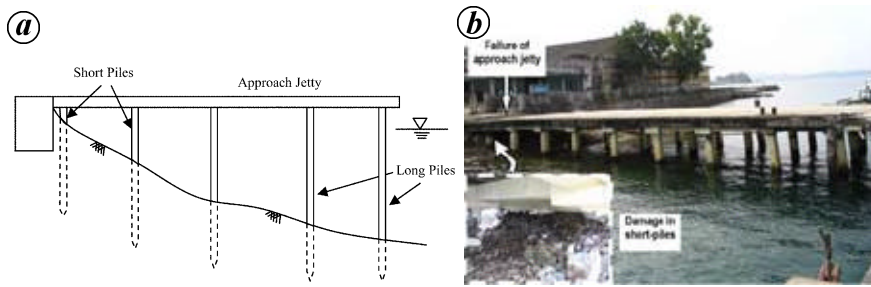
Generally berthing jetties are constructed away from the shoreline inside the sea to get sufficient water depth for anchorage of ships. These are connected to the shore by approach jetties supported by piles, which generally are embedded in the sloping ground and therefore, the unsupported length of the piles varies along the length of the approach jetty (Figure 4 a). The piles mostly affected by this earthquake were those having comparatively shorter unsupported length (short piles) towards the shoreline. These comparatively stiffer, short piles attract more shear forces during earthquakes than those with relatively longer unsupported length and hence more flexible. Such damages were observed in the piles of the approach jetty of Mayabandar where the approach slab fell-off from the ends due to damages to the short piles (Figure 4 b), while little or no damage was found in the relatively longer piles. Therefore, either proper dredging of seabed should be done to increase the unsupported length of the shorter piles or the shorter piles should be designed to withstand large amount of shear forces to prevent short-column failure during an earthquake.

**Figure 4.** *a*, Pile-supported approach jetty. *b*, Damage in short piles of the approach jetty at Mayabandar Harbour in Middle Andaman Islands.

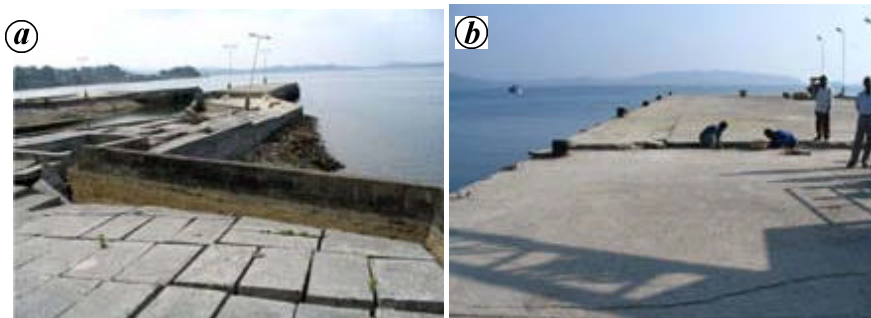
Poor performance of several ports during the past earthquakes throughout the world has been primarily due to liquefaction of the soil<sup>6</sup>. During the Sumatra earthquake, the approach pavement and seawall around the slipway at Mayabandar Harbour were severely damaged due to liquefaction of soil (Figure 5 a). Some soil improvement technique, e.g. vibro-flotation, dynamic compaction can be used to overcome the problem of soil liquefaction. Further, installation of compaction piles also can reduce the possibility of soil liquefaction.

seismic zone map)<sup>2</sup>. This inadequate detailing of transverse reinforcement may lead to shear failure at the top of the piles of the approach jetty at Diglipur Harbour. These piles were also affected during the 2002 Diglipur earthquake<sup>4,5</sup> and some cosmetic retrofitting was done with 10 to 15 cm thick micro concrete. No assessment was made of the ability of the structure to resist strong earthquake shaking in future. A part of the berthing jetty at Diglipur Harbour sunk due to pile failure underneath (Figure 5 b).

**Figure 5.** *a*, Damaged side bund of slipway at Mayabandar Harbour in Middle Andaman due to liquefaction of soil. *b*, A portion of the berthing jetty at Diglipur Harbour sunk due to failure of piles. This portion of the jetty cannot be approached by the vehicle for loading/unloading of goods.

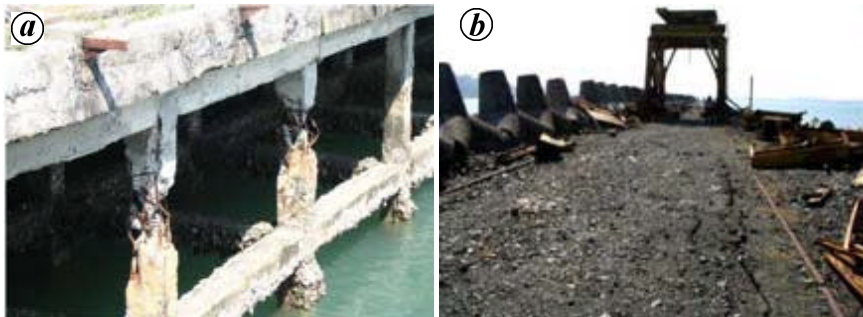
for the severe damages. Jetty structures are continuously in contact with severe and very severe coastal environment (IS 456: 2000)<sup>7</sup>, which led to the deterioration of concrete and steel reinforcement by chemical, electrochemical and mechanical processes. The common deterioration mechanisms are corrosion of steel reinforcement, alkali-aggregate reaction (AAR), carbonation, abrasion, scour and cracking. Steel corrosion is caused by electrochemical processes, AAR and carbonation result from the chemical reaction between the marine environment and concrete, and the rest are mechanical processes. Corrosion of steel reinforcement is prevalent in the splash and tidal zones where alternate wetting and drying takes place. It deteriorates the cover concrete, exposing the reinforcement of piles and deck slabs. Corrosion of the exposed reinforcement in some piles at Rangat Bay Jetty was so severe that the transverse ties were practically missing, which led to the failure of these piles during the earthquake (Figure 6a). Use of galvanized or plastic-coated reinforcing bar along with periodic maintenance of these piles may reduce the risk of such damages. Carbonation and AAR are common in submerge and tidal zones. In the tidal and splash zone, abrasion of concrete piles takes place by the repetitive impact of waves, and the water-borne sands and floating debris which destroy the concrete cover and expose the steel reinforcement. Wave action also increases strain in the piles and thereby causes cracks, which in turn accelerate corrosion of the steel reinforcement by permitting the ingress of chloride, water and oxygen. High performance epoxy-coating materials may be used to protect concrete and steel from such mechanical attack in marine environments.

Apart from jetties, other harbour structures that were affected are breakwater, slipway, passenger hall, etc. The Breakwater at Rangat Bay consists of 100 m long RC-pile trestle followed by rubble mound portion (length 375 m) which was covered with four-legged ‘tetrapods’ of 4 to 10 tons capacity each, to protect rubble from rough sea waves. Several piles of the reinforced concrete trestle were damaged exposing the steel reinforcement, while the deck slab of the trestle was not damaged. Some tetrapods on the sea side of the breakwater were dislocated due to the tsunami. Longitudinal cracks were developed at the centre at different places

along the length of the rubble mound portion of the breakwater (Figure 6b). Typical failure mode of such breakwaters during earthquakes is ‘settlement associated with significant foundation deformation beneath the rubble mound’<sup>8</sup>. Stability against horizontal forces, e.g. sea waves, earthquake loading, etc. is maintained by shear resistance of the rubble, resistance to overturning and bearing-capacity failure.

**Figure 6.** *a*, Severe corrosion led to damage of columns of approach jetty at Rangat Bay Harbour in Middle Andaman. *b*, Rangat Bay Harbour in Middle Andaman, longitudinal cracks on top of the breakwater.
