Performance of Structures in the Andaman and Nicobar Islands (India) during the December 2004 Great Sumatra Earthquake and Indian Ocean Tsunami

C.V.R. Murty,^{a)} M.EERI, Durgesh C. Rai,^{a)} M.EERI, Sudhir K. Jain,^{a)} M.EERI, Hemant B. Kaushik,^{a)} Goutam Mondal,^{a)} and Suresh R. Dash^{a)}

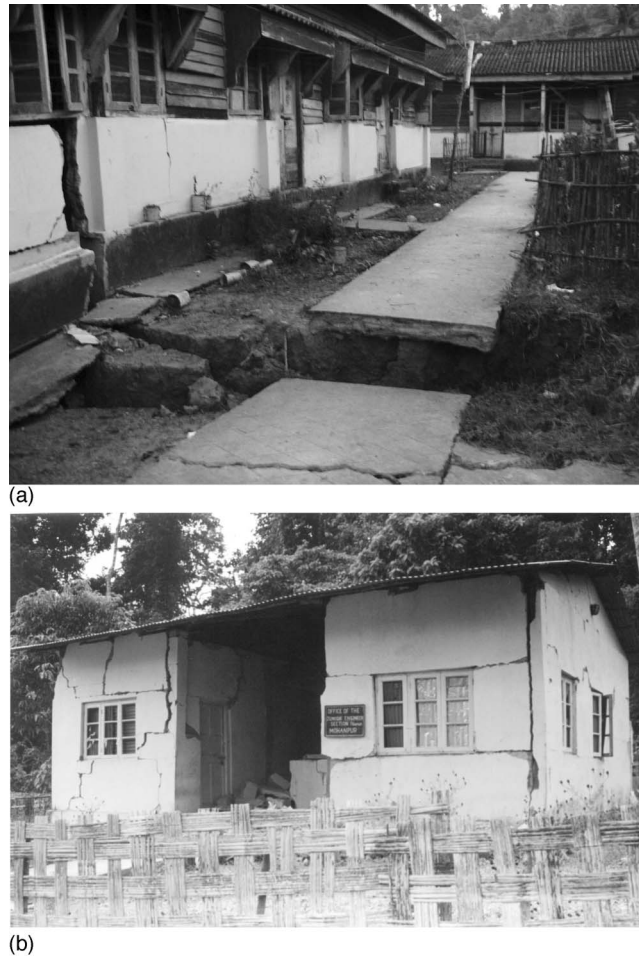
Amplification of ground motion coupled with liquefaction and lateral spreading of alluvial soil caused severe damage to the colony. Liquefaction in the form of sand boils was observed at different places. The ground shaking was so strong that people were not able to stand during the earthquake. Lateral spreading and other liquefaction-related phenomena were responsible for extensive damage to residential buildings (Figure 4) and health care facilities in the low-lying areas, especially in the vicinity of water bodies,

Figure 4. Damage to residential buildings: (a) severe damage to houses in the government residential area in Nimbudera village in Middle Andaman Island, where large ground motion and liquefaction were noted; and (b) at Mohanpur village in North Andaman Island, a single-story masonry building—despite having a light roof—sustained severe damage due to the lack of any earthquake-resistant features; the area around the building seems to have suffered significant amplification of the ground motion (photos: G. Mondal).

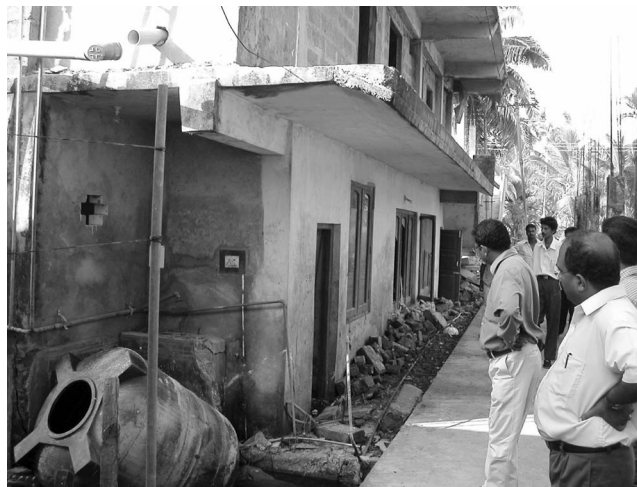
Figure 5. Settlement of RC buildings at Bamboo Flat near Port Blair (photo: H. Kaushik).

Settlement of buildings was observed at several locations in Port Blair, possibly due to foundation failure, erosion/settlement of underlying soil due to inundation of the region by tsunami waves, and liquefaction. In most cases, buildings near the sea settled in the earthquake, and signs of liquefaction, if any, were washed away when the tsunami struck. Two RC buildings and several shops in the shopping complex in Bamboo Flat near Port Blair settled, possibly due to liquefaction (Figure 5). Several buildings in the harbor area in Port Blair settled due to structural failure of some of the foundation piles. Figure 6a shows settlement of piles in the passenger terminal building at Haddo Wharf. Figure 6b shows severe damage at the junction of an RC pile and its pile cap supporting an RC building used for storage at Haddo Wharf.

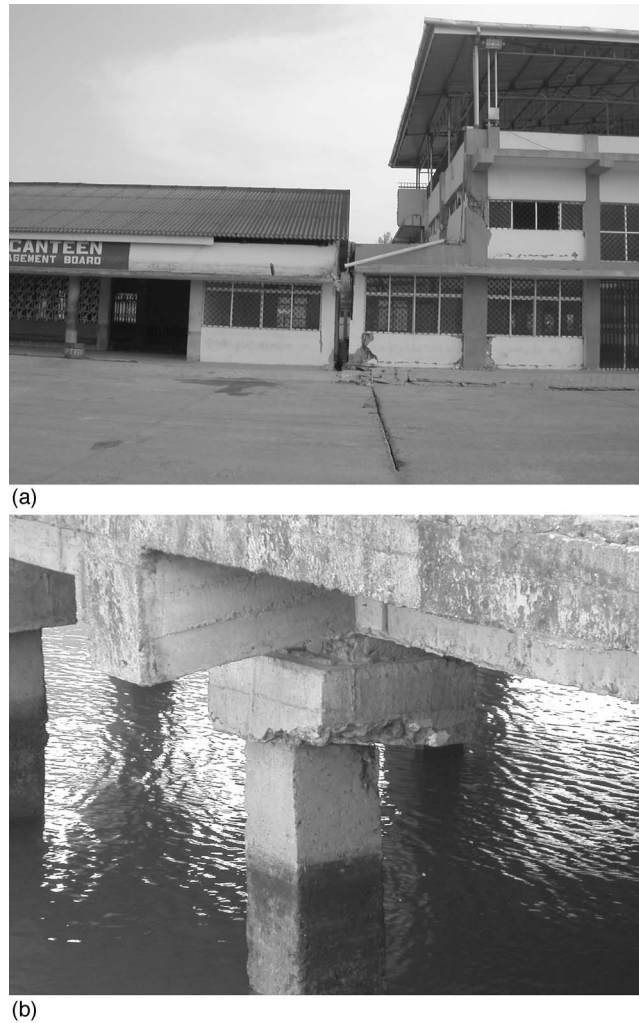
Figure 6. (a) Foundation (RC piles) settlement/failure resulted in settlement of the passenger terminal building at Haddo Wharf. (b) Dislocation of a pile cap in an RC storage building at Haddo Wharf (photos: H. Kaushik).

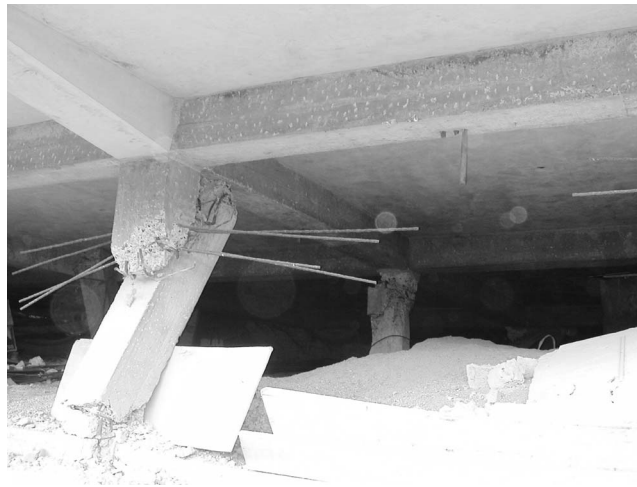
Figure 7. Buildings in Port Blair that were subjected to similar ground shaking intensity performed differently: a three-story RC-frame building collapsed in a brittle manner (photo: S. Jain).

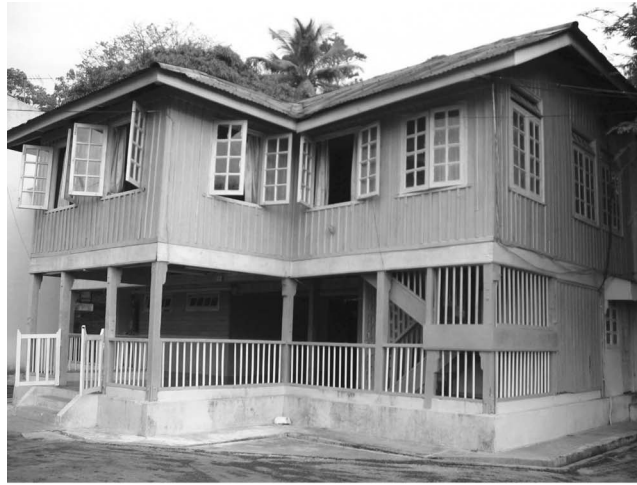
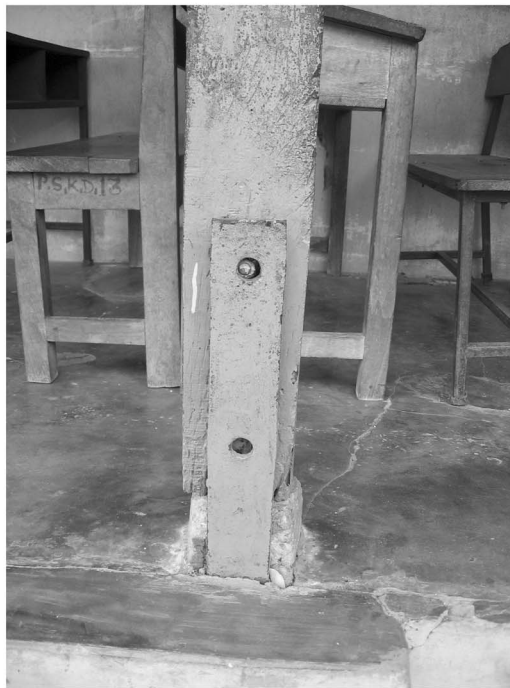
was observed to be poorly maintained (Figure 8b). However, even these structures performed well in contrast to the brittle unreinforced masonry buildings.

Figure 8. (a) In the Port Blair area and Rangat, wooden buildings with simple configurations performed well during ground shaking. (b) Some buildings with poor maintenance of the joinery between the wood frame and masonry plinth also performed well (photos: D. Rai).

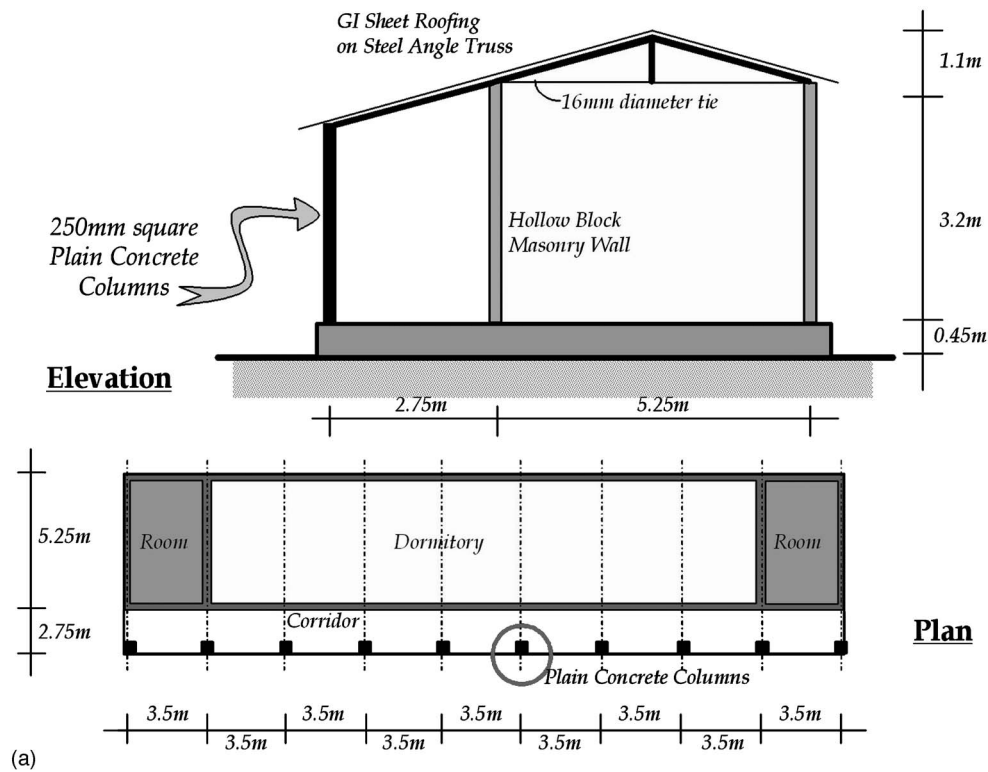
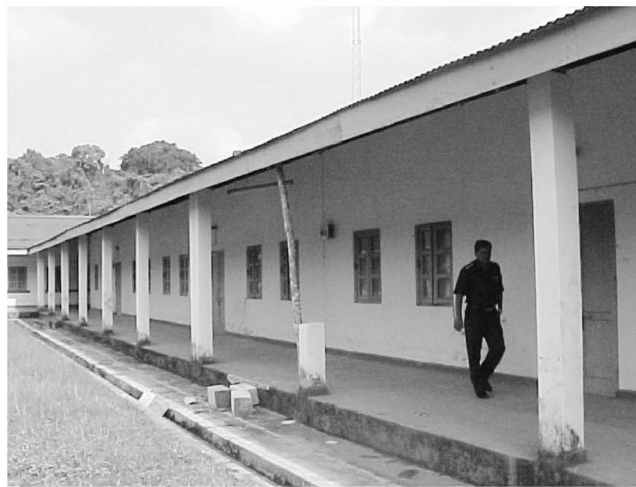
built as load-bearing masonry during 1982–83 by the Border Roads Organization (BRO). The typical barracks unit is 31.5 m long and 5.25 m wide. The ends have 3.5-m-wide rooms, but the rest of the building does not have cross walls. The superstructure is built of precast hollow cement blocks (twin cell with a 25-mm thick wall, 390 mm long \times 190 mm wide \times 190 mm high), while the foundation is in precast solid cement blocks. The veranda has 250-mm square plain concrete columns. The choice of plain concrete columns was made by the BRO to reduce the use of wood; this is different from the usual choice of wooden columns in the traditional structures of similar configuration in the island area. The roof consists of corrugated galvanized iron (GI) sheets supported on a steel angle truss. The bottom chord of the truss over the room is a 16-mm-diameter bar running across the room (Figure 11a). However, there is no such truss over the veranda area; the rafter rests directly on these plain concrete columns without any horizontal ties. A continuous lintel band is provided all around, but no vertical reinforcement is provided at wall corners and openings. However, two HYSD bars of 8 mm diameter are provided at every fourth course (\sim 800 mm centers) in the mortar bed joints. In general, these structures sustained horizontal cracks in the wall between the eave level and the lintel band along the full length of the building. Also, the plain concrete columns in the veranda area sustained cracks at the top and bottom. In one such building, such a column even collapsed (Figure 11b). Similar buildings with a larger number of cross walls performed better.

Figure 11. Military barracks in the Army land area at Campbell Bay in Great Nicobar Island: (a) typical dimensions of a unit, (b) collapse of a plain concrete corridor column (photo: S. Dash).

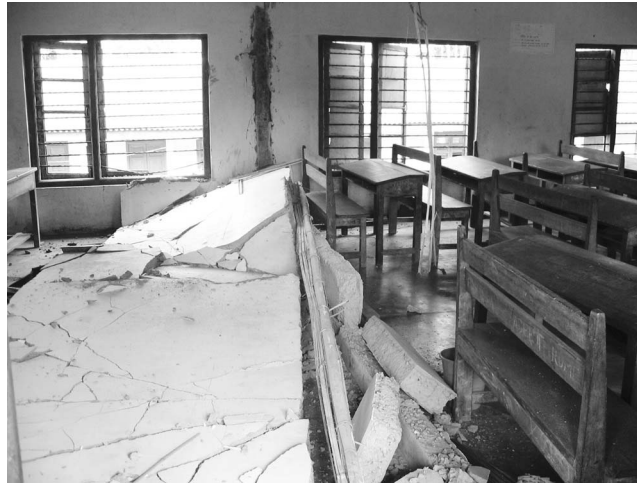
Figure 12. Slender masonry walls became dislodged because of out-of-plane instability and poor connection or no connection to the surrounding structural elements at the senior secondary school building in Adazigin, Middle Andaman Island (photo: D. Rai).

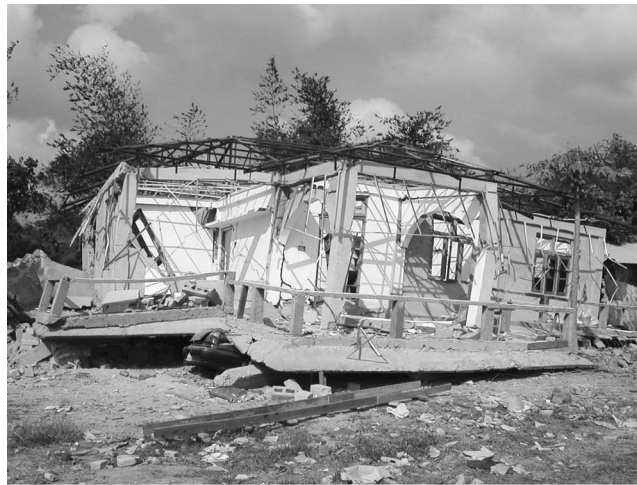
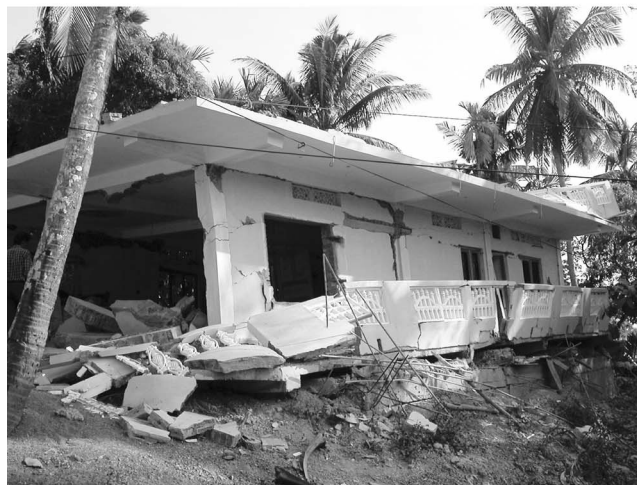
Figure 13. An RC-frame residential building that had been built on stilts near Port Blair collapsed because of severe seismic shaking in the Bamboo Flat area (photos: S. Jain).

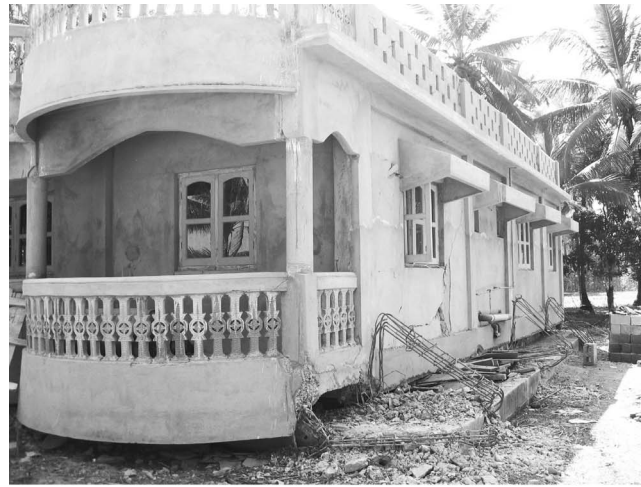
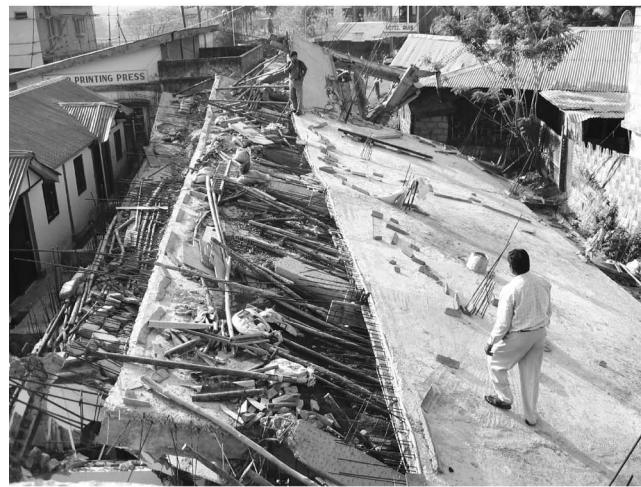
Figure 14. (a) Collapse of an open-story RC house at Rampur, near Mayabandar (photo: D. Rai). (b) Collapse of the RC bare frame of a three-story building under construction at Rangat, Middle Andaman Island (photo: G. Mondal).

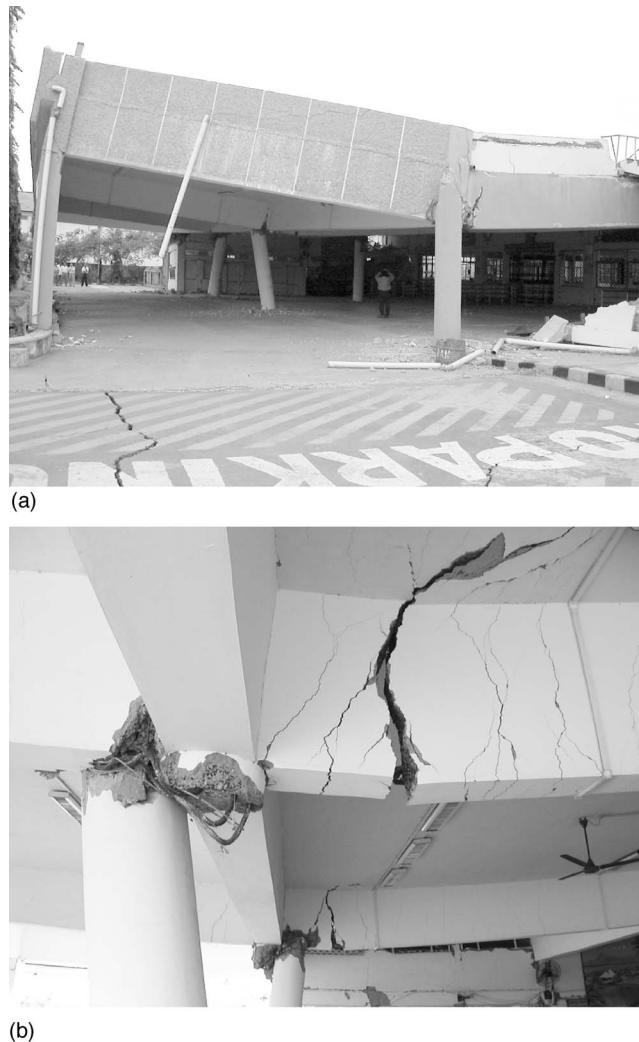
Figure 15. (a) The passenger terminal building at Haddo Wharf collapsed due to the failure of brittle RC columns (photo: S. Jain). (b) Failure of RC columns and large flexural cracks in RC beams (photo: H. Kaushik).

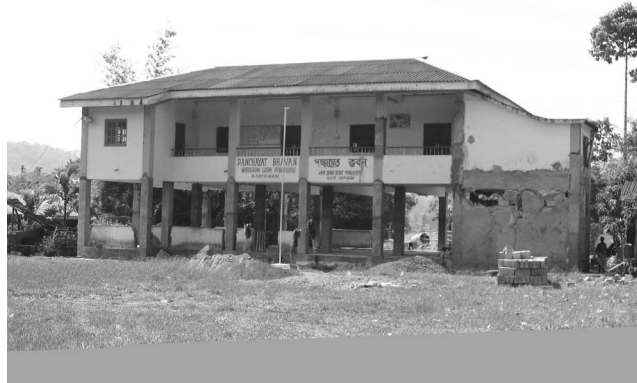
Figure 16. The Nabagram *panchayat bhavan* building was shaken by two earthquakes—on 14 September 2002 and 26 December 2004. Severe cracking and damage were observed in the soft first-story columns, and columns in the first story that were primarily damaged in the 2002 earthquake because of “missing” ties were now more severely damaged in the 2004 earthquake, even though they had apparently been “retrofitted” (photo: D. Rai).

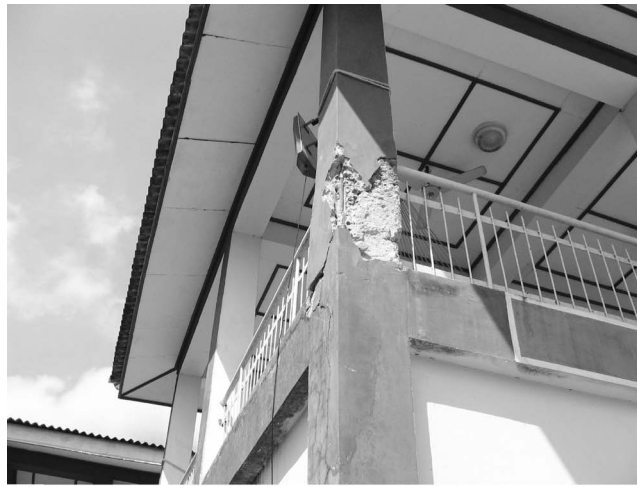
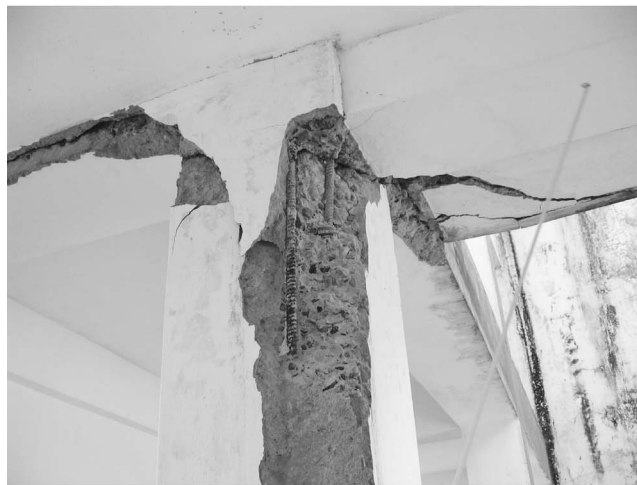
Figure 17. A two-story RC-frame Turtle Resort building in Shibpur, south of Diglipur, with an irregular structural configuration was also damaged during the 14 September 2002 $M_L=6.0$ earthquake in North Andaman Island, but only cosmetic repairs were undertaken after that event. This building then sustained damage during the 26 December 2004 earthquake in the same places. (a) Bottom of an upper-story column, and (b) top of a lower-story column (photos: D. Rai).

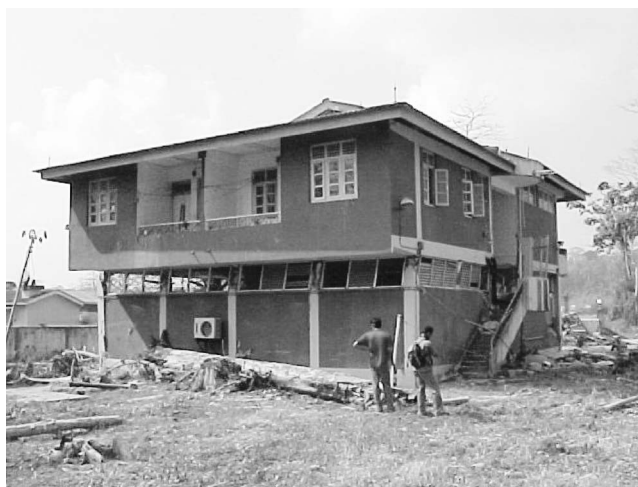
Figure 18. The BSNL telephone exchange building on higher ground at Hut Bay in Little Andaman Island was severely damaged due to earthquake shaking—it was twisted about the vertical axis during the shaking and sustained severe irreparable damage in its structural members. The structure was also flooded by the tsunami runup, and severe loss was sustained in non-structural elements and contents (photo: C. Murty).

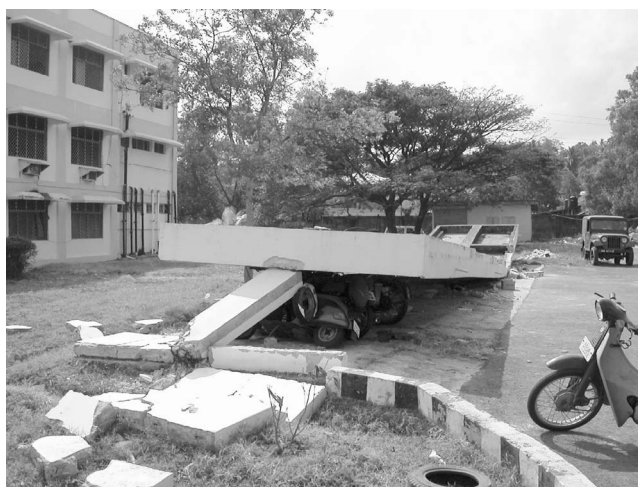
Figure 19. Collapse of a 2-m-high shelter for bicycles and motor scooters near the Port Management Board office complex in Port Blair (photo: S. Jain).

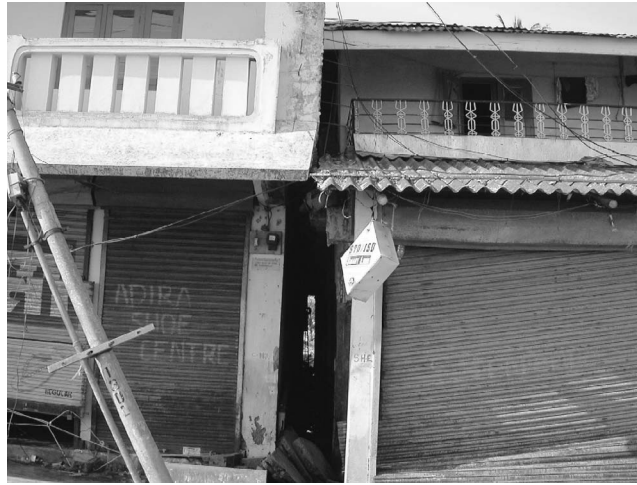
Because of the scarcity of open space, buildings in Port Blair are generally constructed very close to each other without a sufficient gap for large lateral deformations during strong ground shaking. Several buildings in the Bamboo Flat shopping complex (Figure 21) suffered substantial cracking and damage at the floor level in slabs, and in columns due to pounding with the adjacent buildings. The L-shaped three-story RC school building at Mohanpura in Port Blair, constructed in stages between 1986 and 1989, was damaged at the expansion joints in the building between different blocks.

Figure 21. Pounding occurred between closely constructed buildings in and around Port Blair. These buildings are in the Bamboo Flat shopping complex (photo: S. Jain).

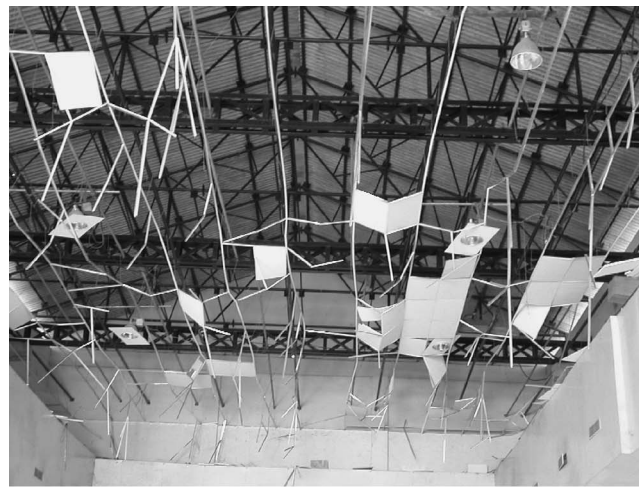
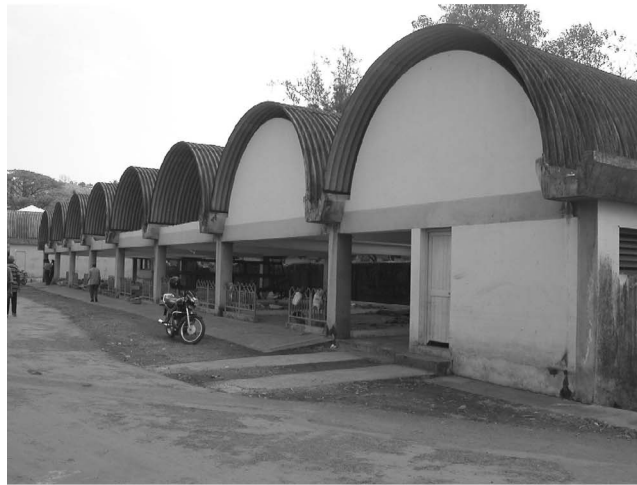
In the old dry dock in the marine jetty dry dock complex in Port Blair, several instances of nonstructural damage due to earthquake shaking were observed. The false ceiling of a fiberglass boat shed collapsed completely, disrupting the already-affected work in the shed (Figure 22a). Laterally unsupported masonry walls in shell structures used as a storage area in the dry dock complex collapsed due to the absence of any confining elements (Figure 22b).

Figure 22. (a) Collapsed false ceiling of the fiberglass boat shed in the marine jetty dry dock complex (photo: S. Jain). (b) Out-of-plane collapse of nonstructural masonry walls in a storage structure at the dry dock (photo: H. Kaushik).

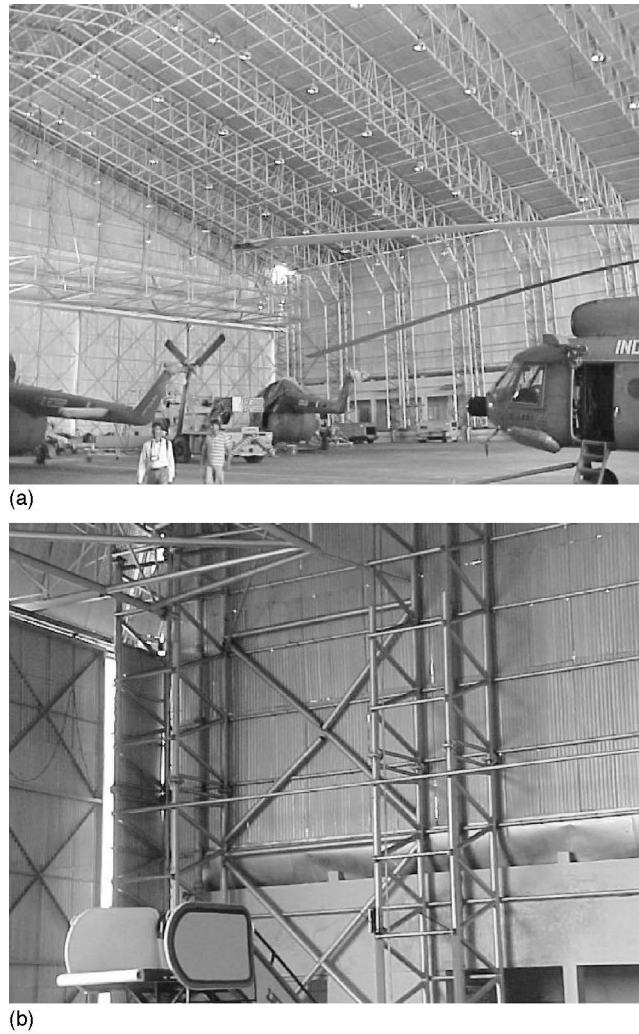
The steel tubular frame structure of the helicopter hangar at Car Nicobar Airport is $60 \text{ m} \times 60 \text{ m}$ in plan, with a gable roof 14 m tall at the eave level and 21.5 m at the crown. Eleven tubular trusses at 6-m spacing run along the transverse direction of the hangar. Each tubular truss has a $1.5 \text{ m} \times 1.7 \text{ m}$ rectangular plan configuration (1.7 m along the transverse direction of the hangar) with 160-mm-diameter pipes as corner elements, 100-mm-diameter pipes as inclined braces along the transverse direction, and 80-mm pipes as horizontal braces in the longitudinal direction of the truss. The 11 tubular gable trusses are connected to each other through steel pipes running in the longitudinal direction, except in the end bays, where three X-braces are provided over the 14-m vertical height between the end two trusses (Figure 23a). The braces are made by welding the two pipes directly to each other without any gusset plate arrangement; the fillet welding was performed along the curved interface surface. During the earthquake, the end X-braces failed along these curved weld lines (Figure 23b). The third-story braces even fell down to the ground.

Figure 23. Helicopter hangar at Car Nicobar Airport: (a) tubular truss configuration, and (b) weld failure at the X-braces in the end panels (photos: C. Murty).

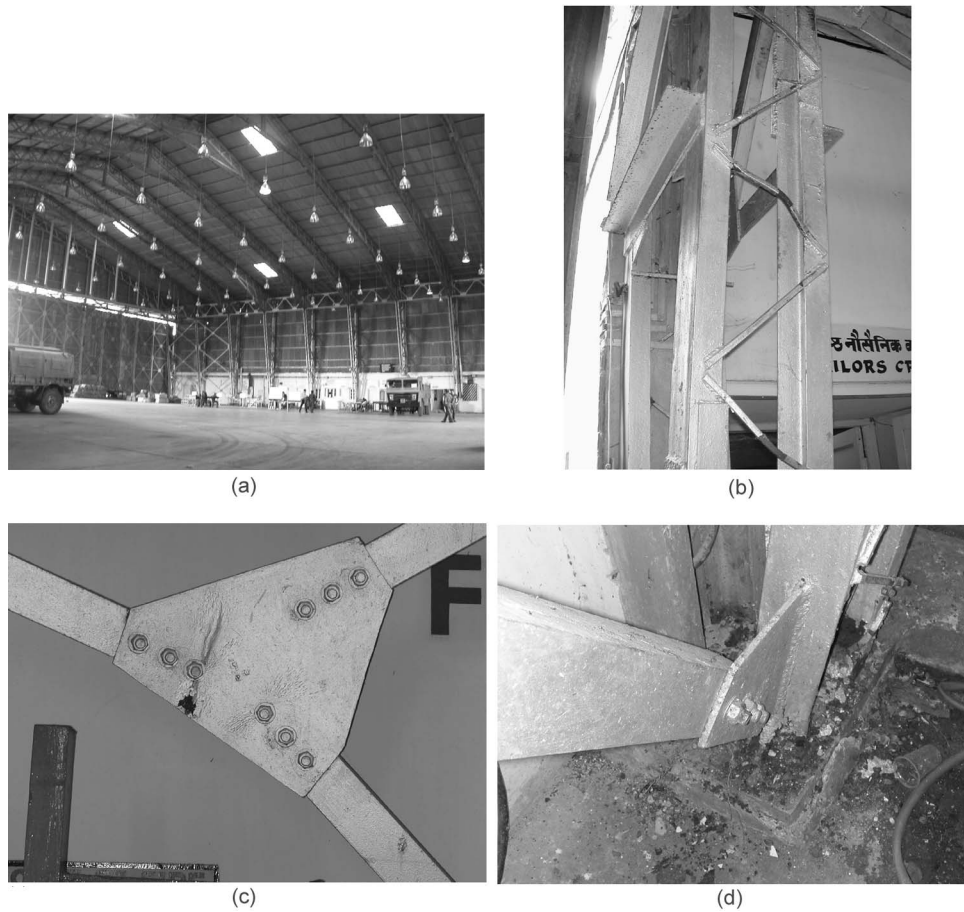
The hangar structure at Port Blair Airport, known as the INS Utkarsh Complex, also suffered slight damage due to ground shaking. The steel-frame structure, constructed in 1986, was $50 \text{ m} \times 50 \text{ m}$ in plan, with a roof truss 10 m tall at the eave level and 14 m at the crown (Figure 24a). Many of the braces in the steel columns, which were made of 15-mm square bars, were found to be buckled (Figure 24b). Several of the gusset plates connecting inclined brace members between adjacent columns buckled because of non-concurrent members meeting at the plate (Figure 24c). Severe corrosion was observed at the junction of the base plate and columns (Figure 24d).

Figure 24. INS hangar at Port Blair Airport: (a) truss configuration, (b) buckling of braces in steel columns (photos: H. Kaushik), (c) buckling of gusset plates connecting nonconcurrent braces between adjacent columns, and (d) severe corrosion at the junction of the base plate and column at the ground level (photos: S. Jain).

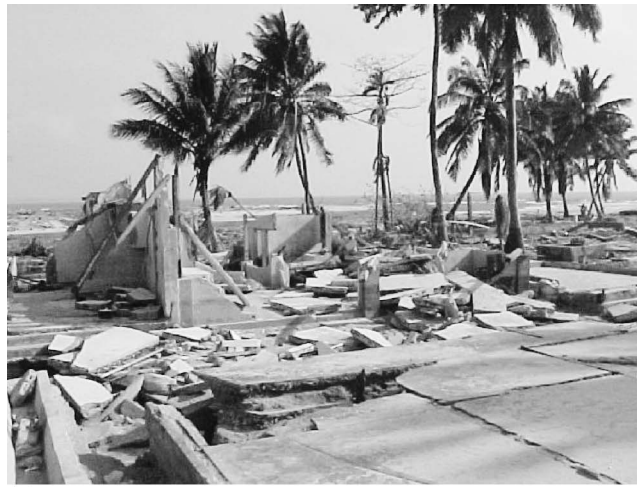
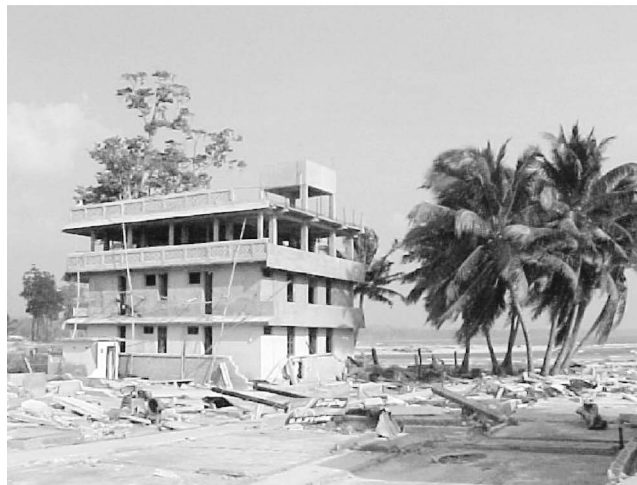
Figure 25. (a) General destruction of non-engineered structures that resisted the giant tsunami waves in the fishermen's colony (Machchi Dera area) at Hut Bay in Little Andaman Island (photo: C. Murty). (b) Three-story RC-frame building with many masonry infill interior walls located right at the shore adjacent to the fishermen's colony at Hut Bay in Little Andaman Island; this building sustained no apparent structural damage despite lateral pressure from the tsunami (photo: S. Dash).

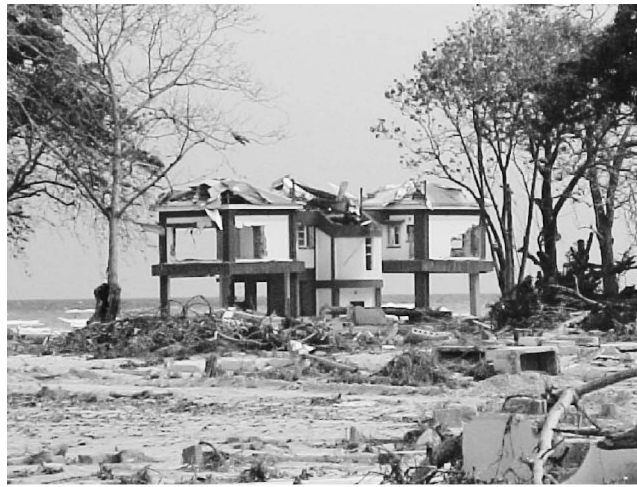
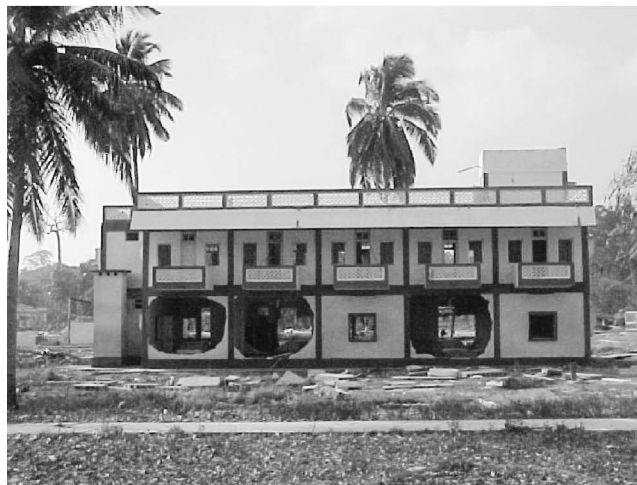
with masonry infills sustained severe damage only in the first story, owing to the punching out of the infills by the large lateral pressure of the tsunami (Figure 26b). In cases where a number of buildings were built in a row normal to the coast, the giant waves destroyed the structures toward the coast; buildings in the rear of such a row managed to survive because they were shielded from the giant wave by buildings in the front (Figure 27). In all, the number of surviving buildings at the shoreline of islands like Little Andaman and Car Nicobar is only a very small fraction of the total number of houses. Many structures that are seemingly standing are severely damaged or almost destroyed, with their basic structural safety in question due to scouring of the soil from underneath the foundation (Figure 28).

Figure 26. (a) Two-story RC-frame shorefront building with masonry infills in the military residential area in Car Nicobar Island. It was inundated but resisted the wave effects. Even though the building frame survived the wave effects, the great pressure sucked away the masonry infills, the occupants, and the contents. (b) Two-story RC-frame building with masonry infills about 300 m from the shore at Hut Bay in Little Andaman Island. The first story of this Andaman & Lakshadweep Harbour Works residential facility was submerged. It sustained severe structural damage in the first story due to lateral pressure of the tsunami and could not save the lives of people in the lower story (photos: C. Murty).

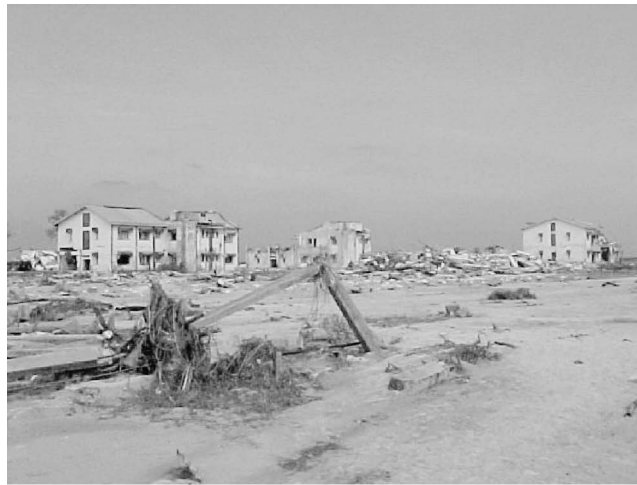
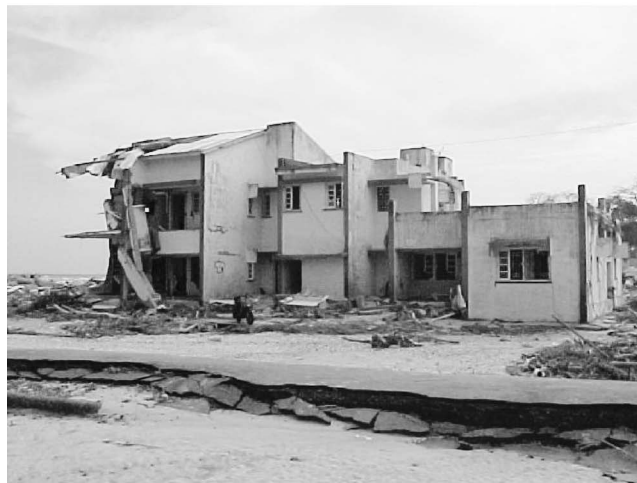
Figure 27. Military residential area in Car Nicobar Island: (a) buildings in a row normal to the shore show progressively increasing damage toward the coast, and (b) in large shorefront structures, the seaward section was severely damaged while the back side was relatively undamaged (photos: S. Dash).

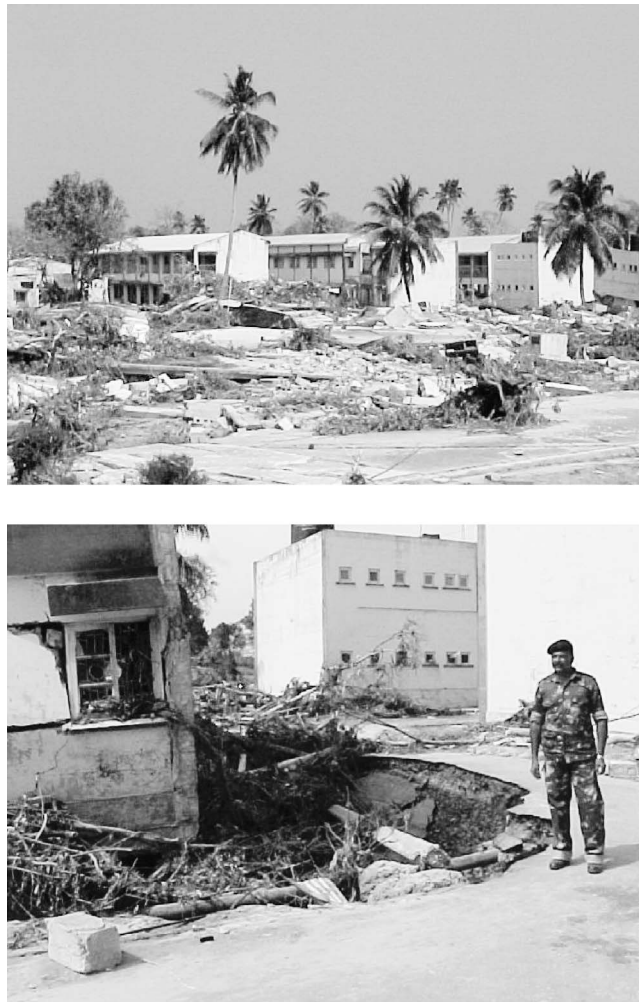
Figure 28. These buildings at the Air Force Colony in Car Nicobar Island are apparently standing after the tsunami, but their foundations have been scoured away (photos: C. Murty).

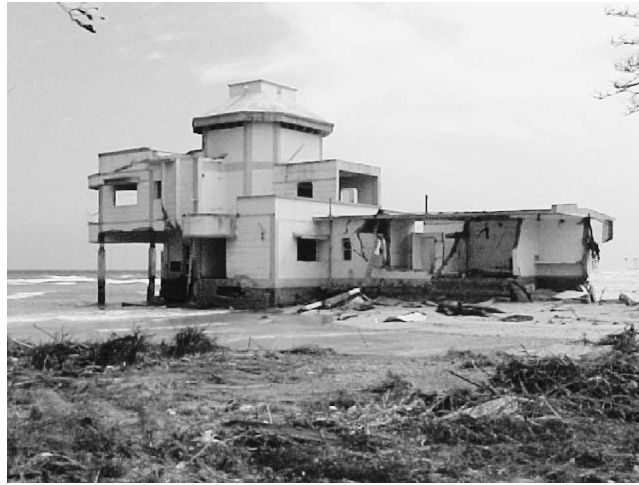
Figure 29. This RC-frame MES inspection bungalow now stands in waters at the Air Force Colony south of Malacca on the east coast of Car Nicobar Island (photo: C. Murty).

pressing view and tell the story of the brute force of the waves. The Military Engineering Service (MES) inspection bungalow at the Air Force Colony on this island was situated about 100 m from the seashore. Due to the eastward tilting of the Burma microplate on which the A&N islands are located and the subsidence of the eastern coast of the A&N islands, the shore at the Air Force Colony on Car Nicobar Island subsided by about 1.5 m. Owing to this, the water level of the sea in this area was reported to have risen by about 1.5 m after the earthquake. As a consequence of this ground shaking, subsidence, and tsunami, this building sustained severe structural damage and is in a state of incipient collapse, with the seawater lashing at its column footings (Figure 29).

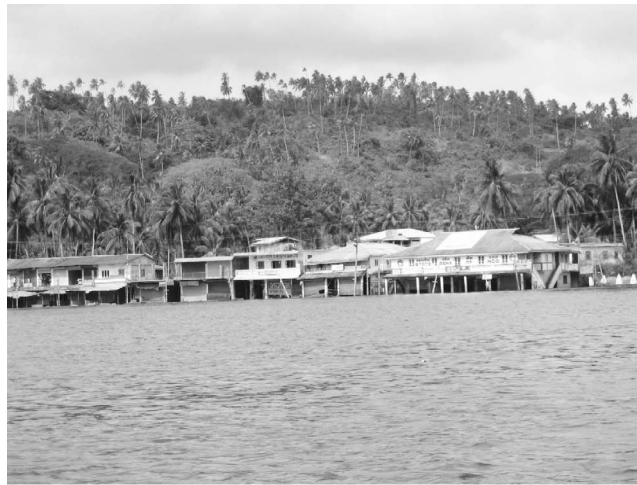
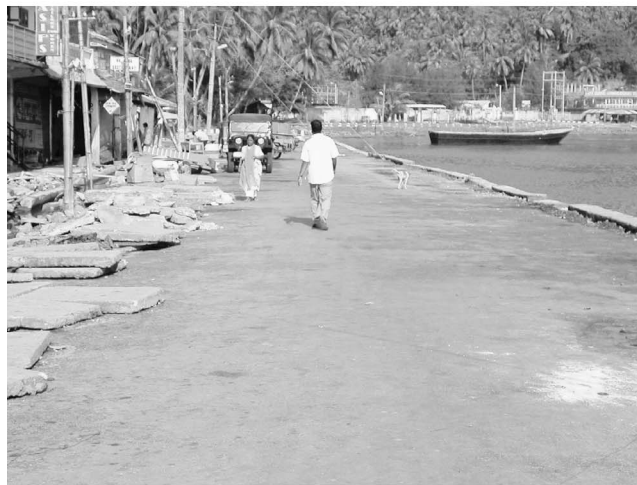
Figure 30. (a) Inundated shops in the Bamboo Flat area near Port Blair (photo: D. Rai), and (b) heavy RC drain covers were displaced from drains by the tsunami (photo: S. Jain).

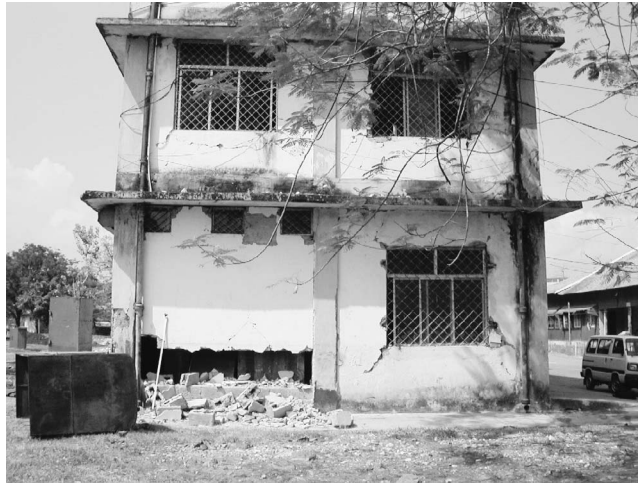
On the other hand, in the Andaman Islands, while tsunami-induced damage to the contents of buildings was significant, the fury of the waves was less and caused less tsunami-induced damage to the structure of the buildings themselves. For instance, in the Bamboo Flat area near Port Blair in South Andaman Island, the street-front shops were inundated because of land subsidence. The steel shutters of the shops were damaged, and the drainage covers were displaced (Figure 30). In some other buildings in the same region, the boundary walls collapsed. In the old dry dock in the marine jetty dry dock complex in Port Blair, the water pressure caused out-of-plane collapse of the masonry infill walls (Figure 31).

Figure 31. The old dry dock in the marine jetty dry dock complex was inundated in seawater after the event, and the masonry walls were damaged (photo: H. Kaushik).

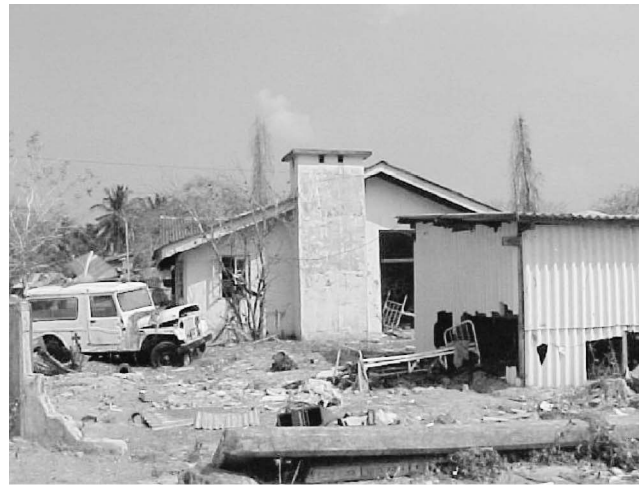
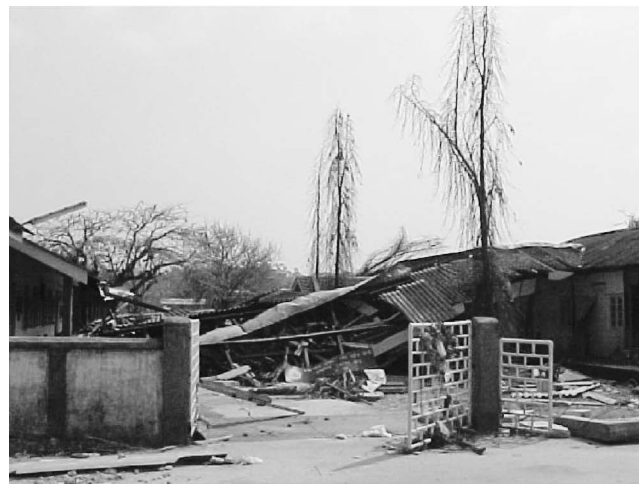
members such as columns and roof trusses are corroded, and the connections are weakened. The loss of the hospital severely affected the postearthquake care of the survivors on the island.

Figure 32. A hospital unit at Hut Bay in Little Andaman Island that is several decades old: (a) steel beds were punctured through the asbestos vertical cladding during the tsunami, and (b) collapse of the front portion of the hospital due to ground shaking (photos: C. Murty).

Because of the tsunami, civic administrators need to consider relocating the limited critical infrastructure, like hospitals, at higher elevations. At Hut Bay in Little Andaman Island, the hospital was about 500 m from the coast and sustained partial collapse during earthquake shaking and inundation (Figure 32). The partial collapse is attributable to the rusted structural steel building system that is many decades old; its main structural
