Performance of structures during the Sikkim earthquake of 14 February 2006

Hemant B. Kaushik*, Kaustubh Dasgupta, Dipti R. Sahoo and Gayatri Kharel

Performance of structures in different areas of Sikkim, during the earthquake of 14 February 2006, is reviewed. The earthquake caused damage to heritage structures as well as modern buildings. Both masonry and reinforced concrete buildings showed poor performance. On the other hand, traditionally constructed wooden houses performed extremely well. The damage seen in and around Gangtok was clearly disproportionate to the size of the earthquake, which was a moderate 5.7 on the Richter scale. This very clearly establishes the high level of seismic vulnerability of the region. The damage is primarily attributed to poor design and construction practices, and lack of quality control. Urgent need for trained human resources and for creation of a system of checks and balances, to ensure safe constructions in Sikkim is highlighted.

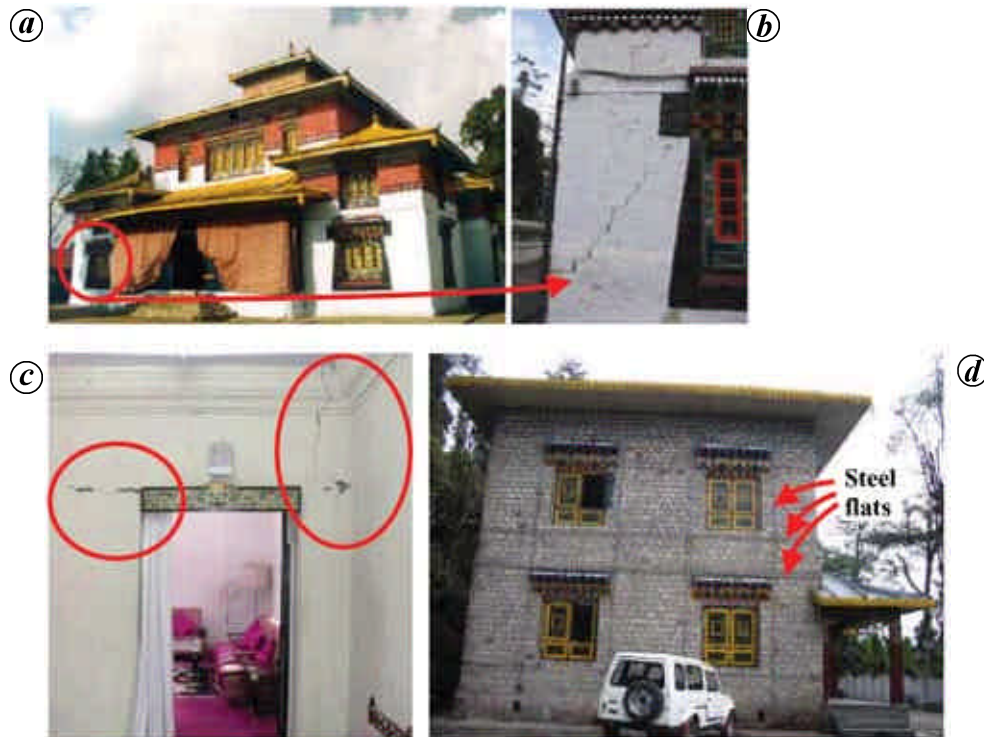
Figure 3. Performance of masonry structures at Gangtok. *a, b*, Wide shear and vertical cracks in masonry walls at corners and near openings in Enchey Monastery. *c*, Numerous cracks near door/window openings were observed at Raj Bhavan. *d*, Good performance shown by retrofitted Archive building (arrows show steel flats used to retrofit the building after the 1988 Bihar–Nepal earthquake).

Generally, stone-masonry structures in the area are of undressed stones with mud mortar. A few important structures have dressed stone masonry with mud and lime-based mortar (e.g. the Raj Bhavan). Stone-masonry buildings suffered damages primarily because of undressed stones used without proper bonding between adjacent courses of masonry, and also at the corners. The mud mortar used as bonding material in these buildings further aggravates their lateral strength capacity. Some of the important masonry buildings damaged during the earthquake are Enchey monastery (Figure 3 *a* and *b*) and the Raj Bhavan (Figure 3 *c*). These buildings were also damaged during the 1980 and 1988 earthquakes⁴. It seems that these buildings were only ‘repaired’ and not adequately retrofitted against future events. During the present earthquake, several masonry walls of these buildings suffered damages in the form of inclined shear cracks, and vertical cracks (Figure 3 *a–c*). These cracks were concentrated at the corners, and also at the location of window and door openings. The two-storey Archive building was previously the Legislative Assembly building at Gangtok, until it was damaged during the 1988 Bihar–Nepal earthquake. Subsequently, this masonry building was retrofitted by fixing horizontal and vertical steel flats of about 50 mm × 8 mm size on all the outer faces of the exterior walls in each storey (Figure

3 *d*). The building sustained no damage during the present earthquake. Clearly, sensible retrofitting of important heritage structures can be critically useful in the future earthquakes.

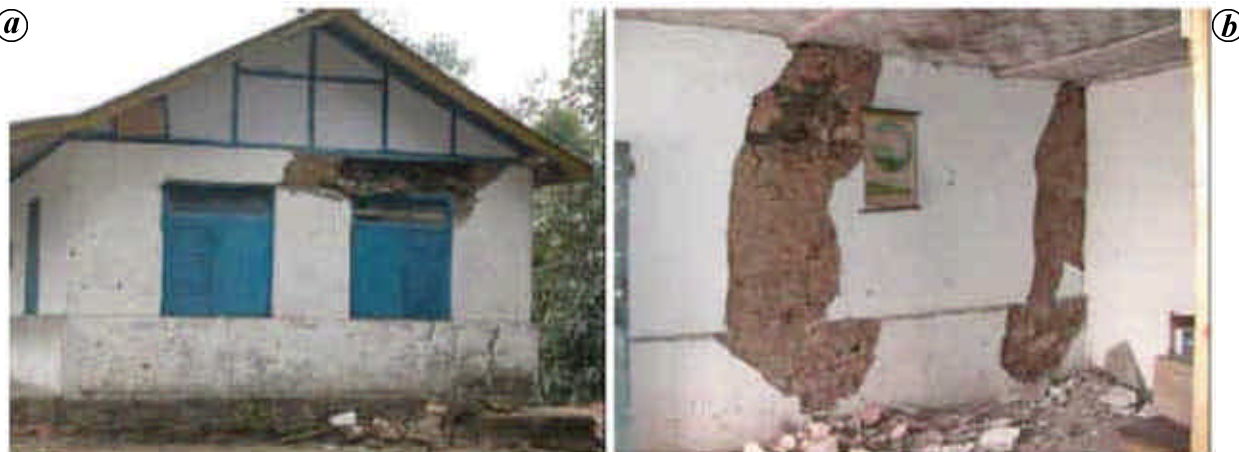
In rural areas of Sikkim, low-cost school buildings are generally constructed by the state government using stone masonry with mud mortar. Several such buildings suffered severe damage during the present earthquake. Earthquake-resistant features such as horizontal bands at various levels and stones at the corners are generally not provided in such constructions. This resulted in the formation of severe cracks near the corners and at the location of openings in such buildings, when subjected to even mild shaking (Figure 4). In addition, out-of-plane tilting of several masonry walls was observed at some places.

Figure 4. *a, b*, Severely damaged stone masonry low-cost school buildings in Sikkim. (Government Primary School, Thamidara near Gangtok).

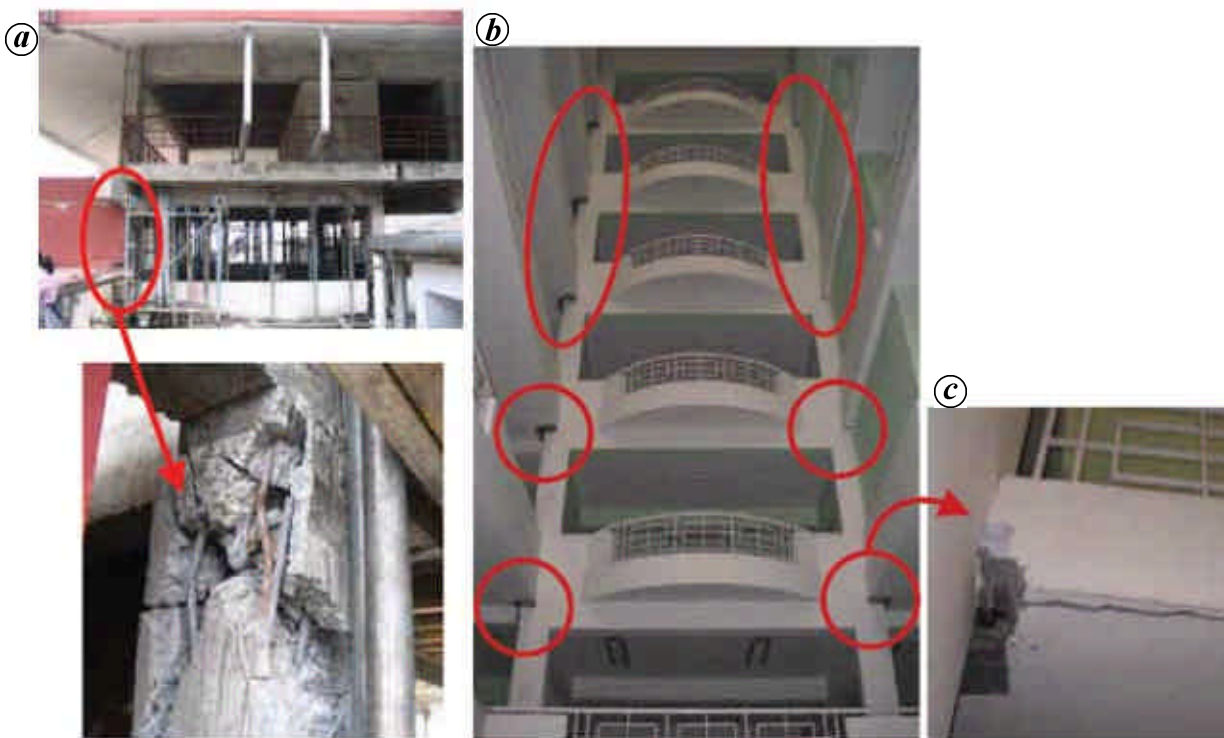
Figure 5. Damages in nine-storey RC hostel building (SMIMS). *a*, Damaged RC column supporting water tank on the roof. *b* and *c*, Pounding damages at the ends of the two wings took place at all the floor levels.

The nine-storey masonry-infill RC-frame hostel building at Sikkim Manipal Institute of Medical Sciences (SMIMS), Tadong, Gangtok suffered damages in walls and columns.

Several masonry-infill walls developed diagonal cracks due to the earthquake. One RC column below a water tank at roof level suffered heavy damage because of inadequate shear reinforcement, and improper lap splicing in longitudinal reinforcement (Figure 5 *a*). A few hostel rooms in the top storey just below the damaged column were evacuated soon after the shaking. Pounding damages were observed between two long wings in the building and corridors connecting these (Figure 5 *b* and *c*). Another four-storey RC building at Deorali suffered damages and was

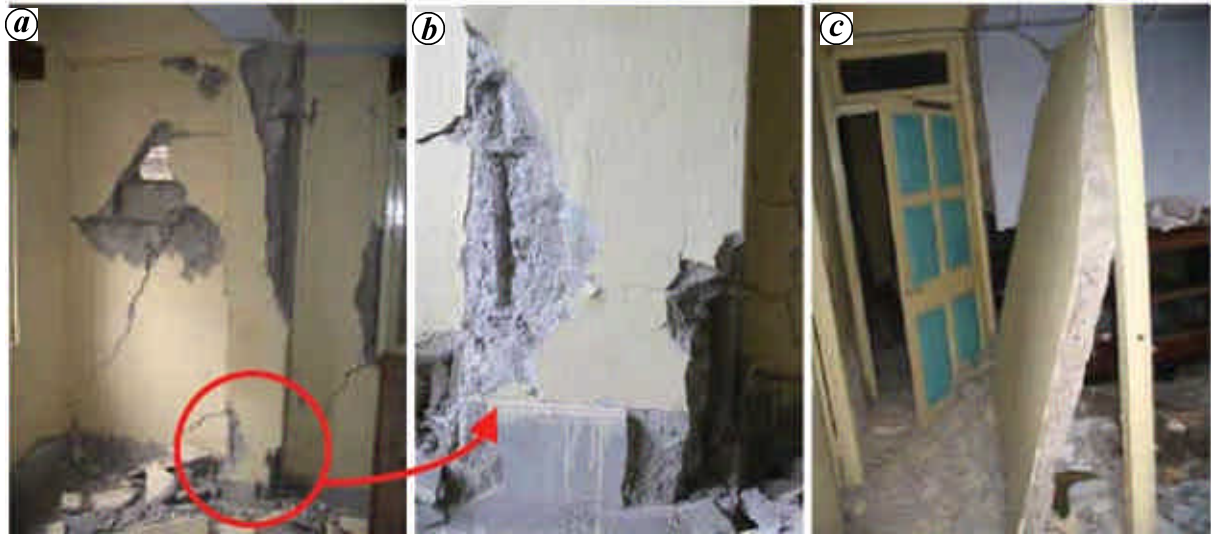
Figure 6. Damage in residential building at Deorali. *a*, Severe cracking in infill walls and damaged RC column. *b*, Exposed mild steel in damaged RC column; and *c*, Out-of-plane failure of infill wall.

evacuated. Severe damages were observed in several RC columns of the building, exposing mild steel bars as main reinforcement (Figure 6 *a* and *b*). Poor material quality and poor connection between perpendicular masonry walls resulted in out-of-plane failure of one infill wall, and severe damage to other infill walls in the building (Figure 6 *a* and *c*).

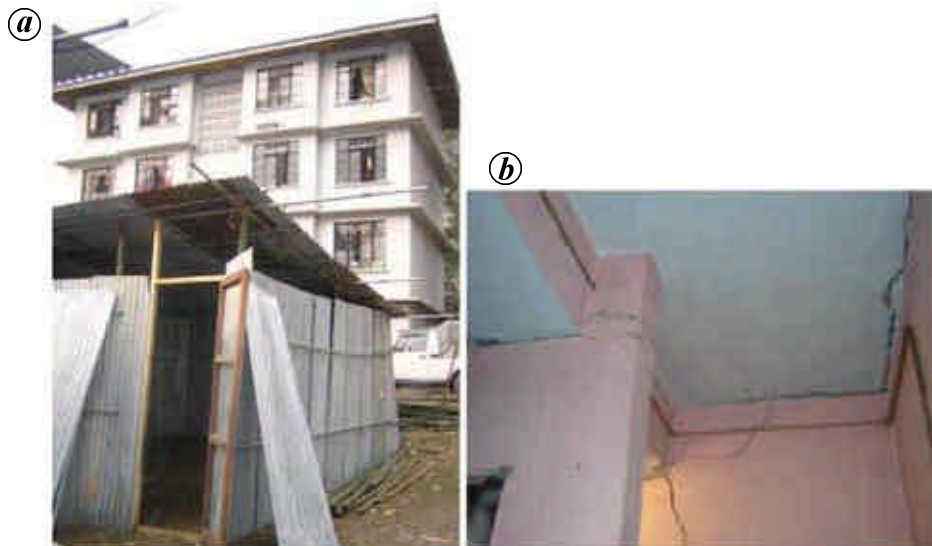
Figure 7. Four-storey government residential building (SNT colony) at Ranipool which suffered severe damage. *a*, Temporary shelters constructed using GI sheets in the backdrop of the RC quarters. *b*, Damaged columns and walls in one of the quarters.

along with cracks in several other infills. In several RC columns of the building, spalling of cover concrete due to corrosion of reinforcement bars was observed along with inadequate shear reinforcement. Several RC buildings (up to four-storey high) of Sikkim Nationalized Transport (SNT) colony at Ranipool near Gangtok suffered similar damages (Figure 7 *a*). At least one quarter was severely damaged (Figure 7 *b*), and the government had already given orders for evacuation. At the time of reconnaissance visit, temporary relief quarters (~7 m × 7 m) using GI sheets, bamboo posts and GI pipes were being constructed in front of the RC buildings, and residents were instructed to move into them (Figure 7 *a*).

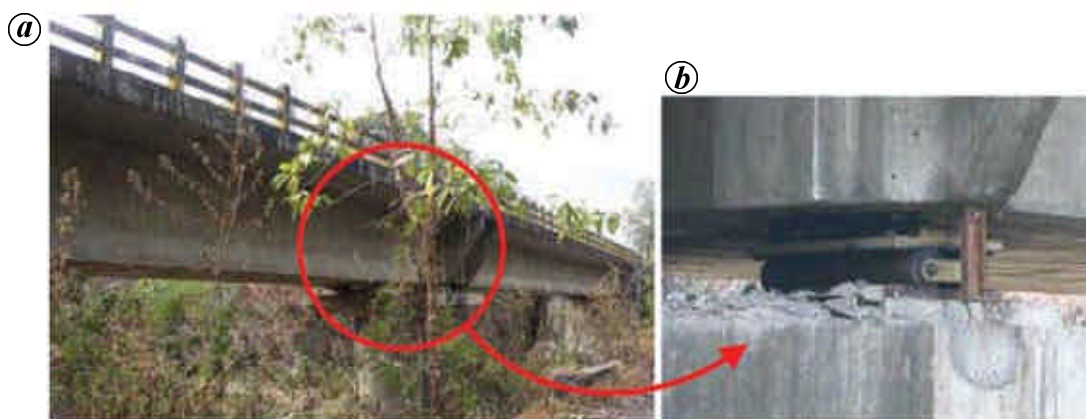
Figure 8. Two-span RC Tarkhola bridge between Melli and Rangpo appeared to be slightly damaged at the location of roller bearings on top of central pier. *a*, Bridge overview; *b*, Closer view of central pier cap showing spalling of concrete and insufficient lateral restrainer made of steel at the top of the pier.

There are several bridges on National Highway 31A, which connects Sikkim to the rest of the country. In the Tarkhola bridge between Melli and Rangpo, spalling of concrete was observed at the top of the central pier near bearings (Figure 8). One needs to ascertain if this was caused by the earthquake. Bridge-deck lateral restrainers, which can prevent the spans from dislodging-off the piers, were observed in most of the bridges along NH 31A. However, these steel lateral restrainers appeared to be insufficient in holding the bridge decks during severe ground shaking expected in seismic zone IV (Figure 8*b*). An RC pedestrian foot bridge constructed in 1989 near STNM Hospital, Gangtok sustained minor damage in the form of spalling of cover concrete in one RC beam due to corrosion of reinforcement bars. Horizontal cracks were observed in masonry walls of an RC office building of the Sanitation Section, Urban Development and Housing Department, Sikkim, constructed under the foot bridge at one end.
