PERFORMANCE OF BUILDINGS IN PORT BLAIR (INDIA) DURING THE GREAT SUMATRA EARTHQUAKE OF 26 DECEMBER 2004

Hemant B. Kaushik¹ and Sudhir K. Jain²

ABSTRACT

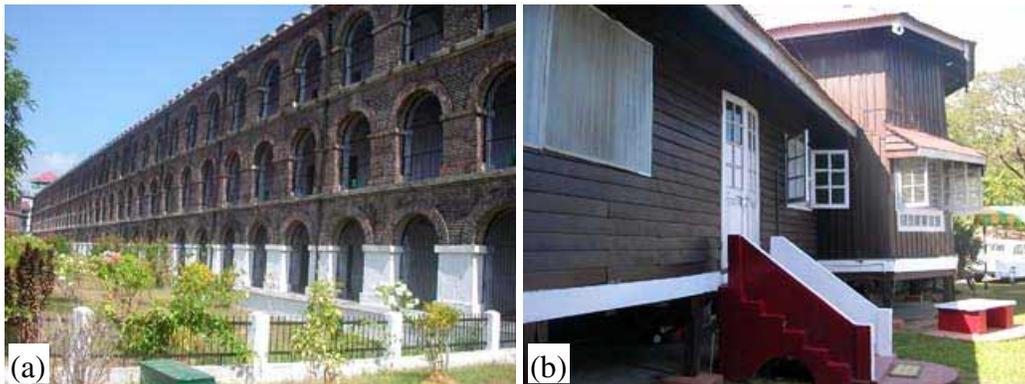
Figure 1. Undamaged historical and traditional construction in Port Blair: (a) masonry structure of Cellular Jail, and (b) timber house at Marine Hill, Port Blair.

Due to the shaking induced by the earthquake of 26 December, traditional timber buildings in Port Blair performed extremely well (Fig. 1b), while the RC buildings had varying levels of performance depending upon the quality of construction. Serious deficiency was observed in design and construction expertise for RC buildings at all levels. Common men are constructing these without involving engineers. Even when engineers are involved, earthquake resistant design and construction features may or may not be followed. For example, performance of several privately built RC buildings in Port Blair was disastrous. On the other hand, several Government buildings in Port Blair constructed by engineers using consultants also suffered extensive damages and partial collapse. For example, at Marine jetty dry dock, recently an office complex was being shifted from a 50 year old timber building, which was

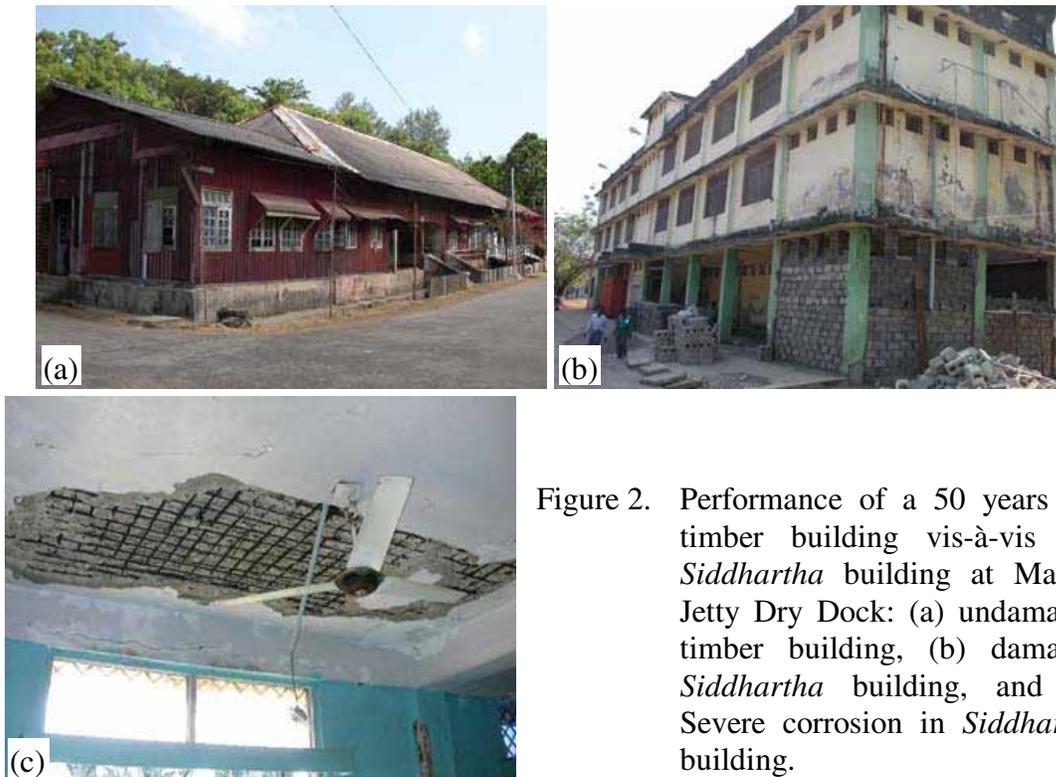
considered to be dilapidated (Fig. 2a) to a newly constructed 3-storey RC building (*Siddhartha*) situated right across the road (Fig. 2b). In 10 years of its existence, severe corrosion was observed in *Siddhartha* building due to poor quality of construction (Fig. 2c). However, the timber building performed well during the shaking. Damages were also observed in *Siddhartha* building because of earthquake shaking in the form of cracks in RC columns, crushing and out-of-plane failure of infills at several locations, etc. As a result, *Siddhartha* building had been vacated while the old timber building was being used as the office complex.

Figure 2. Performance of a 50 years old timber building vis-à-vis RC *Siddhartha* building at Marine Jetty Dry Dock: (a) undamaged timber building, (b) damaged *Siddhartha* building, and (c) Severe corrosion in *Siddhartha* building.

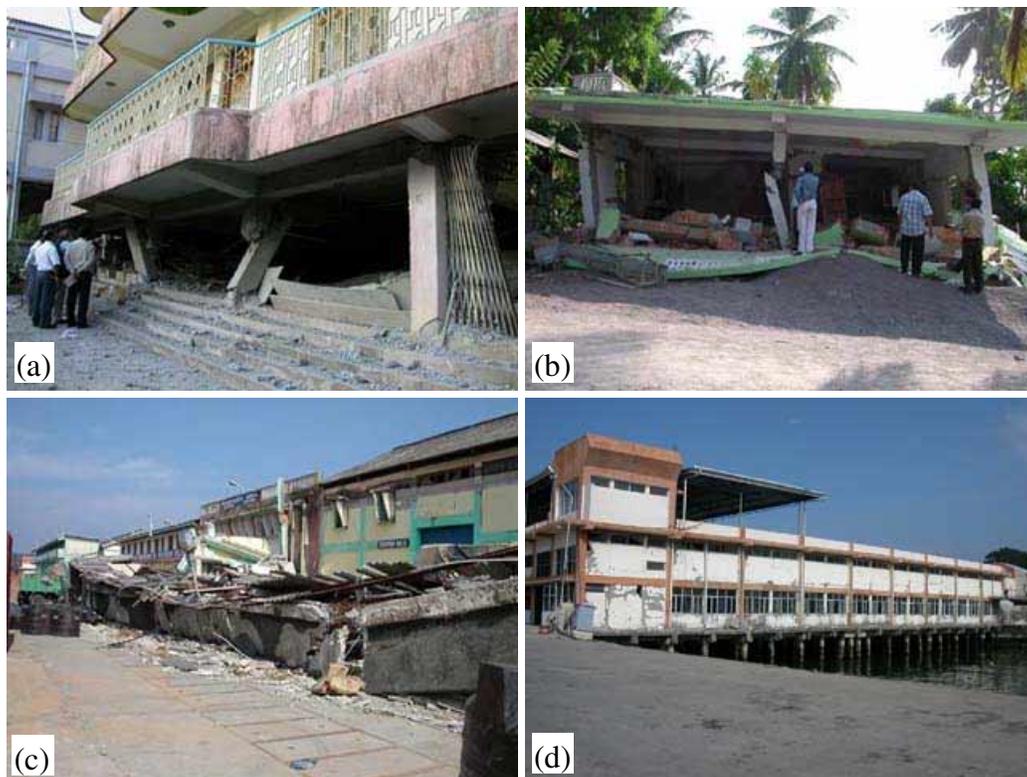
Several buildings on stilts in and around Port Blair suffered severe damages or complete collapse due to shaking (Fig. 3). Most of these buildings were privately owned and constructed without engineering supervision and lacked proper seismic design and ductile detailing. In some of the buildings which did not collapse, the stilt storey columns suffered extensive damages. In a collapsed 3-storey building at Naya Gaon, the upper stories suffered only nominal damages in the RC frame and masonry infill (Fig. 3a). Some recently constructed buildings on stilts at Bamboo Flat collapsed completely (Fig. 3b). A 2-storey Police-Barrack Government owned building in which the open first storey was used for storage purpose collapsed at Haddo wharf (Fig. 3c), whereas the adjacent buildings with infills in the first storey survived the shaking.

Figure 3. Collapse of RC buildings at (a) Naya Gaon, (b) Bamboo Flat, and (c) Haddo wharf, and (d) partially collapsed Passenger Terminal Building at Haddo wharf.

The partially collapsed Passenger Terminal Building at Haddo wharf (Fig. 3d) was formally designed by a structural engineering firm in Chennai and constructed by contractor with engineering supervision. This is a newly constructed important building with heavy usage on a busy wharf. Because of large openings provided for ventilation, nominal masonry infill walls were present in the RC frames on periphery of the building; however, infill walls were not present in the inner frames to generate open space. Ductile reinforcement detailing was not found in RC columns of the building. The building was partly supported on RC piles on the sea-

side and partly on spread footing on relatively soft soil, which aggravated the damages in the building.

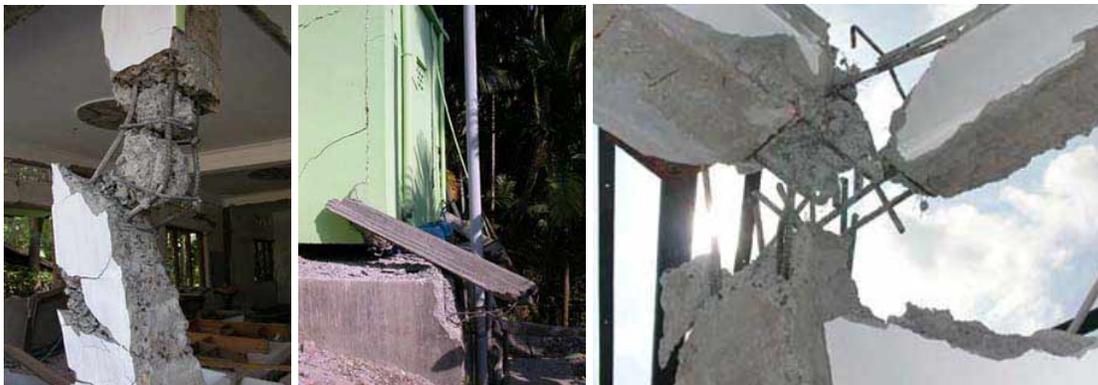
Predominant construction practice in Port Blair is to provide a very light lateral reinforcement in columns (6-8 mm diameter with 90° hooks at about 200-250 mm spacing). Therefore, stilt storey columns of several buildings suffered extensive damages in brittle shear mode resulting into complete collapse of some buildings (Fig. 3). In several columns in buildings at Bamboo Flat, the 90° hooks of the shear reinforcement opened up leading to buckling of longitudinal bars and subsequent crushing of concrete (Fig. 4). In the Passenger Terminal Building at Haddo wharf, several columns and beams sustained extensive damages in shear and flexural modes due to inadequate design (Fig.5).

Figure 4. Poor shear design attributed to several column failures in buildings at Bamboo Flat.

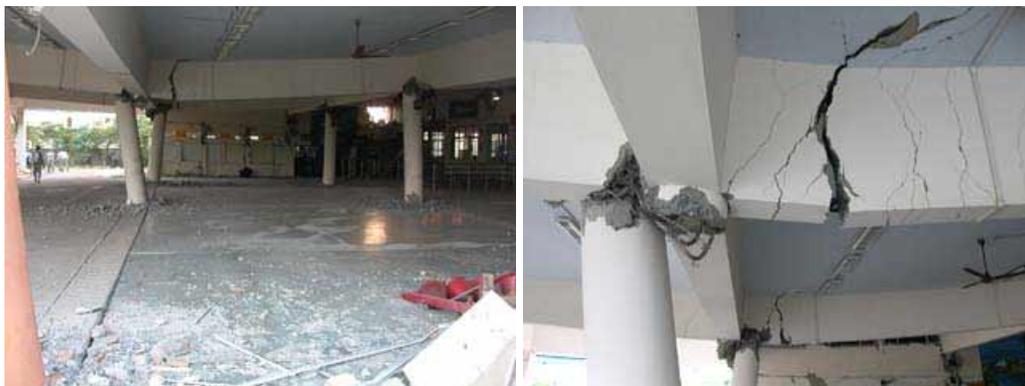
Figure 5. Severe cracking in RC members of Passenger Terminal Building at Haddo wharf.

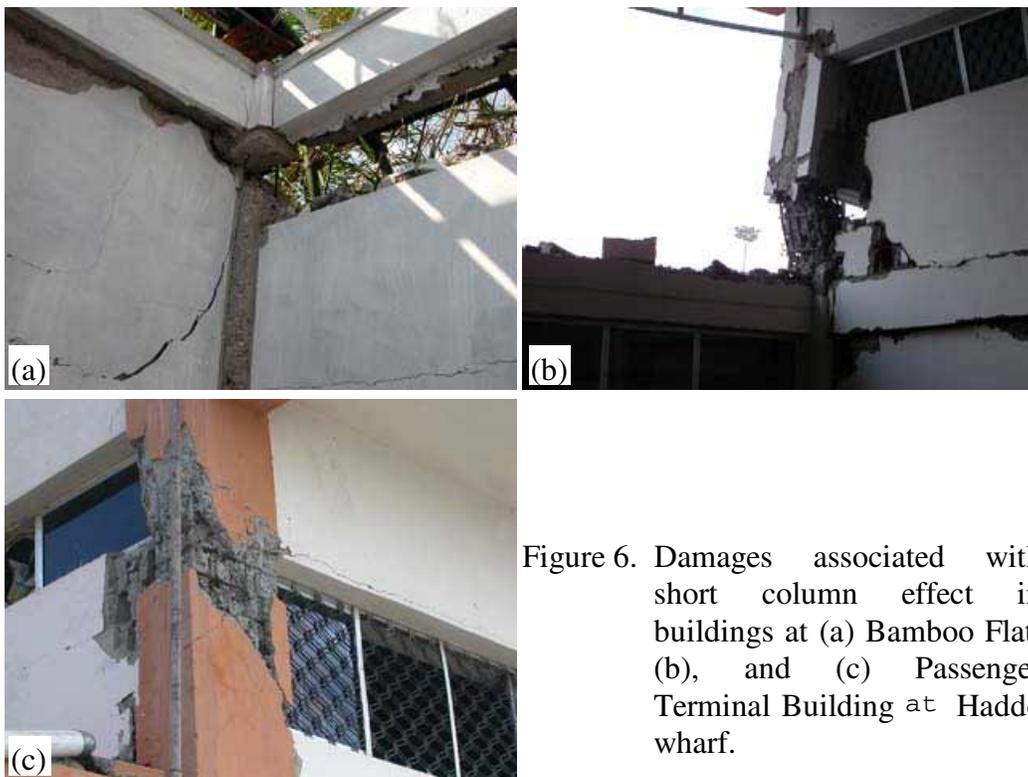
In several buildings, masonry infills were used in RC frames only up to partial heights because of functional requirements, such as, ventilation. In addition, openings are generally provided in the infills for provision of doors and windows, which created *short column effects*

and significantly increased shear demands in the columns. Several short columns in buildings at Bamboo Flat and in Passenger Terminal Building at Haddo wharf suffered extensive damages at the locations where partial height infills were provided (Fig. 6).

Figure 6. Damages associated with short column effect in buildings at (a) Bamboo Flat, (b), and (c) Passenger Terminal Building at Haddo wharf.

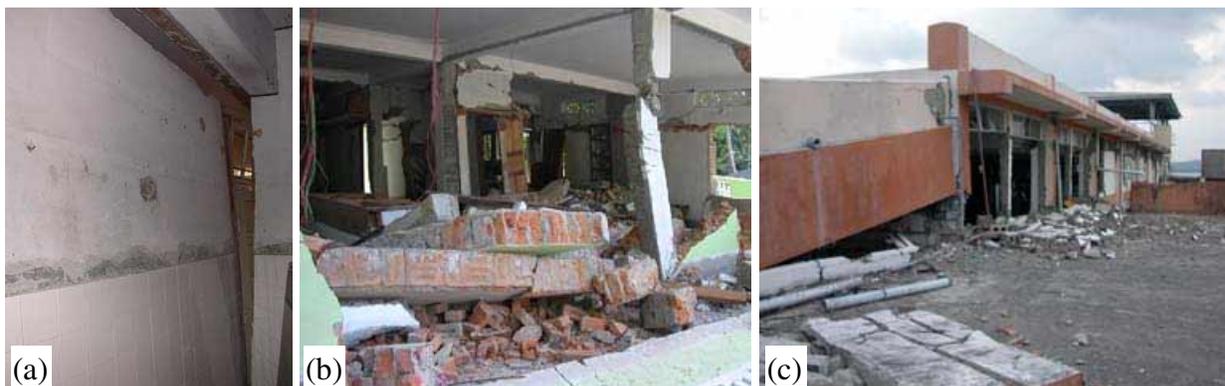
Out-of-plane failure of masonry infills was observed in several RC buildings primarily due to poor quality of masonry, and inadequate and loose joint between RC frame and masonry walls. In a three-storey school building at Mohunpura in Port Blair, long infill walls tilted out-of-plane (Fig. 7a). The collapsed 3-storey building at Bamboo Flat had out-of-plane collapse of several infill walls (Fig. 7b). Similar damages in masonry infills were also observed in the Passenger Terminal Building at Haddo Wharf (Fig. 7c).

Figure 7. Out-of-plane failure of masonry infills in buildings at (a) Mohanpura (school building), (b), and (c).

(b) Bamboo Flat, and (c) Passenger Terminal Building at Haddo wharf.

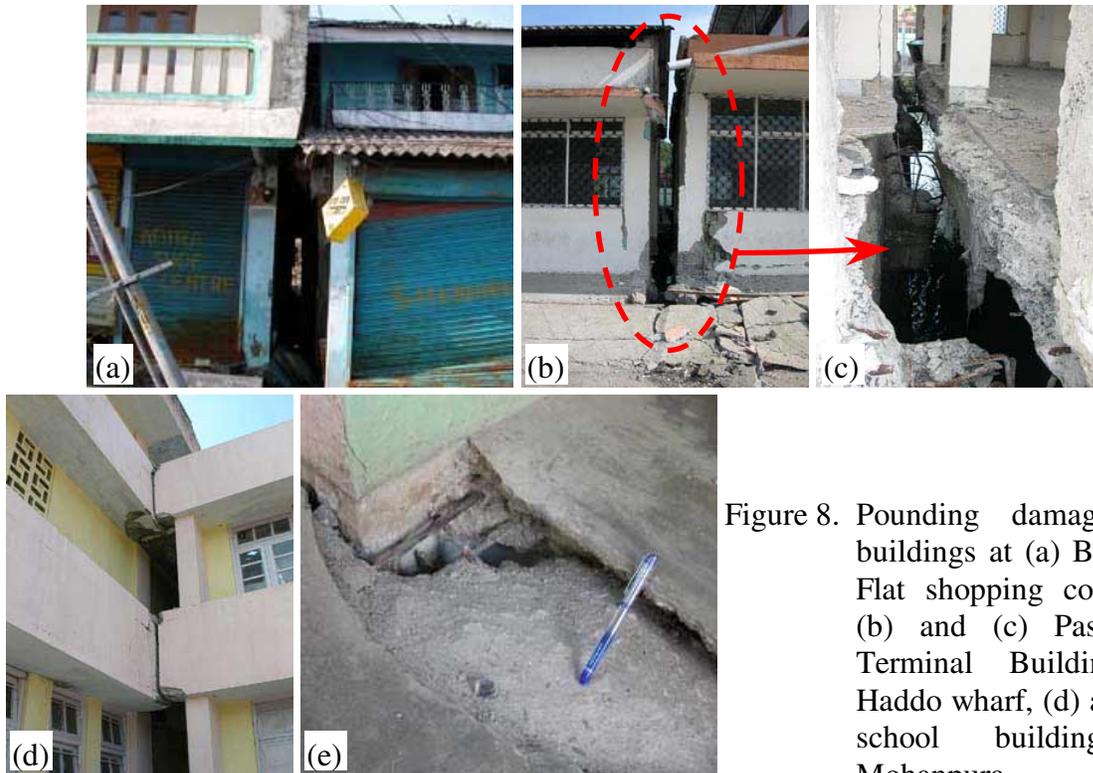
Several buildings in the Bamboo Flat shopping complex and Passenger Terminal Building at Haddo wharf suffered substantial cracking and damages at the floor levels in slabs, and in columns and masonry infills because of pounding with adjacent blocks (Figs. 8a, 8b, 8c). An L-shaped 3-storey RC school building at Mohanpura constructed in stages between 1986 and 1989 was damaged at the expansion joints provided between different blocks (Figs. 8d and 8e).

Figure 8. Pounding damages in buildings at (a) Bamboo Flat shopping complex, (b) and (c) Passenger Terminal Building at Haddo wharf, (d) and (e) school building at Mohanpura.

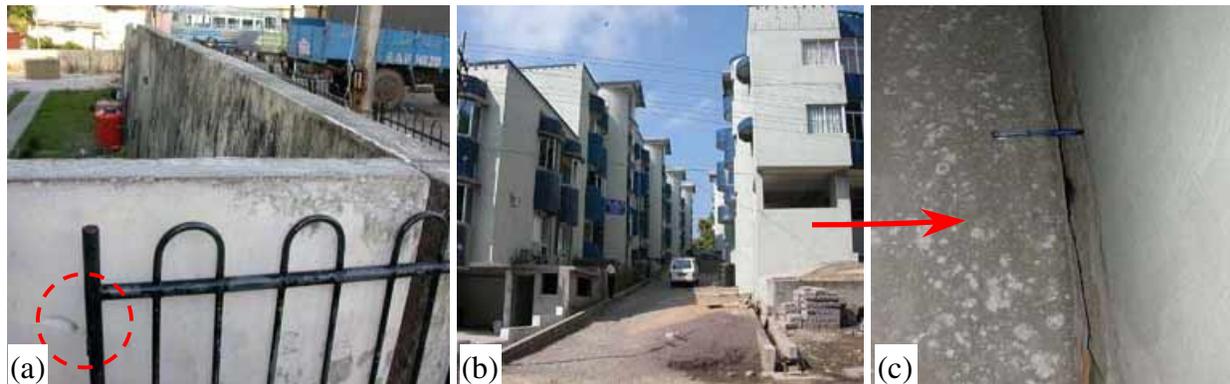
Many RC buildings in Port Blair are constructed on sloping ground. Ground sliding along the slope up to about 50-75 mm was observed at plinth level of several buildings at Aberdeen Market and Dilanipur (Fig. 9). Fig. 9a shows a marking on a masonry wall produced by a steel gate in front of Police station building at Aberdeen Market before the earthquake. During the earthquake, the 3-storey building moved along the slope by about 75 mm, while the steel gate connected to a retaining wall did not slide with the building. Figs. 9b and 9c show lateral movement of about 50 mm at the plinth level of a 3-storey RC building at Dilanipur.

Figure 9. Ground sliding along slopes resulted in permanent lateral movement in (a) Police station building at Aberdeen Market, (b), and (c) residential building at Dilanipur.

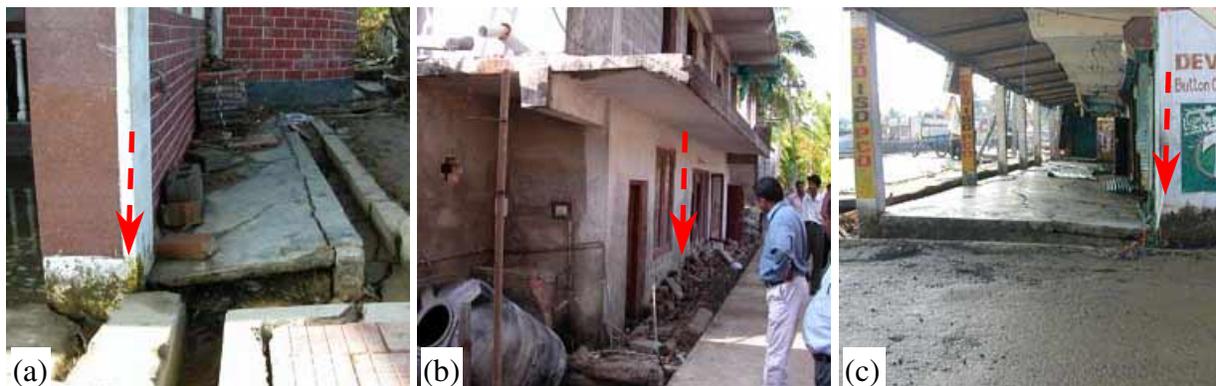
In most of such cases buildings located near the sea settled down and signs of liquefaction, if any, were washed away by the tsunami. At least two RC buildings (Fig. 10a, 10b) and several shops in the shopping complex (Fig. 10c) at Bamboo Flat settled down possibly due to liquefaction. Several buildings located in harbor area in Port Blair settled down due to structural failure of some of the foundation piles, e.g., Operation Wing building at Marine jetty (Fig. 11a) and Passenger Terminal Building at Haddo wharf (Fig. 11b). Damages were observed at the junction of a RC pile and pile cap supporting a RC storage building at Haddo wharf (Fig. 11c).

Figure 10. Settlement of several buildings at Bamboo Flat (a) 2-storey RC building, (b) 3-storey RC building, and (c) shopping complex.

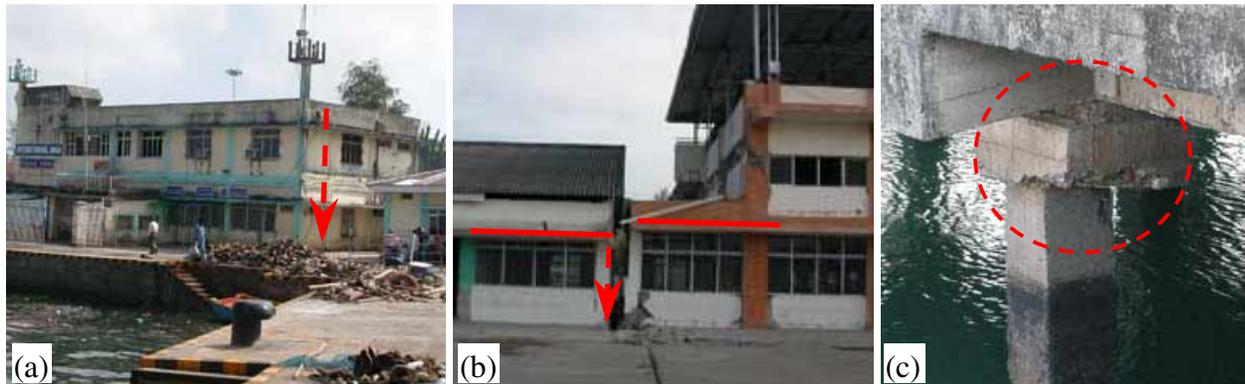
Figure 11. Foundation failure resulting into settlement of buildings (a) Operation Wing building at Marine Jetty, (b) Passenger Terminal Building at Haddo wharf, and (c) RC storage building at Haddo wharf.

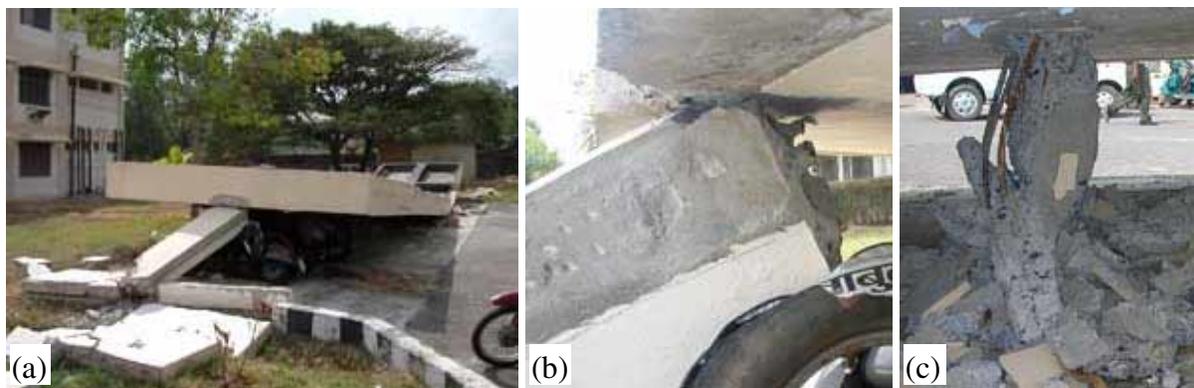
The digital strong-motion instrument installed at Port Blair by the India Meteorological Department failed to record the main event; therefore, PGA is estimated by an approximate analysis of a collapsed RC scooter stand. The scooter stand in the Port Management Board office complex was 20 m long, 3.3 m wide, and 2 m high supported on six columns spaced equally at 4 m without any filler walls or non-structural elements (Fig. 12a). All the columns (size: 200×300 mm) failed causing collapse of the entire structure. The columns had 4 bars of 16 mm dia. and 2 bars of 12 mm dia. as longitudinal reinforcement, and most of the bars were

found to be severely bent. Transverse reinforcement in the columns consisted of 8 mm dia. bars at 150 mm spacing.

Figure 12. Collapsed RC scooter stand at Marine jetty office complex: (a) collapsed structure, (b) longitudinal rebars of at least two end columns were continued only up to soffit of the top beam, and (c) shear reinforcement was not present in at least one interior column.

It was observed that the longitudinal rebars of the two end columns were continued only up to the soffit of the top beam (Fig. 12b). Therefore, it is assumed in the analysis that the plastic hinges will form at only the bottom of both the end columns. On the other hand, plastic hinges are assumed to form at both the top and bottom of the inner columns. Also, shear reinforcement was not found in about half the height in one of the interior columns (Fig. 12c). Thus, concrete is considered to be unconfined in the analysis and the columns were assumed to have negligible ductility. A rough calculation indicates that the lateral load capacity of the structure was about 25% of its self weight, which suggests that the PGA in the region may have been at least 0.1g.
