AN EMPIRICAL METHOD FOR PREDICTING DAMAGE CAUSED BY AN EARTHQUAKE TO ARTIFICIAL HOUSING SITES

Kenzo YOSHIKAWA¹, Takao ITO², Arturo B LUNA³, Akie ASADA⁴ And Yoshinobu MORI⁵

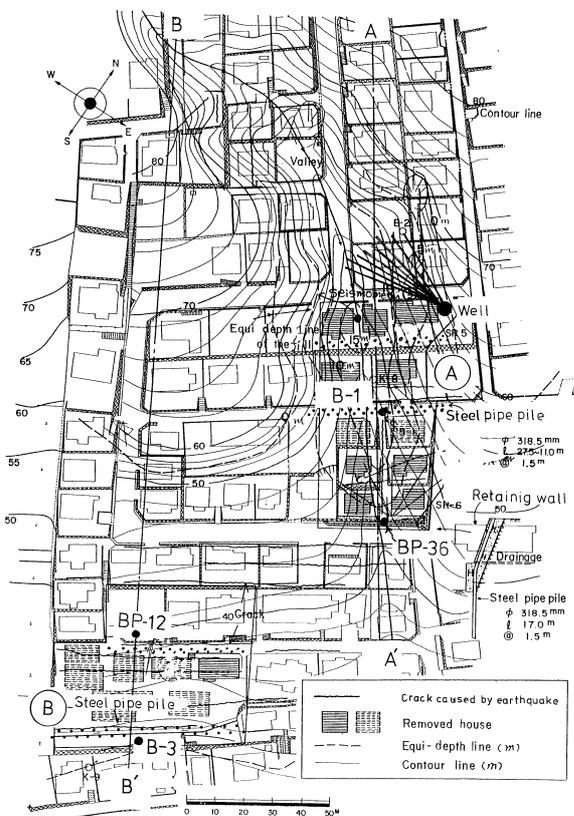
Fig.1(a) Plan view of Midorigaoka.

Fig.1(a) shows an aerial view of extremely damaged housing sites in Midorigaoka-1chome. Eleven houses in block A and seven houses in block B, indicating by hatching, were so severely damaged by the earthquake that their owners were obliged to move. Approximately twenty years ago, a steep valley at an angle of almost 15 degrees existed along the A-A' line of block A. Housing sites were constructed by filling in the slope of the valley with loam and gravel, fractured sandstone, mudstone and tuff to a depth of between 5m and 10m. This fill was not compacted. The cross-section along the A-A' line is shown in Fig.1(b). Loose sandstone and talus lies under the fill with N values varying from 0 to ten. The slope has moving both in the direction of A-A' and perpendicular to A-A'. In addition, in the six months following the earthquake, extreme variation was observed at

a depth of 18.5m, suggesting the presence of a sliding plane within the sandstone bedrock. The southern portion of the area illustrated in Fig.1(a) is block B, another damaged housing area. Before the earthquake, seven houses marked by hatching occupied block B. However, all these houses were destroyed by the earthquake, and the inhabitants were forced to move elsewhere. Since the earthquake, a position of the embankment was removed and pipe piling were driven into the ground to stabilize this area. A cross-sectional view of the ground along B-B' line is shown in Fig.1(c). The B-B' line does not lie along the valley. When housing sites were constructed in this area, the slight slope was filled in using loam, gravel, sandstone and tuff. Standard penetration tests conducted on the hill at these sites revealed that the N value decreased between 0 and 5. The results suggest that housing sites near point B-3 sunk slightly in the half-year after the earthquake. In addition, the steel piling designed for and constructed in the damaged Midorigaoka area are shown in Fig.1(a) and 1(b). This area had been subjected to considerable ground movement. Static analyses were performed at two circular slip surfaces located at depth of 5.0m and 18.5m. Parameters used for analysis were based on a C-φ daigram employing the conventional stability analysis method with an induced strength of $\tan \phi = 0.18$ and $C = 0$, and a safety factor. Based on the results of these analysis, a buttress-type retaining wall with a steel pipe piling foundation was constructed at B.P-36, and steel pipe piling stabilizer were designed and constructed at B-1, SR-5 and B.P-13.

Steel pipe piling measuring 318.5mm in diameter were inserted into prebored holes to a depth of $1 \frac{1}{3}$ times the thickness of the fill comprising the surface layer. An H beam was inserted into each pile, and the empty space remaining inside the pile was filled with concrete. The piles were sunk at intervals of 1.5 meters in two staggered lines. At B.P-36, a pre-existing concrete block wall was widened and a new concrete wall was built upon a steel pipe piling foundation. In addition, a reinforced concrete well measuring 5m in diameter was constructed to a depth of 20m at the upper portion in block A in order to collect ground water flowing along the valley using eight underlying horizontal pipes installed in the lower part of the well, resulted in a lower water table under the fill. After these repairs, the 18 houses in block A and B were forced to move and the ground was readjusted. Since then, no body has been allowed to live or enter these areas.

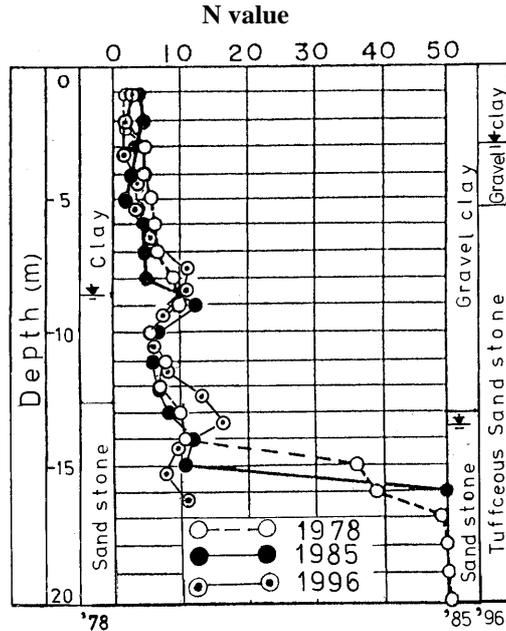
Fig.2(b) Variation in N values at B.P36 in Midorigaoka.

In Fig.2(b), the variation in N values at an interval of one meter is illustrated for 1978, 1985 and 1996. In the eighteen years following the earthquake, no variation in N values was observed at a depth of 0 to 13m. Consequently it is clear that the housing sites near B.P-36 will likely suffer damage under the circumstances of a similar earthquake.

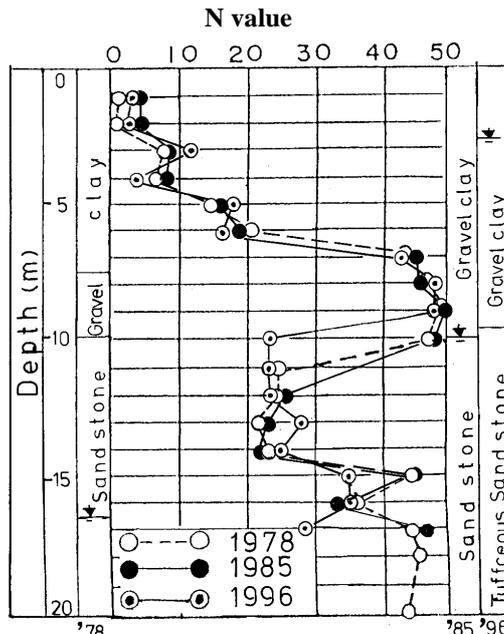
Fig.2(d) Variation in N values

Fig.2(d) shows the variation in the distribution of N values obtained in 1978, 1985 and 1996. No variation was observed at a depth of 0 to 10m, again indicating that the housing sites near B-3 are likely to suffer damage under the circumstances of a similar earthquake in the future. After the repair works were complete, 18 houses in blocks A and B were forced to move to other districts, and the ground was readjusted. Since then, no body has been allowed to live in these districts.

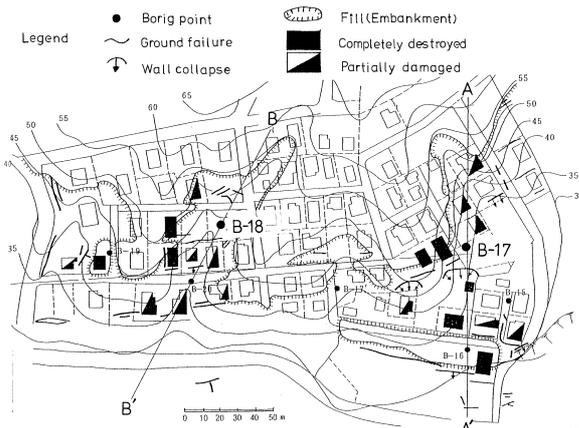
Fig.3(a) Plan view of Aramaki-Genshinden

The Aramaki-Genshinden area is located in the northern section of Sendai City. Housing sites were constructed on a hillside, having an average inclination of 5 to 10 degrees from 20m to 80m above sea level from 1960 to 1962. The section underlying the rock bed was composed of loam, gravel, loose sandstone and tuff [Fig.3(b) and 3(c)]. Sites where houses received extreme damage were created using fill comprised of fractured rock. As shown in Fig.3(a), 8 houses were destroyed and 13 were partially damaged in this area. These houses were heavily damaged because they had been built on uncompacted fill. Conversely, houses built on the cut remained intact. Most of the houses built on the fill suffered severe damage due to ground fissures or collapse of masonry stone retaining walls. Housing sites were constructed by filling in the slope of the valley along Lines A-A' and B-B' to maximum depths of 10m and 8m, respectively. According to the standard penetration test, most of fill materials used registered N values between 1 and 10, as shown in Fig.3(b) and 3(c). In order to observe the long-term variation in ground movement, pipe strain meters were sunk into the ground at Points B-16, B-17 and B-17'. During the six months following the earthquake, no variation in strain was observed at these locations. Thus, no repair work was performed in the Aramaki-Genshinden housing area. As shown in Fig.3(a), locations B-17 and B-18 are in the right and left sections of Aramaki-Genshinden district, respectively. In Fig.4(a) and 4(b), variation in N values is indicated at an interval of one meter at locations B-17 and B-18 for 1978, 1986 and 1996. N values at a depth of 0 to 7m were lower in 1986 and 1996 than in 1978 at both locations B-17 and B-18. Thus, the housing ground softened during the eight years following the earthquake. Consequently, severe damage to houses seems likely to occur in the event of a similar earthquake because no preventive works were performed in Aramaki-Genshinden district.

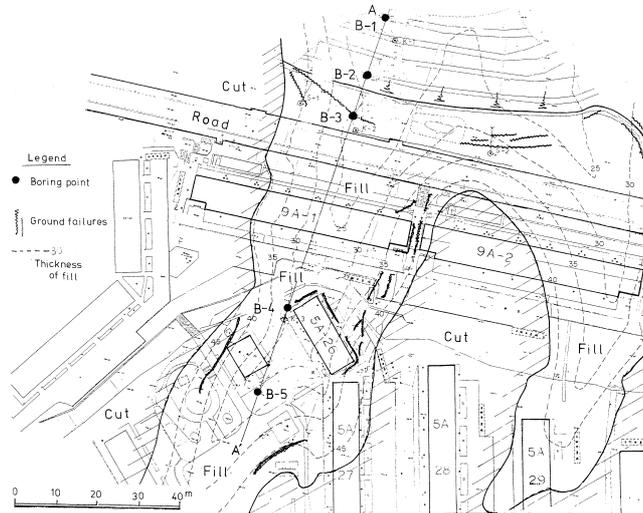
Fig.5(a) Plan view of Tsurugaya .

Tsurugaya housing district is located in northeastern Sendai City. Housing site was constructed on filling consisting of sandy soil on a hillside having an average inclination of 10 degrees and a maximum thickness of approximately 15m, as shown in Fig.5(b). The section underlying the bed-rock was composed of sandstone and tuff. Severe ground fissures were observed in fill consisting of fractured rock. According to a standard penetration test, most of the fill materials had N values ranging from 1 to 10. Fig.5(a) shows a plan view of sites containing severe ground fissures. Ground fissures occurred along the boundary between the cut and fill in the southern part of the road. However, in the northern part of the road fewer cracks were observed at top of the slope. The authors were concerned that slope failure might occur immediately after a future earthquake. In the southern section of the road, the fill that was piled around Apartments 9A-1, 9A-2, 5A-26 and 5A-27 subsided slightly during the earthquake. As a result, concrete slab pavement around the buildings settled and failed, and stairs were separated from one of the building. In the northern part of the road, gas pipes, water supply pipes, and drainage pipes were broken at several points due to ground fissures. A retaining wall supporting apartment 2B in block A was suspected to have been subjected to slight ground movement. Therefore, static analysis was performed at two circular slip surfaces. Parameters used for analysis were based on a C- ϕ diagram employing the conventional stability analysis method with an induced strength of $\tan \phi = 0.28$ and $C = 0.95\text{tf/m}^2$, and a safety factor of 1.00 for one slip surface and 0.96 for the other. Based on this analysis, the following three measures were proposed to stabilize the retaining wall; (1) The construction of a new masonry block retaining wall with a reinforced concrete piling foundation. (2) The construction of reverse T-type retaining wall with a steel pipe pile foundation. (3) The construction of a concrete retaining wall with an earth anchor. However, none of these repair works were performed in block A. In block B, stability analysis were also performed on two circular slip surfaces that underlie the site's shallow and deep zones. Using a conventional analysis method, stability was

determined to be 0.95 in the shallow zone and 0.69 in the deep zone. Based on these findings, lowering the ground water level in the shallow zone and the construction of a steel pipe piling stabilizer in the deep zone were recommended. However, these repair works were not performed. Boring locations B-2, B-3 and B-4 are shown in Fig.6(a), 6(b) and 6(c), respectively. As shown in Fig.6(a), 6(b) and 6(c), N values at B-2, B-3 and B-4 were lower in 1996 than 1978 and 1986. Thus, the housing ground near B-2, B-3 and B-4 softened in the eighteen years following the earthquake. Consequently, severe damage to buildings seems likely to occur in the event of a similar earthquake because no prevention work was performed in the Tsurugaya district.

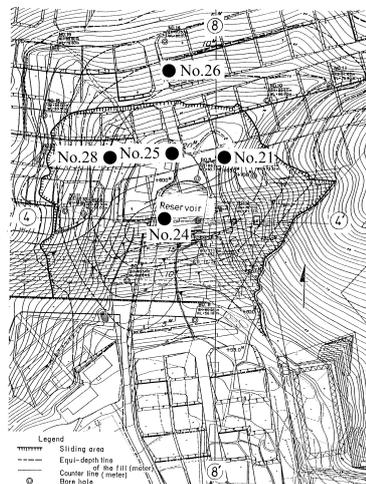
Fig.7(a) Plan view of northern area at Kotobukiyama.

Fig.7(a) shows a map of Kotobukiyama that contains the housing sites that existed prior to development. Thin solid lines are counter lines following the natural ground before the housing sites were constructed. In 1970, there was a valley along the 8-8' line and a reservoir near the middle position of the 8-8' line. In 1972, ridges were cut and the valley filled with volcanic ash soils. As indicated by equidepth lines in Fig.7(a), the maximum depth of the fill was just 20m above the reservoir. Immediately after the earthquake, upper position of the slope above the reservoir started to collapse and shortly after there a large part of the fill behind the slope peak collapsed along the continuous line as illustrated in Fig.7(a). The collapsed mass of soil travelled a good distance aided by the water, coming from the water pipes. Because the housing sites were not yet ready for sale, only one man was killed by mud flow in the collapsed area. A cross section depicted the area along the 8-8' and 4-4' lines prior to development, after development, and following the earthquake are shown in Fig.7(b) and 7(c). As illustrated in these figures, estimates of the ground water table based on the boring work conducted in 1976 were relatively high for the land just above the reservoir. The ground-water appeared to flow down along the valley and the fill was almost saturated just before the earthquake. Immediately after the earthquake, spring water was found on newly shifted surface of the fill, and residual soils flowing downward. To best determine the causes of slope failure, many kinds of soil exploration, such as boring, sampling and sounding were conducted two weeks after the earthquake. N values in the fill, as determined by standard penetration tests in Fig.7(b) and 7(c), fell in the 5 to 10 range. It can be concluded from these results that the collapsed housing sites must have been unstable just before the earthquake.

Significant unevenness in unit weight and compression suggest that the earthquake should have been more solidly constructed. Immediately after the earthquake, the authors investigated the causes of ground failure and, as a result, proposed an earth removal project. The ground was readjusted at a 15 degree slope. In addition, a reinforced concrete well measuring 5m in diameter was constructed to a depth of 20m. Since completion of this construction, no body has been allowed to live in this areas.

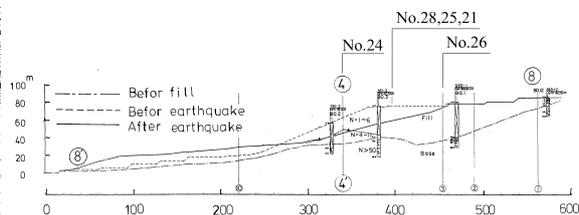
(b) 8-8' cross section

fig.7(b)and(c) Damaged to Kotobukiyama areas housing site.

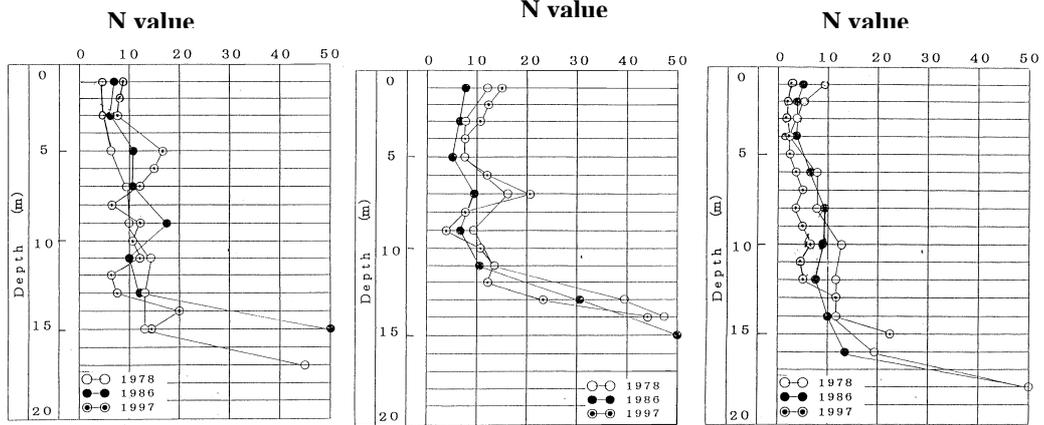
Fig.8(a) and 8(b) shows the distribution of N values obtained at boring No.24 and No.26 in 1978,1986 and 1997. N values at a depth of 0m to 7m increased overtime respectively. A reinforced concrete well resulted in a lower water level. Thus, no ground failures seems likely to occur in the event of a similar earthquake.

Boring locations No.21, 25 and 28 is shown in Fig.7(a). Figs.8(c), 8(d) and 8(e) show the distribution of N values obtained at boring locations No.21, 25 and 28 increased over time respectively. N values at a depth 0m to approximately 12m decreased over time at each boring locations. These penetration tests were performed in the ground after the earth removal and readjustment at a 5 degree slope. In Figs. 8(c), 8(d) and 8(e), averaged N values fell in approximately 5 in 1997. This N value is similar to averaged N value in the Midorigaoka housing sites immediately after the earthquake, in which severe damage to houses occurred. Thus, ground failure seems likely to occur in the event of a similar earthquake. However, the danger of slope failure has been reduced due to readjustment at a 5 degree slope.
