## A SURVEY OF DAMAGE CAUSED BY 1998 EARTHQUAKE IN THE SOČA VALLEY (SLOVENIA)

Matjaž GODEC<sup>1</sup>, Mihael RIBIČIČ<sup>2</sup> And Renato VIDRIH<sup>3</sup>

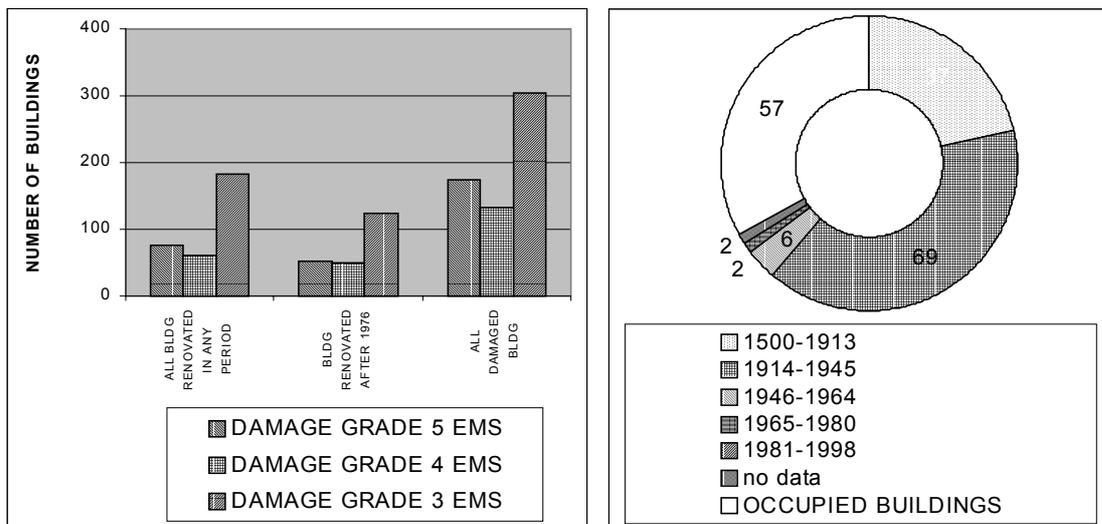
Older buildings had undergone several periods of repair. However, the post-earthquake inspection showed that not all renovation works had served to strengthen buildings to achieve aseismic safety. For the inspection of the damaged buildings showed that 76 (48%) of the buildings with damage of grade 5 had been renovated, of which 53 were renovated after 1976, the year of the Friulian earthquake. Among the buildings with damage of grade 4, there were also 61 (38%) renovated buildings. Most of them (53) were also renovated after 1976. Even such an overview gives an impression that insufficient attention was paid to strengthening buildings during renovation works.

**Fig. 2. Number of bldg. renovated at any time and number of occupied or unoccupied bldg with grade 5 damage.**

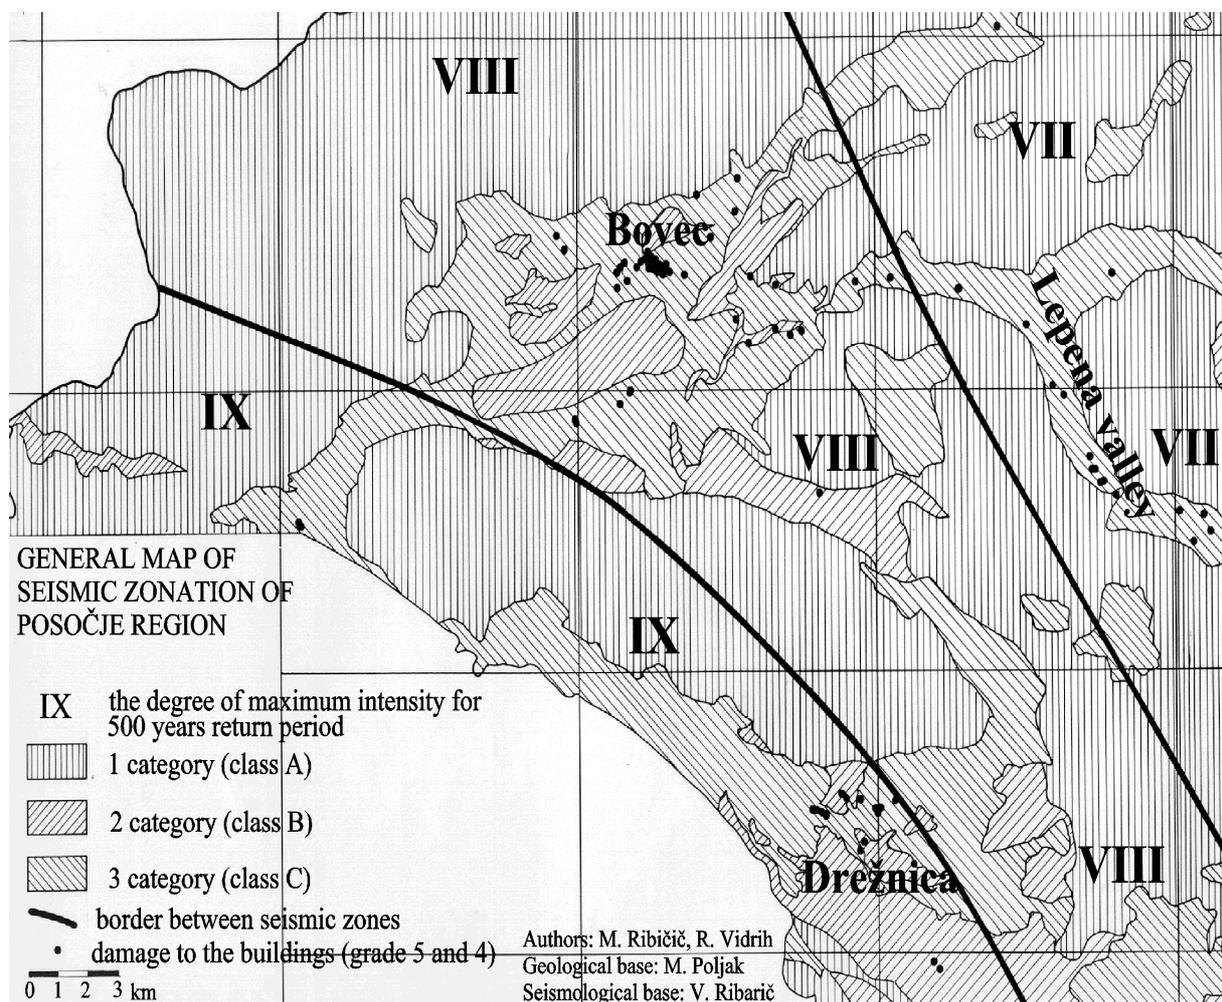
**Fig. 3. General map of seismic microzonation of Posočje Region with types of soil (categories 1 – 3).**

For the needs of repairs after the earthquake, we formed an overview map of seismic microzonation (Fig 3). To prepare the map of seismic microzonation, we used as the basis the official map of seismic hazard, presenting the levels of maximum seismic intensity for the return period of 500 years in Slovenia. This map is valid for planning buildings in seismically active areas. Apart from the map of seismic hazard, we also used the Geological Map of Posočje and much data from geotechnical and geo-physical studies of the area [Vidrih, Ribičič, 1994]. On the map we produced, we separated zones of different seismic intensities with thick lines. The

On the overview map of seismic microzonation, we classified valley alluvial and slope (glacial) deposits into the 3rd ground category. We included in the 2nd category the terrain composed of clastic rock (flysch) or obstructing gravel of the Soča river, deposited in a layer of more than 50 m. The characteristic of clastic rock is that they are covered by a relatively thick weathering layer with poor seismic characteristics. We included in the 1st category the carbonate rock (bedded limestones and dolomites) composing the Alpine region. Analysis of the damage in both quakes (1976, 1998) helped us in construction of the map.
