## THE STRENGTHENING OF AUCKLAND TOWN HALL

Trevor W ROBERTSON<sup>1</sup>

### SUMMARY

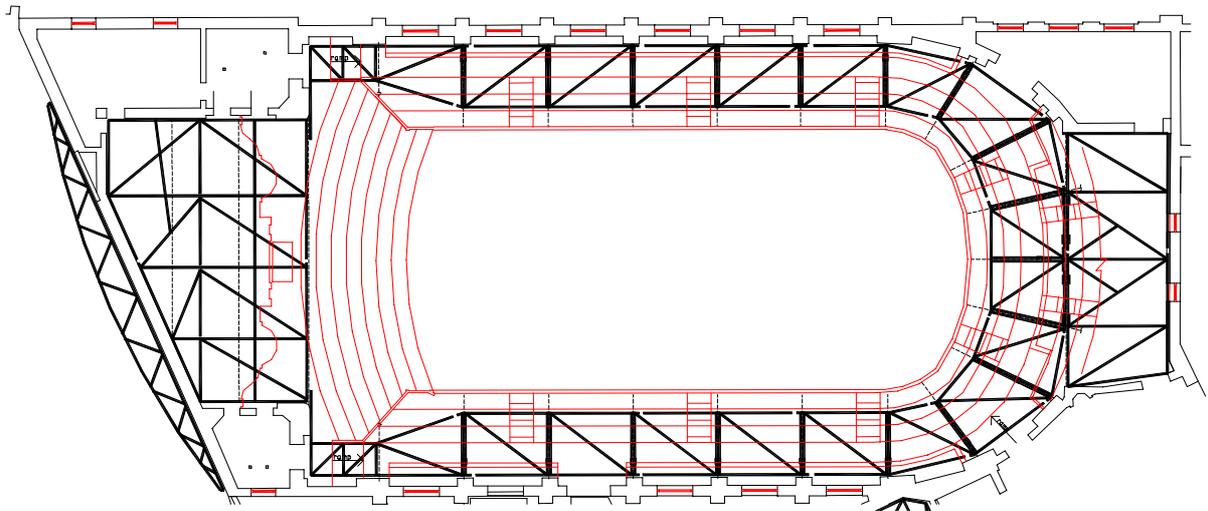
**Figure 7: Great Hall Circle Truss**

The Circle truss, Figure 7, was installed partially under and partially within the original Circle floor construction. It was conservationally important that the trusses were not visible in the finished building and that the soffit line of the Circle was not lowered. The function of the trusses is to resist seismic face loading forces from the perimeter walls and thus reduce their height to thickness ratio. The span to depth ratio of the trusses is necessarily quite large in order to fit within these restrictions and also the chord dimensions were limited to 200 mm depth in order to fit within the existing Circle framing. This limited the stiffness that could be achieved with these trusses. The original masonry walls are some 1200 mm thick at their buttresses and hence have some significant stiffness in their own right. Consequently, the walls and trusses were of comparable stiffness, leading to complex interaction and variable levels of support along the length of the wall. By means of localised (artificial) diaphragms, the face loading mass of the walls was included at mid-height for the ETABS analysis.

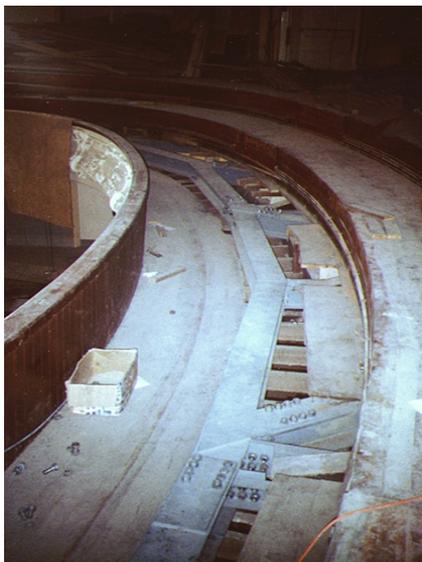
**Figure 8: Circle Truss Inner Chord within Circle Bleachers**

The analysis clearly identified response magnification, due to the flexibility of the diaphragms, as anticipated by theory. The south (rear) wall of the Great Hall is very slender and is also quite heavily loaded under seismic actions. As this wall provides essential support to both the Circle trusses and the ceiling diaphragm its integrity is critical to the whole of the Great Hall. Stabilising this wall presented a significant challenge. The problem was that the wall forms the rear wall of the Organ Loft, which contains some 2000 individual organ pipes, many being quite delicate. The major pipes are mounted against this wall and the loft is so full of pipes that it is difficult to move within the space. It was decided, therefore, that no work should take place within the organ loft. Fortunately, the Council also owned the adjacent rear property, which permitted installation of an external bracing truss overhanging the boundary. This truss is generally not visible as it is to be hidden behind the roof of the neighbouring ACC Garage. In the event that the garage site be developed in the future it may be necessary to reformat the method of support to the wall.

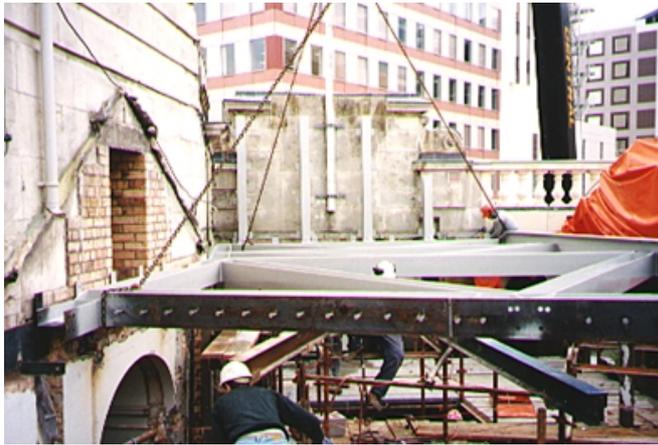
**Figure 9: Tower Restraint Truss**

The Tower itself had been strengthened under a separate contract several years earlier. This strengthening consisted of a steel grillage installed inside the tower extending down to roof level. Below roof level tension straps were installed over the remaining height of the building, buried within the brick walls, to resist overturning. Within the main strengthening contract a massive steel truss was installed at roof level just behind the tower and laced to it. This receives the tower shears at this level and distributes them to the Apex sidewalls as well as controlling torsional response
