STUDY ON SEISMIC DAMAGED AREA WITH LINE – SHAPE IN THE 1995 HYOGO – KEN NANBU EARTHQUAKE

SUN Jian-Sheng, NAGAI Tetsuo, SHIOTSUKI Takahisa and IKEJIRI Takeshi

Technical Research Institute, AOKI Corporation,
36-1 Kaname, Tsukuba City, 300-26 Japan

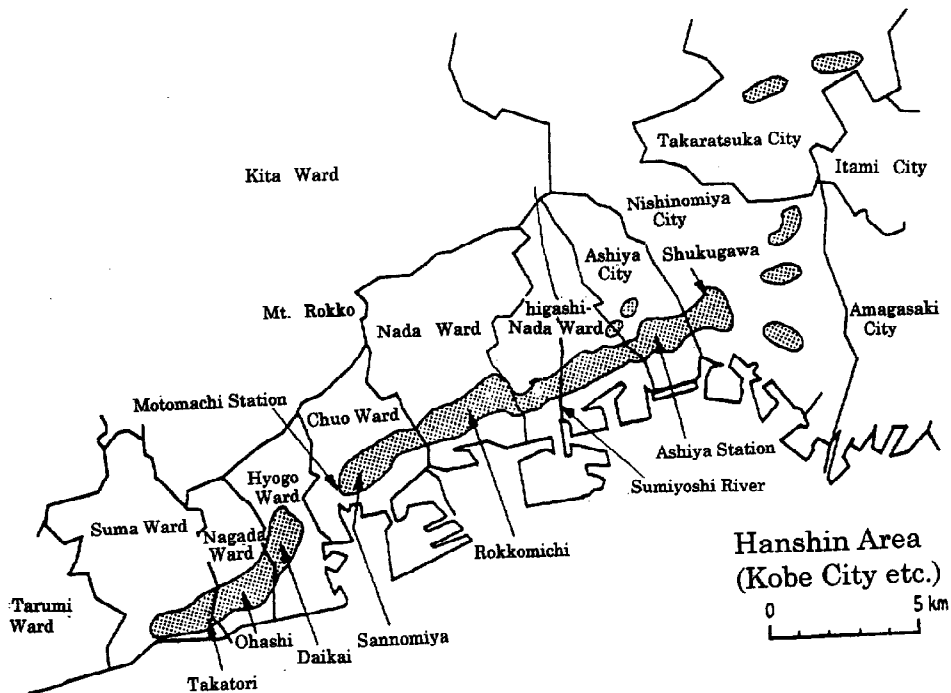
Fig.1 The distribution of JMA intensity 7 (by JWB, ADACHI, 1995)

Fig.1 shows the areas of JMA intensity 7, which look like a band-shaped zone with the length of 20km and the width of 1km. It is along the narrow alluvial plain by the sea. In order to illustrate the relationship between band-shaped damage and geological condition, the authors carried out an on-the-spot investigation of some chosen rivers which cross the band-shaped damage zone.

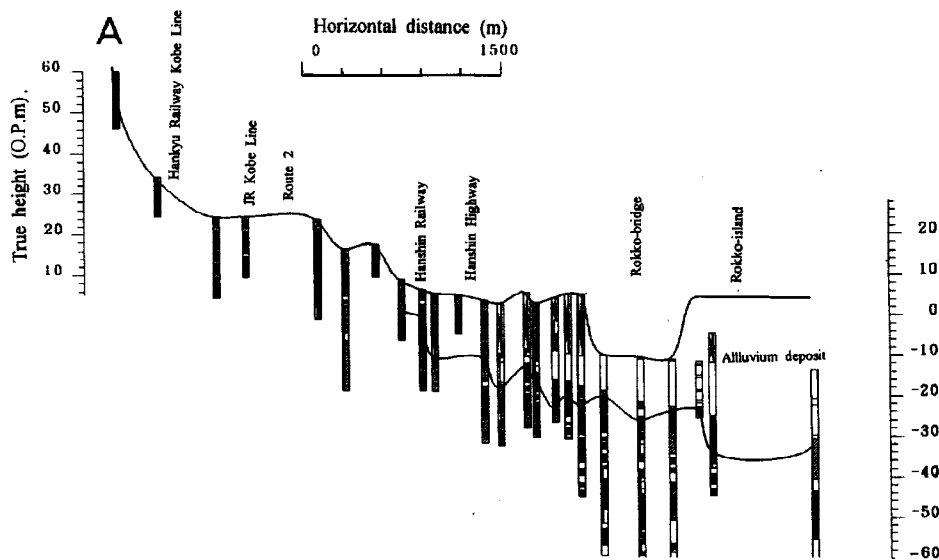
Fig.2 Profile of the Sumiyoshi River crossed Hanshin area
(Kansai Branch of the JSSMFE, 1992)

The Sumiyoshi river crosses the band-shaped Hanshin area. Fig.2 is profile of the Sumiyoshi river along south to north, and it is common in the Hanshin area. In general, the damage ratio is higher with the greater gradient., except for the area near the peak which is to the north of Hankyu railway Kobe Line. The area between JR Kobe Line and the Hankyu Kobe Line is steep inclined, within this area, the damages of roads, banks and buildings formed lines which are nearly vertical to the rivers, and faced east. Fig.3 shows the situation of the observed damage lines, the distance between each other is about 50-100m. The summarization of damage lines ①~⑥ is listed in Table 1. The common points are those damages usually happened in the steep slopes, the surface of roads and the bottom concrete slabs were destroyed due to compression. Fig.4 is the outline of the damage line ③ and ④, which were observed in the north side (the upstream) of canal(on bridge). The structures on both side were safe except for those under damage lines. Such damages can be seen in photo 1 that the surface of roads and the bottom slabs are budged. The concrete facilities in right bank is damaged, and the houses in left hand is collapsed.

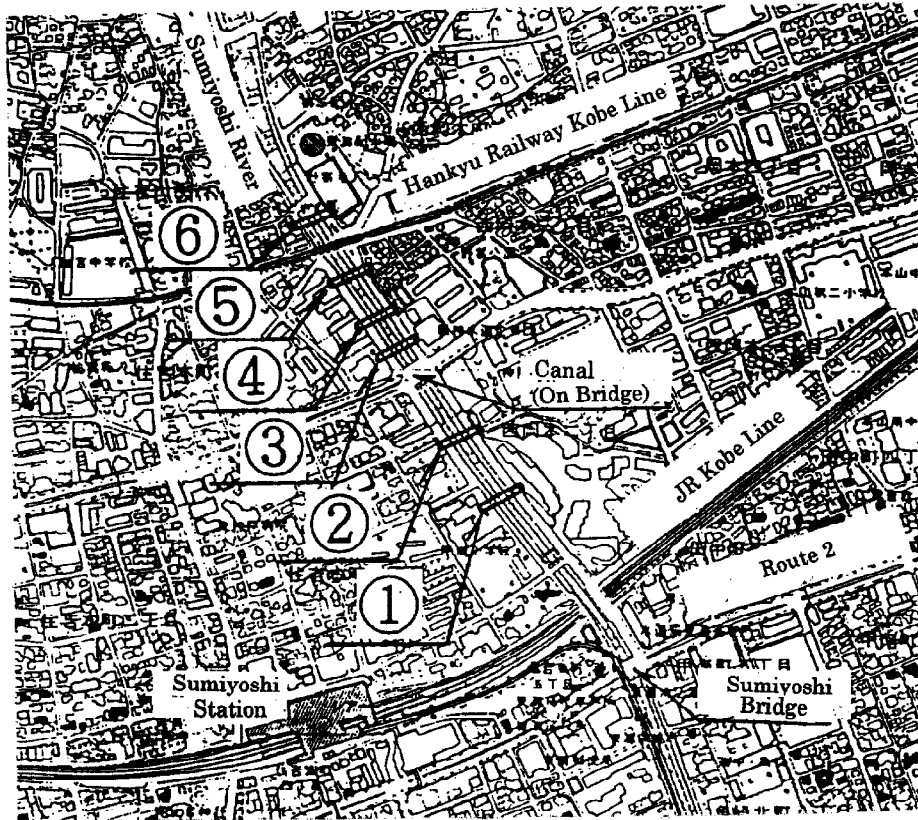
Fig.3 Situation of the observed damage lines along Sumiyoshi River

Between the JR Kobe line and Hanshin Kobe line, with rising and falling roads, most of the buildings were destroyed, and the damage lines cannot be observed. Furthermore, the geology surrounding the river is extremely complex, and the type of damage is therefore changed with the geology condition.

No. of Line-Shape	Situ	Outline of Damage		
		River	Bank Road	Structure
①	Side of the Konan Primary School	Stone Pavement of Banks Cracked, Slab(Compression) damaged	Cracks Faced East on Right Bank	
②		Stone Pavement of Banks is Cracked		
③	From Canal (on Bridge) to Upstream about 50m	Slabs in two Sides are Buckled and Pushed Up	Road pavement of Right Bank is Buckled and Cracks Faced East	
④	From Canal (on Bridge) to Upstream about 100m	Stone Pavement of Road Side is Buckled (Pushed Up and Compressed to Upstream	Road pavement of Right Bank is Pushed Up and Cracks Faced East	Right Bank: Two Buildings are Damaged by Shock, Retaining Wall Joint is Opened. Left Bank: Two Houses are Collapsed
⑤	From Canal to Upstream about 160m		Road pavement of Right Bank is Pushed Up and Cracks Faced East	Left Bank: Houses are Collapsed
⑥	From Hankyu Line to Upstream about 30m			Houses on Two Banks are damaged

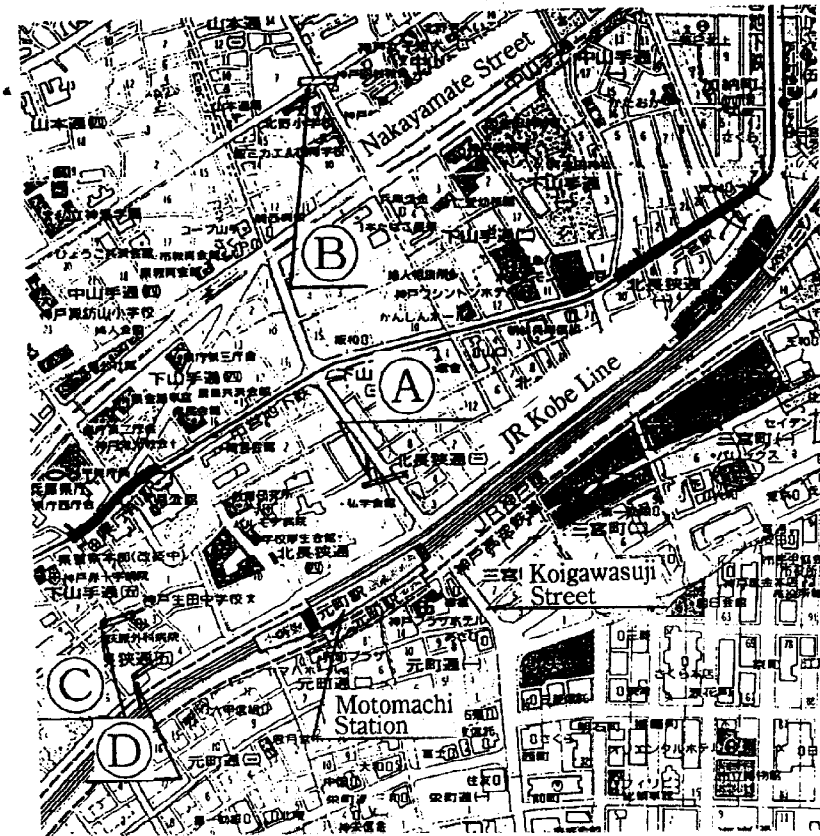
Fig. 5 Situation of the observed damage lines

Koikawa suji is an ancient river bed, it crosses the east part of JR Motomachi station, the zone is band-shaped and discontinuous. To the north of JR Kobe Line, there is also several damage lines at abrupt inclined sites (Fig. 5 A-D), and the damage conditions are listed in Table 2. An detailed investigation was made around point A, and its sketch of the damage is shown in Fig. 6, From which one can see that the cracks, sink of lands and the destruction of buildings and poles, composed the damage lines. One can also see that the severely destroyed buildings is compared with the slightly destroyed one.

No. of Line-Shape	Situ	Outline Of Damage	
		Road	Structure
①	Kitanagahaza-Dori 3-Chome	Marks of Repair on Pavement Faced East	Collapsed Houses Made East-Faced Lines
②	Yamamoto-Dori 3-Chome	Cracks Faced Southeast	At Two Sides of Steep Slope, Collapsed Houses Made Southeast-Faced Line
③	Shimoyamate-Dori 5-Chome	Cracks Faced East	At Two Sides of Steep Slope, Collapsed Houses Made East-Faced Line
④	Kitanagahaza-Dori 5-Chome	Cracks Faced East	At Two Sides of Steep Slope, Damage of Stone and Concrete Retaining Wall Made East-Faced Line
