## TESTING OF DAMAGED STEEL MOMENT CONNECTIONS

Four welded, beam to column, moment connections were taken from a two story building which was severely damaged during the Northridge earthquake (1994). All connections contained cracks which started in the weld at the bottom beam flange and propagated across the column flange into the column panel zone. The test specimens were tested in the "as received" condition to evaluate their residual strength and deformation capacity. They were then repaired in the laboratory and retested to evaluate the effectiveness of the repair procedure. A new "benchmark" specimen was fabricated and tested to serve as a basis of comparison.

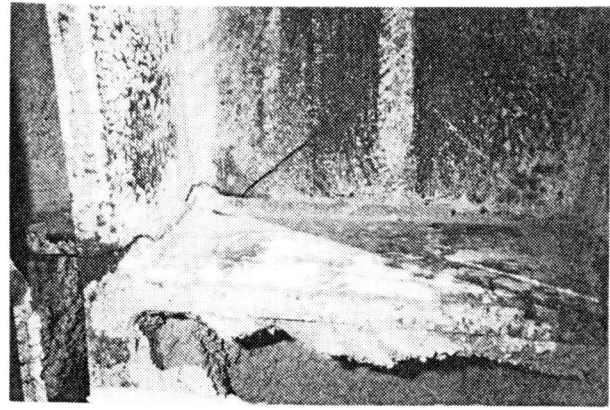
Fig. 2 Cracked Connection

The building, shown in Fig. 1, is a two-story office building which was constructed in 1991 and is located about thirteen miles north of the epicenter. Lateral resistance was provided by single bay, ductile steel moment frames on each of the four sides of the approximately square structure. Following the earthquake, it was immediately "red tagged" as being unsafe for occupancy. Field observations indicated that it was out of plumb by four inches to the south and west with three inches of this displacement occurring in the first story. In order to inspect the moment connections, it was necessary to remove the architectural finish on the exterior of the building. Once this was done it was found that nearly all of these connections at the second floor level had major cracks which appeared to start in the weld at the lower beam flange and extend through the adjacent column flange and in many cases into the column panel zone as shown in Fig. 2.

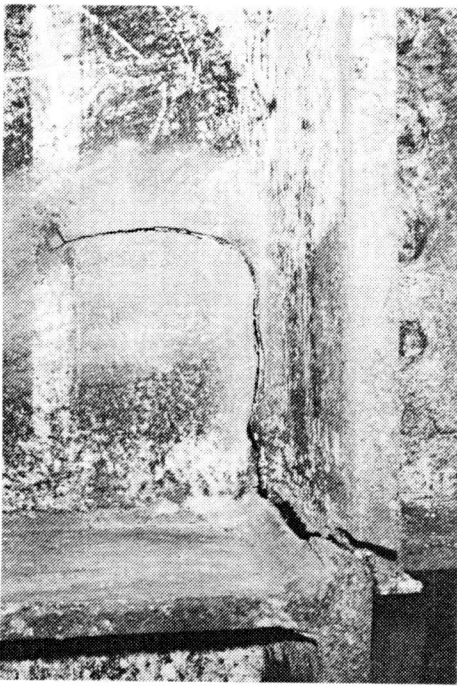
Fig. 7. Panel Zone Crack

This specimen was taken from the north side of the west frame. When taken from the building, it had a crack through the column flange adjacent to the lower beam flange. The crack appeared to have started in the weld connecting the bottom beam flange to the column flange, propagated across the column flange and then into the panel zone of the column. About eight inches into the panel zone, it turned horizontal and ran to the middle of the panel zone where it stopped at the intersection with a vertical plate used for a simple beam connection perpendicular to the plane of the frame. With additional cyclic loading, the crack forked into two branches and did not propagate any further. The test was stopped when the weld connecting the top beam flange to the column flange failed.

A picture of the panel zone is shown in Fig. 7. The hysteretic behavior is shown in Fig. 8, where it can be seen that the behavior remains quite stable up the crack in the top flange weld. With the application of positive load, the cracks are opening and with negative load they are closing. This action accounts for the lack of symmetry in the hysteresis loops generated by all specimens tested in the "as received" condition. The moment versus rotation curve indicates that the specimen was able to reach a positive moment of 4000 inch-kips and a negative moment of 8000 inch-kips compared to the plastic moment capacity of 9440 inch-kips based on the actual yield stress.

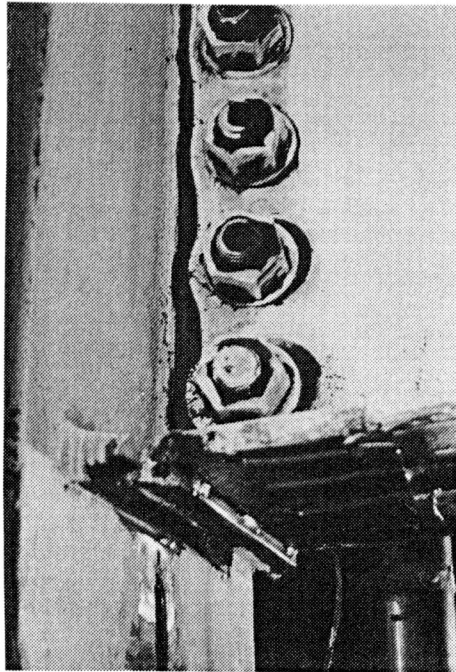
Fig. 10. Bolted Shear Tab, #5

The test proceeded in a normal manner to a displacement amplitude of two inches at which point the specimen failed abruptly on the up stroke by a pull out of the bottom beam flange from the column flange. Rather than stop the test, it was continued under displacement control for six additional cycles. The hysteresis curve, shown in Fig. 9, indicates that at the time of pullout, the load drops from over 100 kips to a new equilibrium state just under 50 kips and the tip displacement continues increasing out to the controlled two inch displacement. With reversal of load, the specimen begins following a new hysteresis curve which is very similar to that obtained for the specimens in the "as received" condition. The test was stopped due to degradation of the bolted shear tab, Fig. 10.

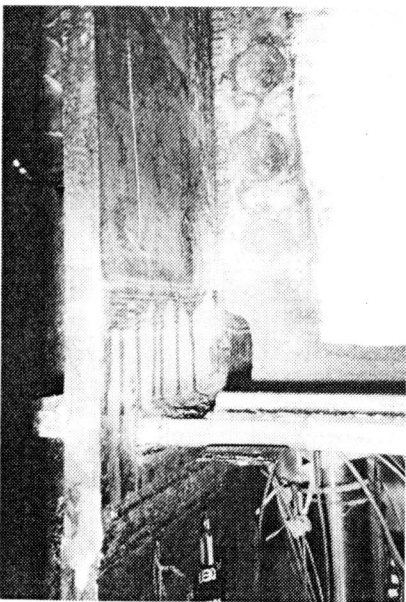
Fig. 11. Specimen #4R, Repaired

The repaired specimen performed very well on retesting. The specimen sustained nine cycles of loading with the last three cycles at a displacement amplitude of 3 inches (4.5% total rotation). The hysteresis loops of load versus displacement are shown in Fig. 12 along with the similar curve for the specimen in the "as received" condition. It can be seen that the repair has been very effective in restoring the original stiffness, increasing the moment capacity and increasing the rotation capacity.

Due to the crack across the column face at the level of the bottom beam flange, it was necessary to remove a section of the column flange and replace it with a new plate, a technique known as "flange replacement". The crack in the top beam flange which occurred during the initial tests also had to be removed. The crack in the panel zone was ground out with a stopper hole placed at the tip of the crack. Rectangular flange plates having the same thickness as the beam flange, were added to both the top and bottom beam flanges with fillet welds on three sides and a full penetration groove weld to the column flange. The shear tab, loosened during the initial testing, was welded on three sides to the beam web using fillet welds. The repaired specimen is shown in Fig. 11.
