CLEAVAGE SHEAR EXPLOSION OF REINFORCED CONCRETE SHORT COLUMNS
BROKEN DOWN BUILDINGS AND THE HANSHIN-EXPRESS HIGHWAYS
AT THE RECENT HANSHIN-AWAJI-EARTHQUAKE IN JAPAN ON THE 17. JAN. 1995

M. YAMADA

Department of Architecture, Faculty of Engineering,
Kansai University, Yamate-cho, 3-3-35
(564) Suita-City, Osaka, Japan

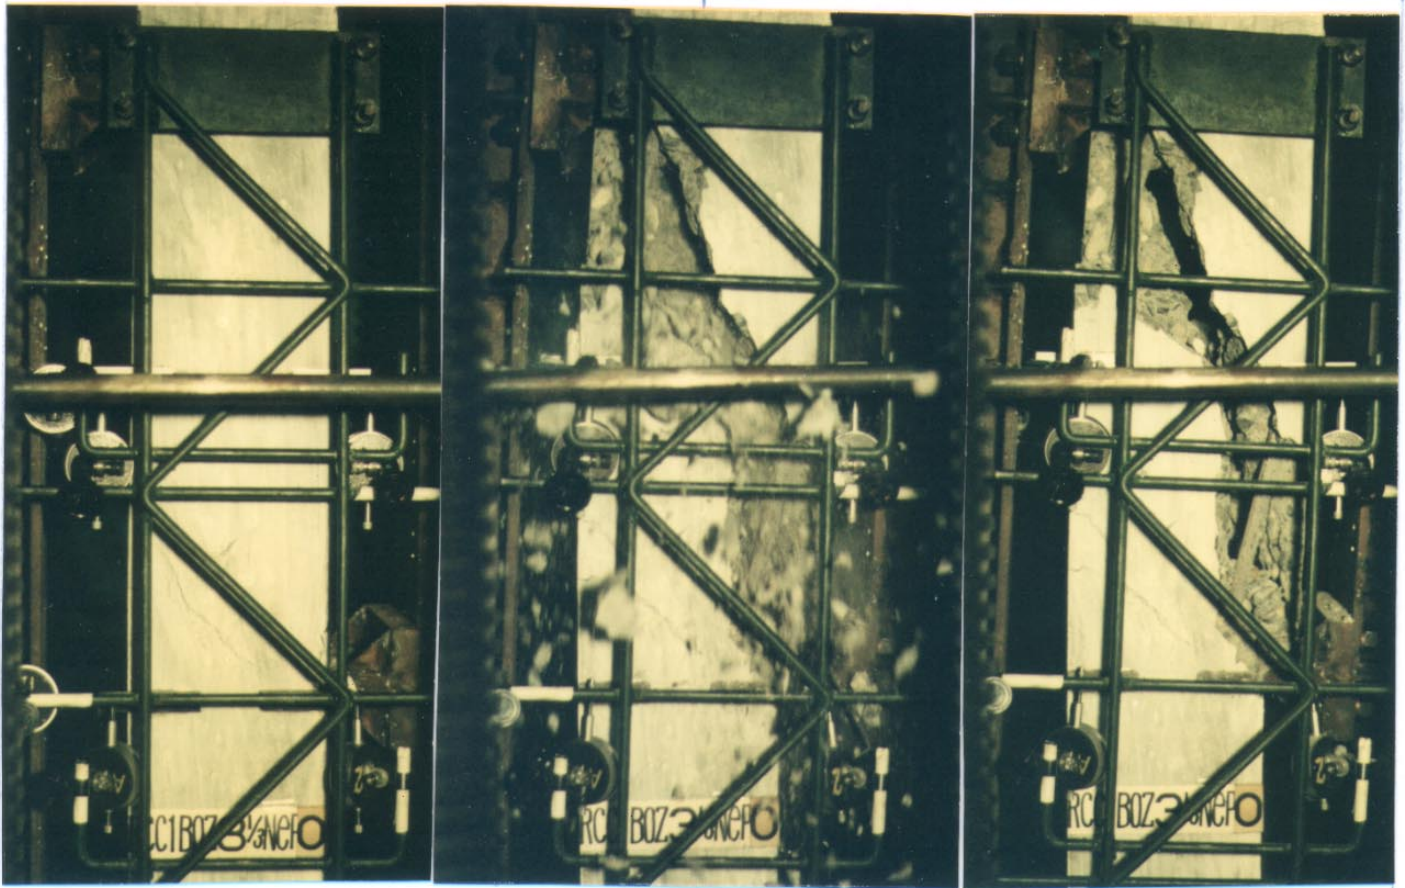
Explosive shear failure of reinforced concrete short columns was found at the first time by the author in the year 1966 (Yamada *et al.*, 1966) and given his warnings of the existing dangers of ordinary designed reinforced concrete buildings with short columns with a shorter shear span ratios a/d than 2 (or height to depth ratios H/D than 4). Photo 1 shows slightly before, at the instance, and after shear explosion.

Photo 1 Shear Explosion of reinforced concrete short column with a shear span ratio $(a/d)=1,8$ or $(H/D)=3$, under a constant axial load level $X=1/3$, (Yamada, et al.(1968)).

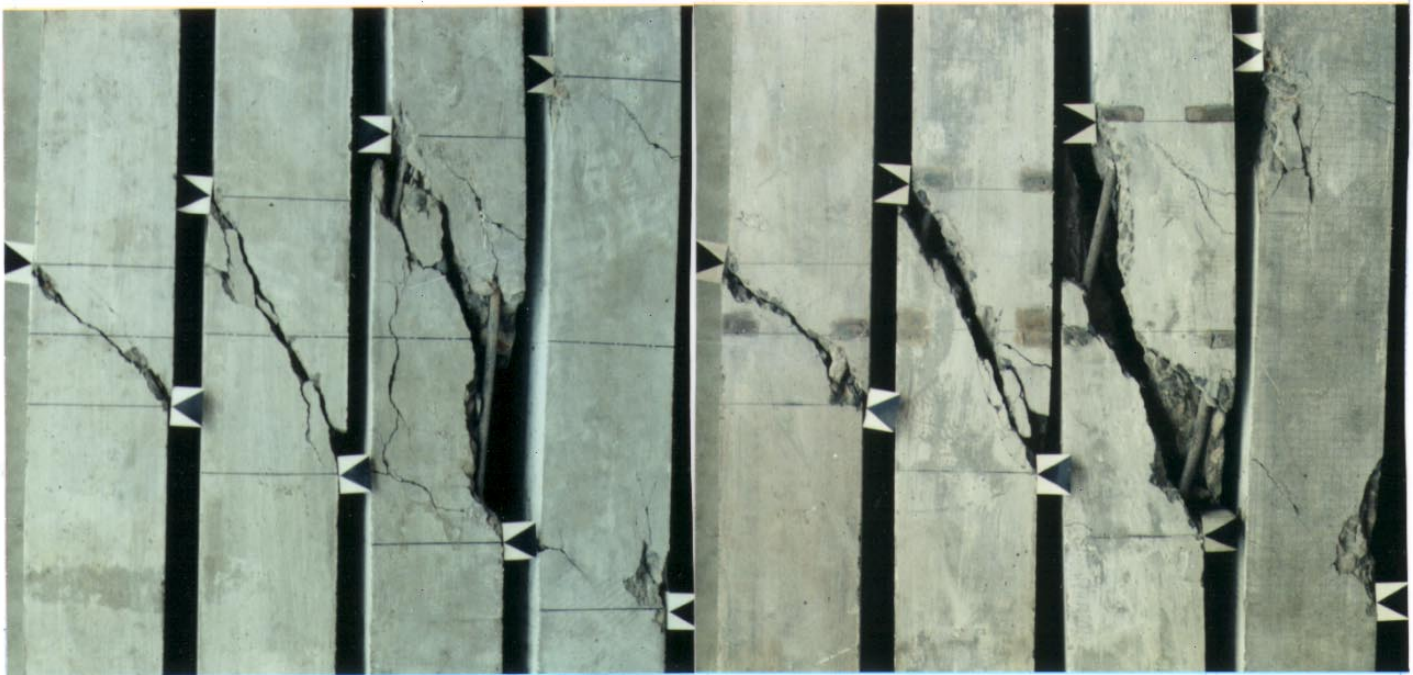
Photo 2 Critical Shear Span Ratio between Shear Explosion and Bending Yield (Yamada, et al.(1968); Yamada,(1974))

especially the transition of fracture mode from shear explosion to bending yield.

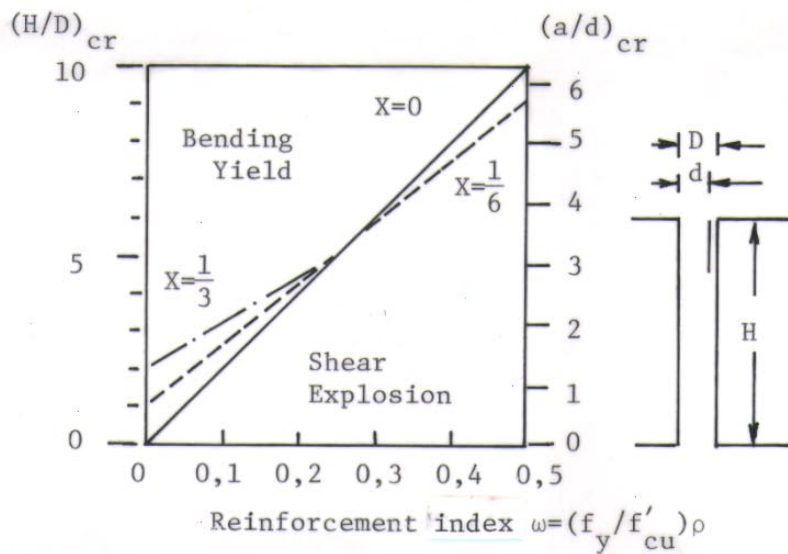
This value divides the two fracture modes of reinforced concrete column between explosive cleavage shear fracture of short column and bending yield of long column with sufficient ductility. Fig. 1. shows the critical shear span ratio as the function of axial load level ratio X and reinforcement index ω .

Fig. 1. Critical Shear Span Ratio $(H/D)_{cr}$ or $(a/d)_{cr}$
 (Yamada, (1974); Yamada, et al. (1974))

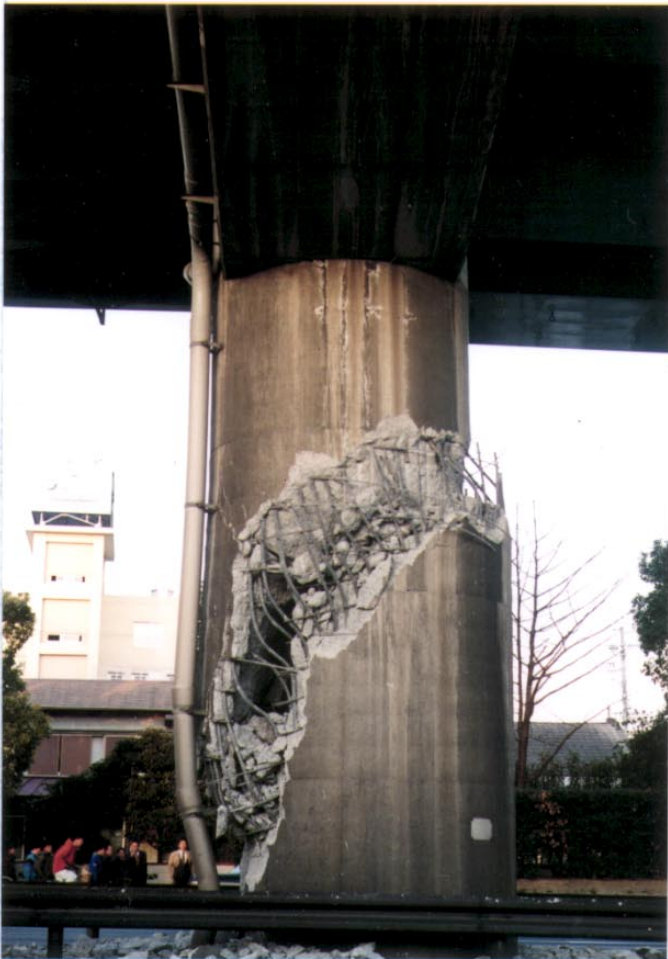
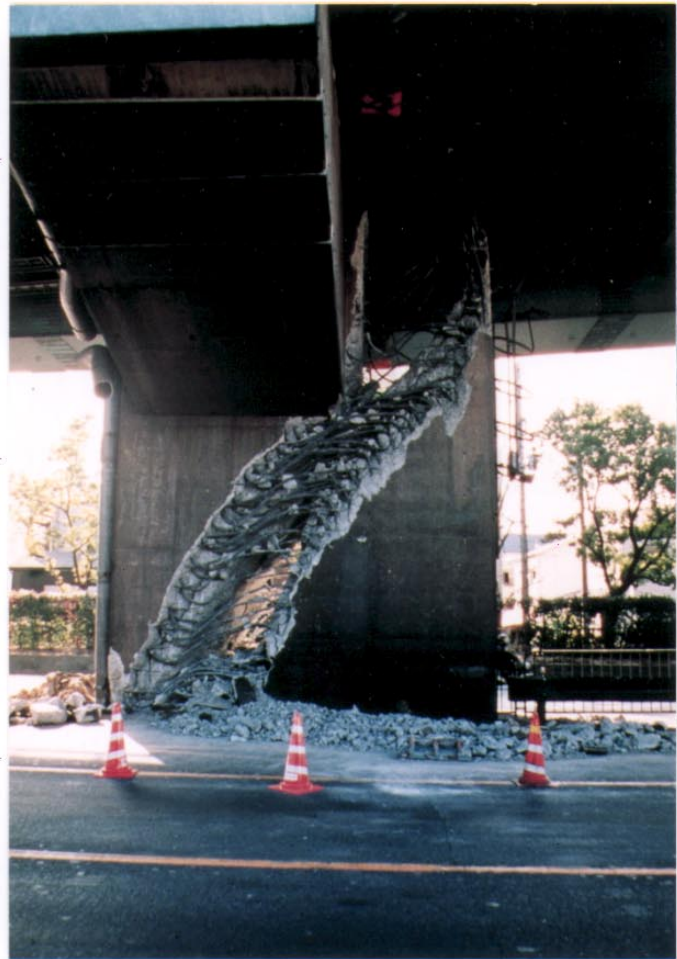
At the Hanshin-Awaji-earthquake, Japan, 17. Jan. 1995 many reinforced concrete short columns in the Hanshin-Express Highway No.3 between Osaka and Kobe, Japan, with round or rectangular cross section were broken down by the typical shear explosion (Yamada, 1996). Some examples are illustrated in Photo 3.

These columns were designed in the year 1966-1967 under the loading condition with a horizontal earthquake load level as 0,2 of gravity acceleration and simultaneously as vertical earthquake load level as 0,1 of gravity acceleration, which was the specially severe design condition at that time. At that time, the warning of the author on the existence of the damages by the explosive cleavage shear failure of such reinforced concrete short columns was not popular and not recognized generally. It was verified later in the year 1968 by the Tokachi-Oki-earthquake, Japan, and 10 years later by the Miyagiken-Oki-earthquake, Japan, 1978.

Photo 3 Destroyed reinforced concrete short columns in the Hanshin-Express Highway No.3 by typical Creavage Shear Explosion, at the Hanshin-Awaji-earthquake, 17. Jan. 1995, (Yamada, (1996)).

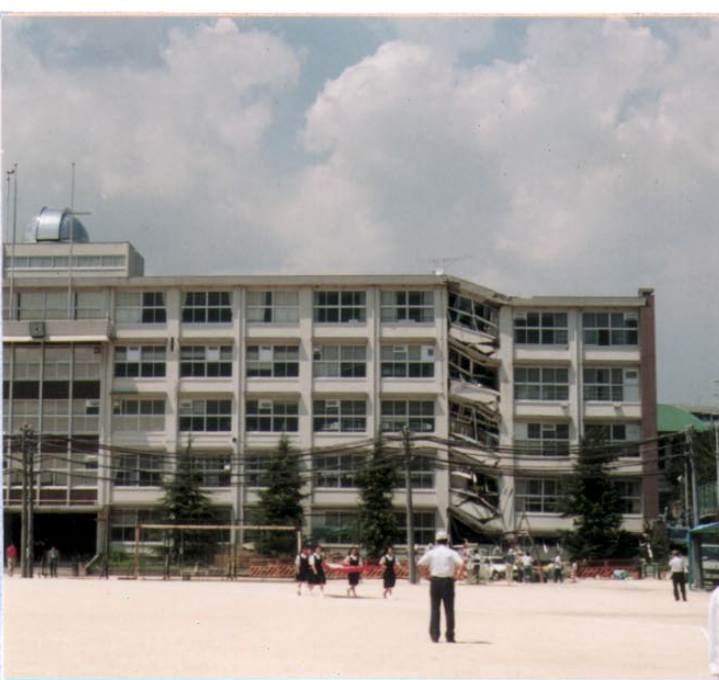
Photo 4 The Nishinomiya City High School

This 5 story building with 81 m x 11 m such as illustrated in Photo 4 was built upon a reclaimed pond and supported by prestressed concrete piles with a diameter of 35 cm. The piles under two bays of the east end of this building were driven into fairly stiff ground, which was former bank of the pond. On the contrary the piles under the main part of this building 14 bays of western side were driven through reclaimed soil with a thickness of about 3 m and into deeper and the level of this main part

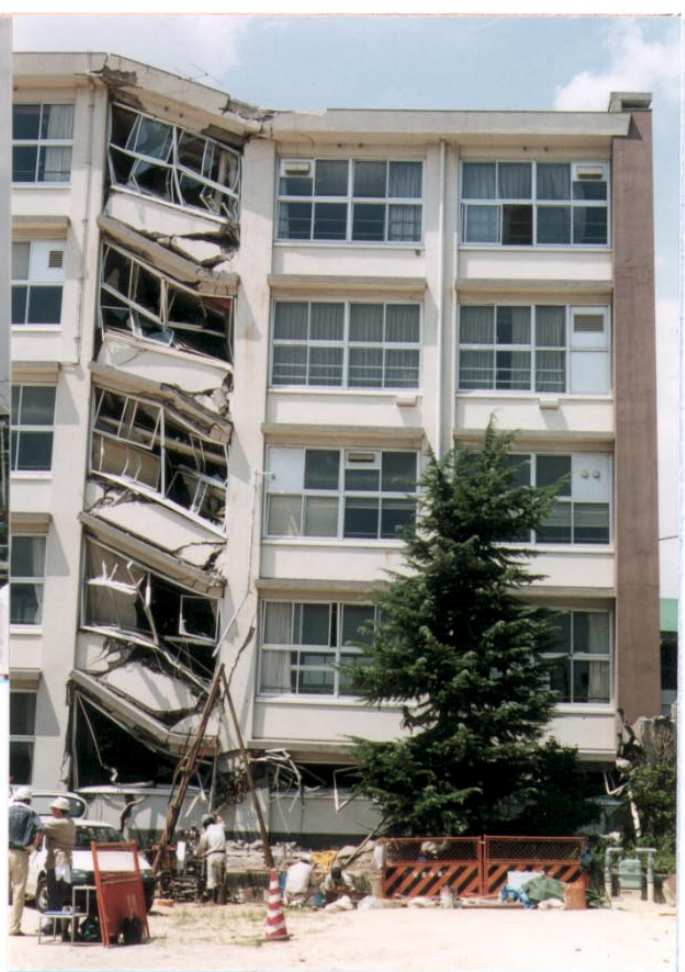
Photo 5 The east two bays

The east two bays are completely broken down by the shear explosion of the columns in the 1st story like Photo. 5. The third bay from the east end was inclined down to eastward.

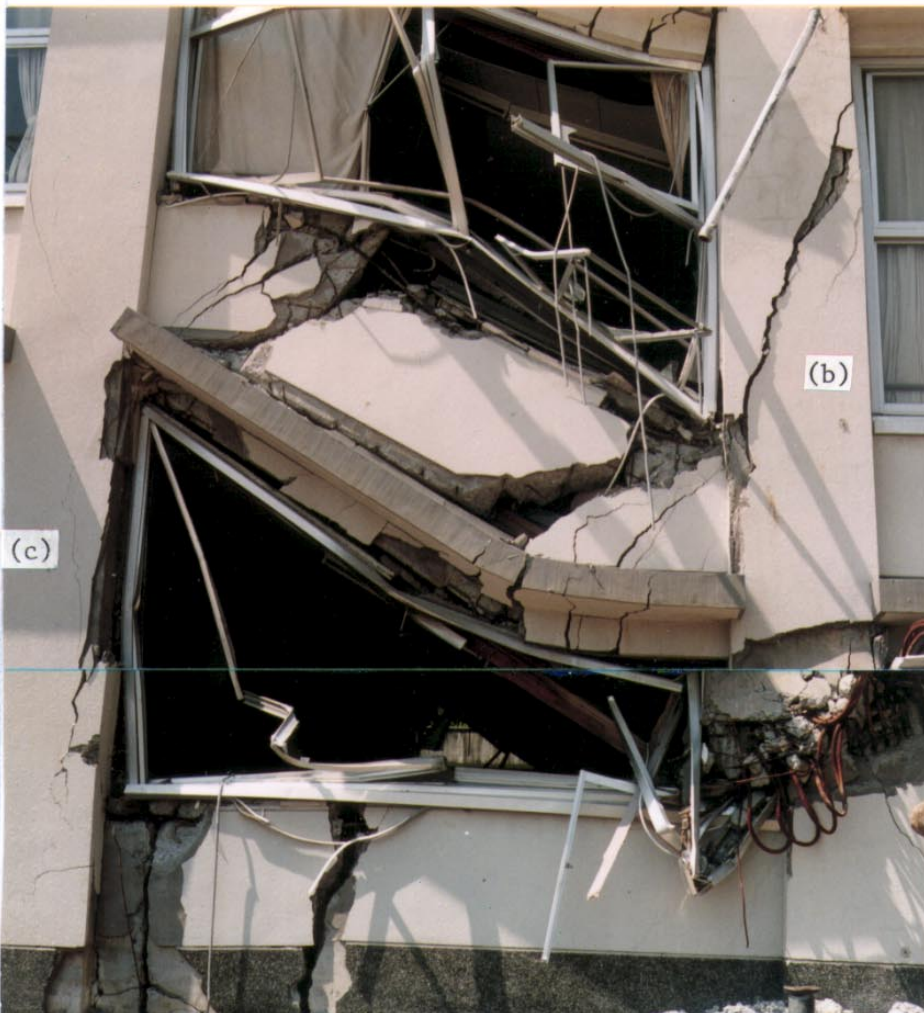
Photo 6 Detail of the third bay

At the falling down process of the east two bays, the third bay might be pulled down at the east end. Then the neighbouring columns at the west end of this bay were pulled by east neighbouring column to east downwards. It was formed shear cracks of opposite direction i.e. west upper to east lower such as illustrated in the fracture process state (4) and clearly recognized in the Photo. 6. (left hand side column).

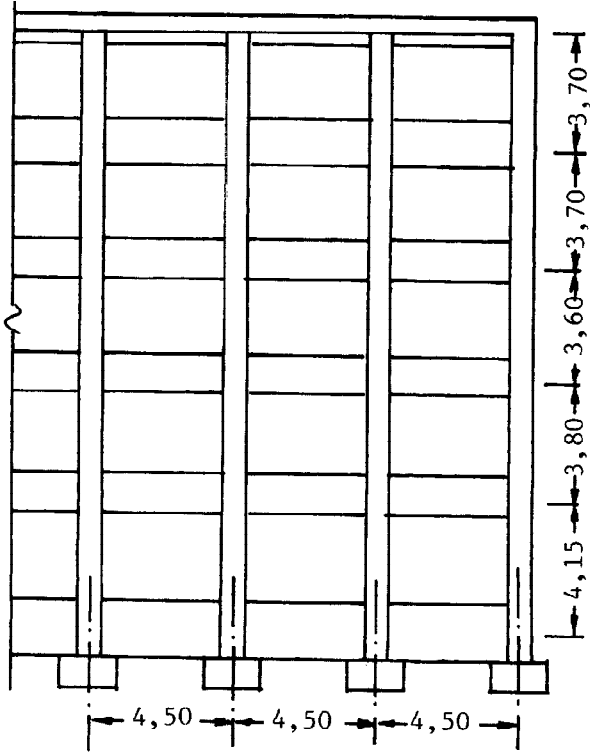
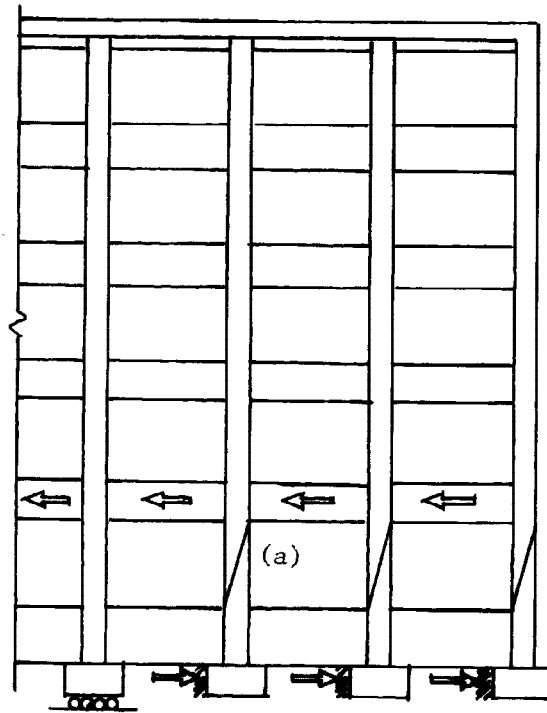
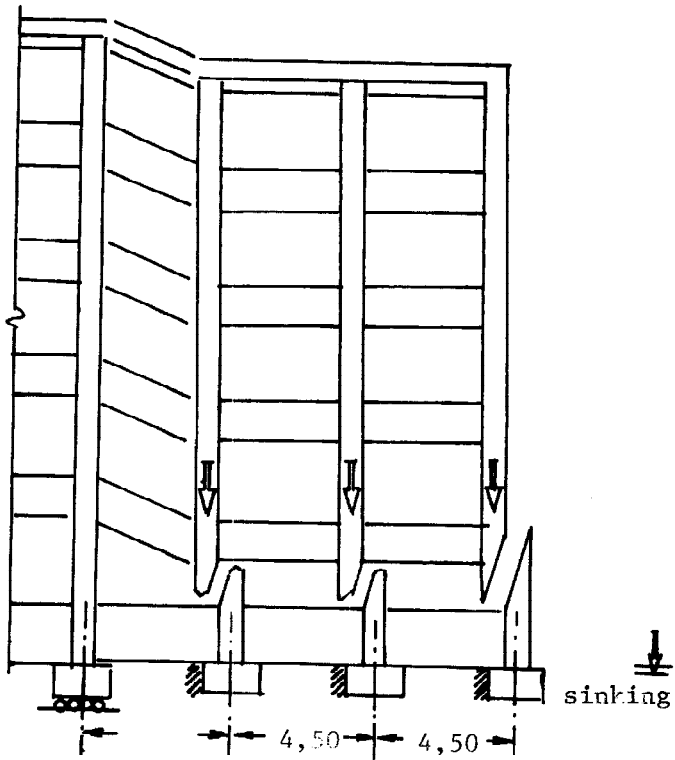
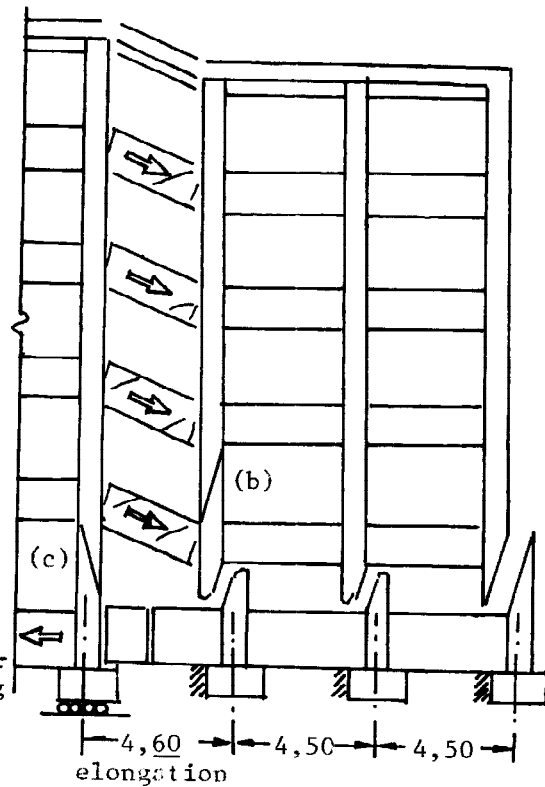
Sliding Fixed
by liquefaction by stiff bank of pond
(2) The first stage:
Shear explosion of short columns
(shear crack (a))

(3) The second stage:
falling down of the east two bays

(4) The third stage:
pulling down of the third bay at the
east end (shear crack (c))

Fig. 2. Deduced collapse processes of the Nishinomiya City High School at the Hanshin-Awaji-earthquake, 17. Jan. 1995, (Yamada, (1996)).

At the first earthquake shock to the eastwards in the ground, the whole building was pushed to the westwards. The east two bays of the building were fixed at the stiff bank of the former pond. On the contrary, the main part of this building with 14 bays in the western side was sliding to the westwards by the liquifaction at the liquifacted layer under 3 m. Then the columns in the first and second story were sheared off, which remain after shock very clearly as shear crack pattern diagonally from east upper to west lower. Especially the 6 columns in the first story in the two bays at the east end were sheared off instantaneously by the huge horizontal pulling force of main western building to westwards such as illustrated in Fig. 2.-(2) like the fracture process state (2) by the stiff fixing action of their basis. By the pulling of main western side building part to westwards, the third bay was stretched out and the elongation of the span reaches over 10 cm at the base beam.

By the dead weight of the upper part of about 620 t of the two bays of east end, of which area is about 100 m², might fall down like the fracture state (3) in Fig. 2.-(3).
