CASE STUDIES OF THE PERFORMANCE OF RETROFITTED BUILDINGS DURING THE 1994 NORTHRIDGE EARTHQUAKE

MARTIN W. JOHNSON AND HENRI KOZA
EQE International, Inc.
18101 Von Karman Avenue, Suite 400
Irvine, California 92715

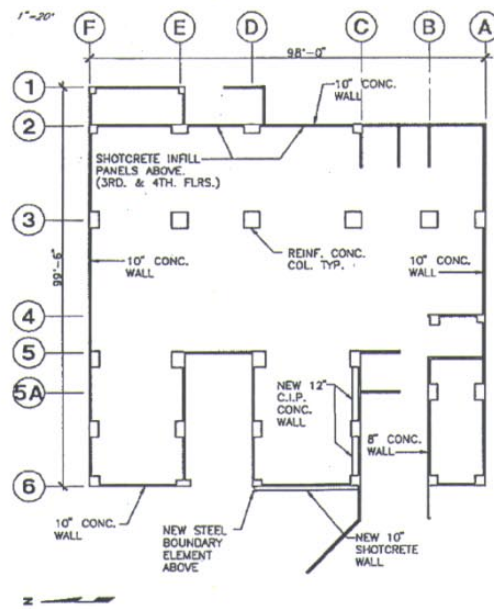
Following the subsequent aftershocks, minor cracks were observed in shear walls at lines C and F at the first story and lines A and 6 in the upper stories. Cracks were observed primarily above door openings and in taller, slender walls. The cracks were all considered minor to moderate and were repaired by epoxy injection. Many of the cracks were suspected to be a re-opening of cracks improperly repaired after the 1971 San Fernando Earthquake. No downtime was recorded, and operations were able to resume immediately after the earthquake.

Figure 1: Industrial Building In Van Nuys - First Floor Plan (Retrofitted Areas Highlighted)

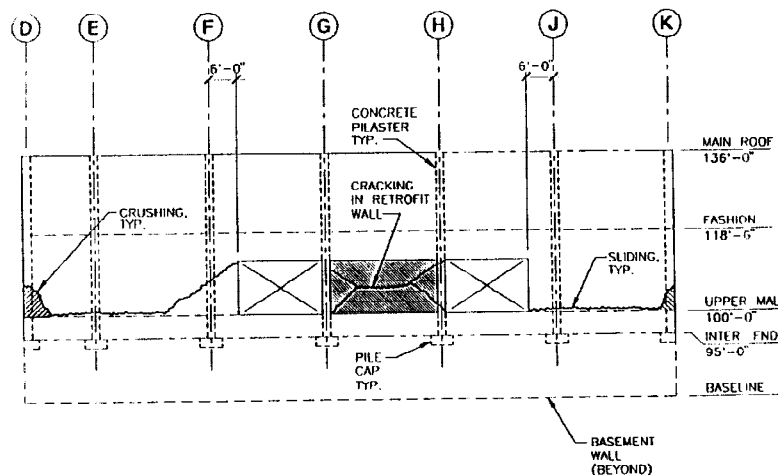
Following the Northridge Earthquake, the building was initially "red-tagged" by local building officials due to observed structural damage. This was later revised to a "yellow tag," after a letter summarizing initial evaluation findings was provided by engineers to the building department. Figure 4 depicts typical general damage observed at an exterior elevation. Temporary shoring posts utilizing steel columns were installed in several areas immediately after the earthquake to stabilize the building.

Structural damage consisted of severe damage to the retrofit shear walls between column lines G and H, as well as moderate crushing and cracking damage to the original-construction shear walls between column lines D and F, at both the east and west sides of the building. Less noticeable, but equally significant, was approximately 2 inches of sliding damage that occurred at the base of each of the original north-south shear walls, along the construction joints between the walls and their foundations. Vertical reinforcing bars at these joints are equal in size and spacing to the wall reinforcing and 100% of the bars are spliced across the joint with a lap length of 12 inches. This compares with current code lap splice requirements of about 30 diameters, plus 50% staggered splices.

Overall, the construction joint detail was marginal to transfer the wall shear forces, if it is assumed that the construction joints were well-roughened and cleaned before the wall was cast. However, although damaged reinforcing bars were observed in the earthquake-damaged joint areas, the damage observed was typically bending and breakage that was associated with the large lateral displacements. No signs of rebar withdrawal

or splitting were observed that might have been associated with a lap splice or development failure. A possible explanation for the sliding failure may therefore be that some combination of insufficient roughness, inadequate cleanliness, and poor concrete bonding may have created a reduced shear-friction capacity along the base of the wall.

Also interesting is the fact that cracking which occurred in the retrofit shotcrete walls tended to occur along horizontal planes, rather than as diagonal cracks. Horizontal shearing and sliding mechanisms normally only occur in concrete walls along construction joints, where a weakened plane is present in the concrete. A similar weakened plane in the building's shotcrete walls might have initiated during construction due to shrinkage cracking in the shotcrete wall, if the shotcrete bonded to the existing concrete at the perimeter and shrank away from the center, or if the sliding occurred along the construction joint created between adjacent "lifts" of shotcrete. This second possibility is considered more likely.

Unlike normal concrete walls, retrofit infill walls do not support significant vertical loads (because the concrete is placed after all building loads are already in place). Therefore, little weight is present to provide friction sliding resistance once an initial horizontal plane of sliding is formed within the wall. Also, the aggregate size used in shotcrete construction tends to be relatively smaller than that used in cast-in-place concrete construction. These two causes may have led to considerable hysteresis "pinching" and stiffness degradation in the retrofit wall.

Figure 4. Elevation of Building, Showing Damage
