## **DAMAGES OCCURRED TO CHURCHES DUE TO THE EARTHQUAKE OF FEBRUARY 8, 1995 IN PEREIRA, COLOMBIA**

P. J. MONTILLA, A. I. UZCATEGUI and S. M. HERNANDEZ

Departamento de Estructuras, Facultad de Ingeniería, Universidad de Los Andes,  
Av. Tulio Febres Cordero, Mérida, Venezuela.

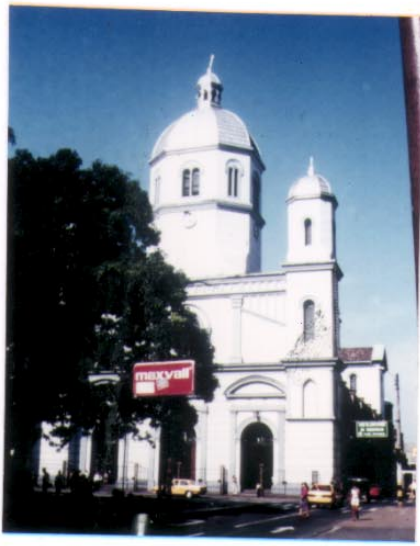
This church is constituted by a central nave and two lateral ones. It has two Towers located at the sides of the Frontispiece and in front of it. In the Presbytery zone there is a spherical cupola. The walls are of brick masonry of great thickness (Photo 1).

The minor damages observed are small cracks on the internal arches and walls and the inclination of the cross located on the top of the central cupola. All of the damages are slight and easily repairable.

Photo 1. Facade of La Pobreza Cathedral.

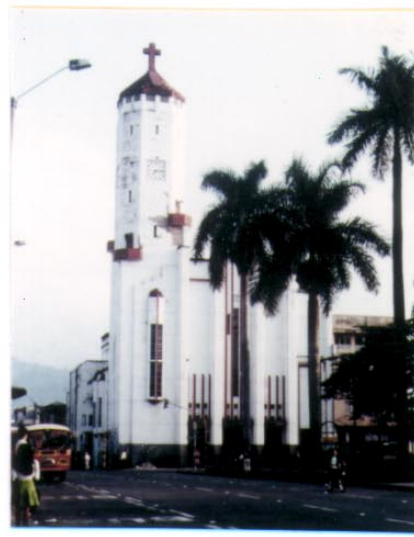
The damages occurred basically to non-structural elements. Loss of plaster was observed at the half of the Tower and an inclined crack located right at the zone of stiffness change between the Tower and the rest of the church (Photo 2). The external ornament and covering fell off the top of one of the columns of the central nave, and being very heavy they fell on to the roof of the left lateral nave close to the Presbytery, causing the failure of the roof and false roof also very heavy, which if it had been occupied could have caused injuries to people in the area (Photo 3).

Photo 2. Facade of Balbanera Church.

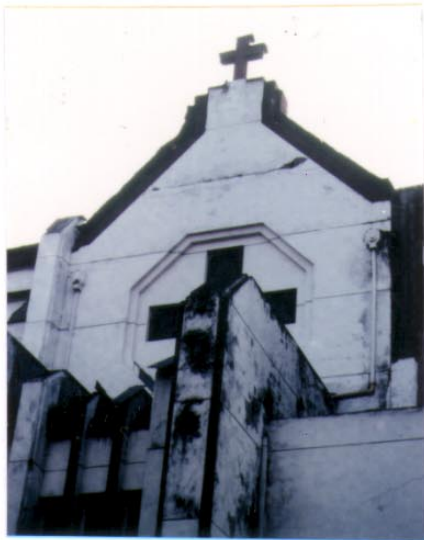
Photo 3. Ornaments fell off the Balbanera Church.

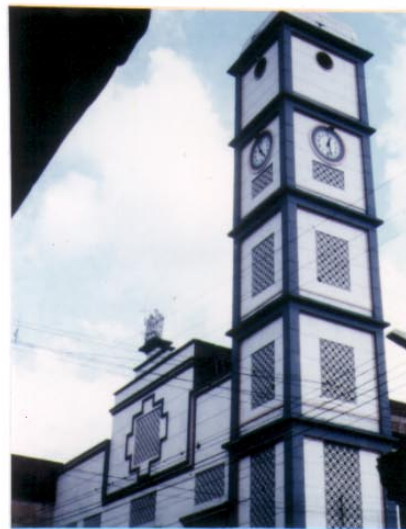
It is asymmetric on the plan, constituted by four naves, one central, two to the left and one to the right. To the right of the Frontispiece and out it is plane, there is a Tower made up of five bodies or levels (Photo 4). The structure of the church is made of reinforced concrete.

Photo 4. Facade of La Trinidad Church.

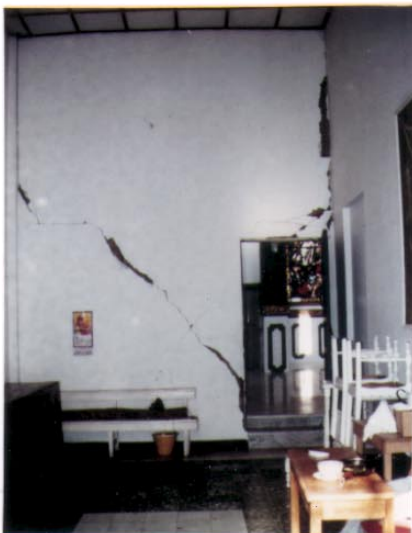
The damages were concentrated in the zone of the Presbytery, in the Tower and in some non-structural elements of the Central Nave. Great cracks were observed in the walls of the Presbytery and of the Sacristy, possibly due to the stress concentration originated by sudden change in stiffness in that zone (Photo 5). In the Tower small cracks were observed in the walls; at the top of the Central Nave some plaster fell off and the ornaments of one of the columns, that fell on to the wooden benches, breaking them (Photos 6 and 7). Also small cracks were observed in the top beams of the Central Nave. Some religious images that were on high stands connected to the columns also fell off (Photo 8). The false roof, made of sheets of heavy material, nearly collapsed in the zone close to the Presbytery. The falling of non-structural elements did not cause loss of lives because the church was empty at the moment of the earthquake.

Photo 5. Great cracks in the Presbytery of Balbanera Church.

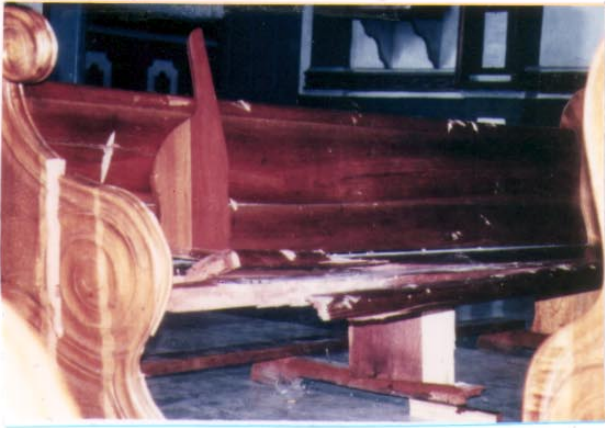
Photo 7. Broken wooden bench in Balbanera Church.

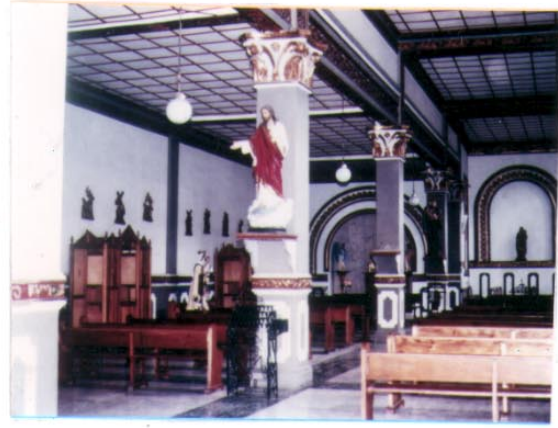
Photo 8. Religious images fell off in the Balbanera Church.

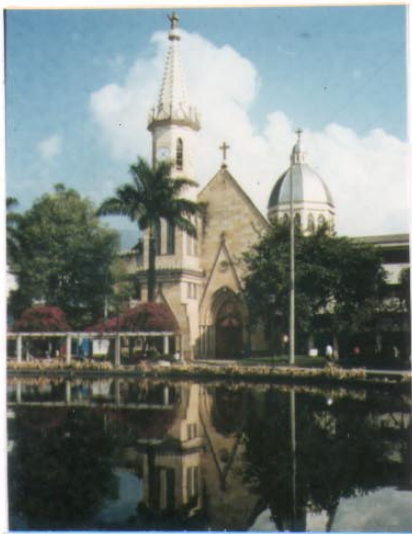
This church is constituted by a Central Nave, two lateral ones and a Tower located to the left of the Frontispiece (Photo 9). There is a spherical cupola in the zone previous to the Presbytery. The structural

Photo 9. Facade of San Antonio Church.

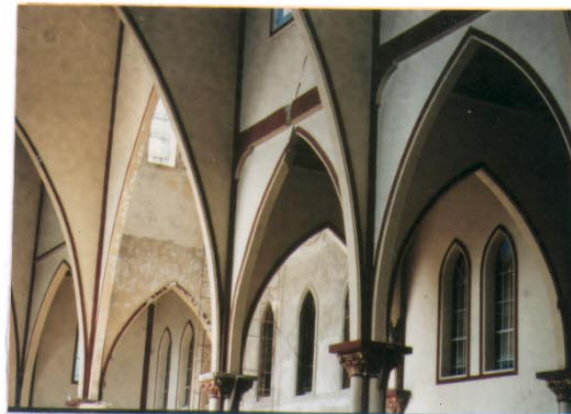
system is of reinforced concrete. The Presbytery is conformed by a system of poorly reinforced concrete arches distributed in the longitudinal and transversal directions. The Central Nave has two longitudinal beams that finish in the arch before the Presbytery, producing a structural discontinuity in that zone (Photo 10).

Photo 10. San Antonio Church. Discontinuity in the zone of the Presbytery

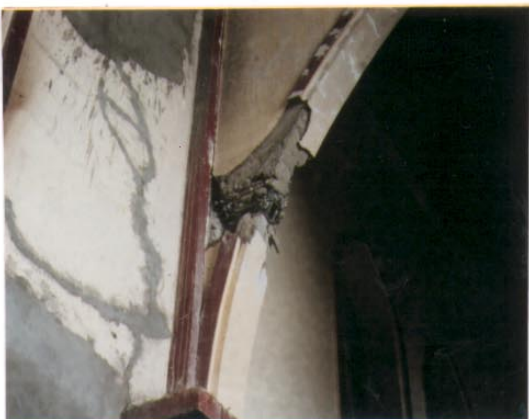
Severe damage was caused to the arches located to the right of Presbytery, at the top and at the column-arch joint; in both places loss of concrete cover and buckling of longitudinal bars were observed (Photo 11). The two central columns that support the arch before the Presbytery showed a considerable lack of verticality, opening the arch, and significant cracking at the base (Photos 12 and 13). The last span of the longitudinal beam that finishes at these columns resulted seriously affected (Photo 10). The border wall of the left lateral nave, made of brick masonry and of great thickness, suffered excessive lack of verticality outwardly, in the zone of the Presbytery, resulting seriously cracked. The top part of this wall, which was laterally unsupported, fell off into the neighbouring building, originating damage to it. Later it was completely demolished (Photo 12). Some religious images that were resting simply on wooden pedestals fell over breaking themselves, without causing injuries to people because the church was closed at that moment. This church was close to collapsing in the Presbytery zone.

Photo 11. San Antonio Church. Severe damage at the column-arch joint.

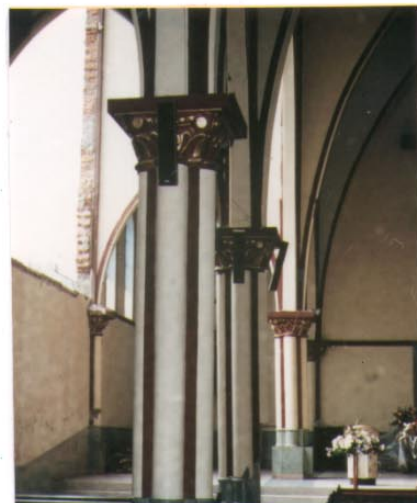
Photo 12. San Antonio Church. Lack of verticality of central column.

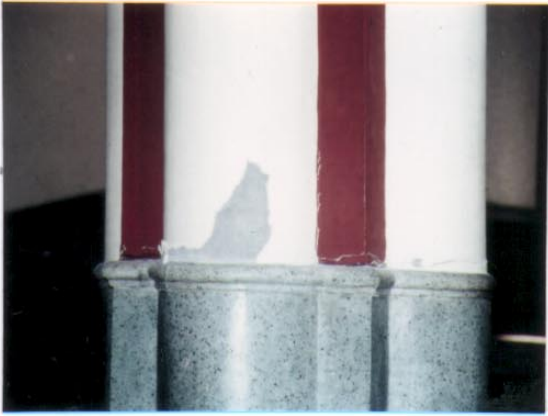
Photo 13. San Antonio Church. Cracking at the base of the central column.

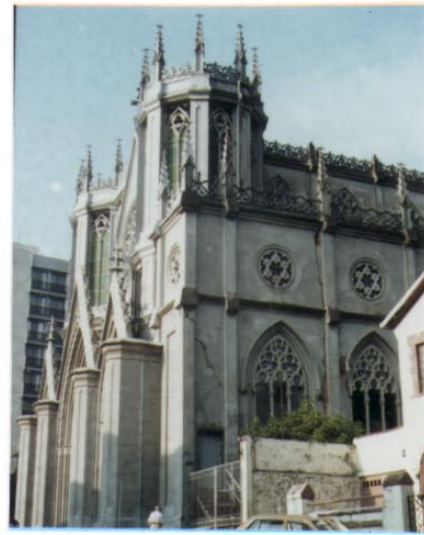
This church has a Central Nave, two lateral ones and two small Towers located at each side of the Frontispiece (Photo 14). The plan is rectangular and asymmetric. It is very high in the Central Nave and its height is reduced considerably in the lateral naves. The roof is made of reinforced concrete slabs, supporting false domes internally. The structural system is of reinforced concrete frames infilled with brick masonry, which form a series of arches in the longitudinal and transverse directions inside the church. The Chorus has a very stiff transverse beam and its structure has a construction joint that separates it from the rest of the church; however, during the construction a connection was made crossing the joint with the reinforcing bars of the longitudinal beam. In the longitudinal direction, between the Chorus and the Presbytery, there is a stiff beam that is interrupted before this last one (Photo 15).

This church had generalised damages, in both structural and non-structural elements. The most severe were concentrated in the zone of the Presbytery and the Chorus, that were close to collapsing. In the zone of the Presbytery, at the top of the columns the concrete suffered fracture and the reinforcing bars buckled due to stress concentration because of a short column effect and due to sudden stiffness change as a result of the discontinuity in the longitudinal beam in the Presbytery (Photo 16). In the zone of the Chorus, at the construction joint, separation occurred between this body and the Central Nave; but, due to the connection through the joint of the reinforcing bars, serious damage was caused in this zone (Photos 17 and 18). In the lateral walls great cracks were produced, specially close to the great opening of windows, that produced zones of weakness fracturing the wall. There was also considerable damages at the zone of union between the church and the Pastoral House, due to uncoupled movement of both buildings. Some heavy parapets that were located above the access doors, presented severe cracks in the union with the church and were near to overturn (Photo 14). Some religious images fell down breaking themselves.

Photo 14. Facade of the San Jose Church.

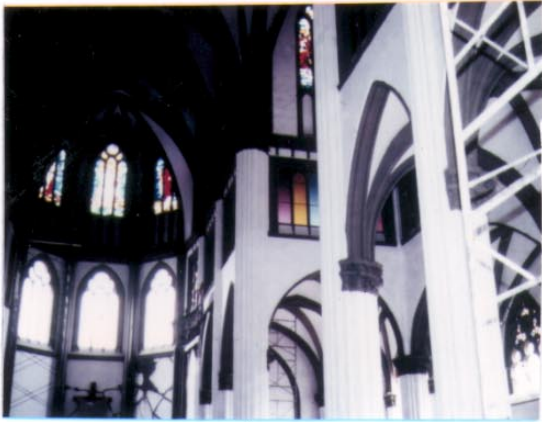
Photo 15. San Jose Church. Beam without continuity to the Presbytery

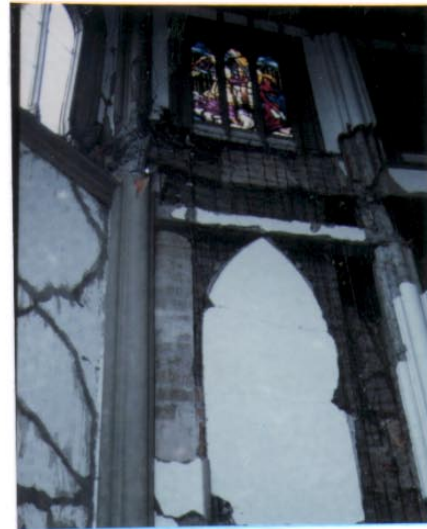
Photo 16. San Jose Church. Fracture of short columns at the Presbytery

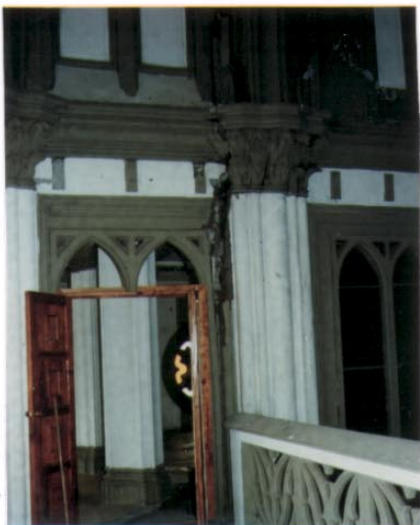
Photo 17. San Jose Church. Separation of the structures of Chorus and Central Nave.

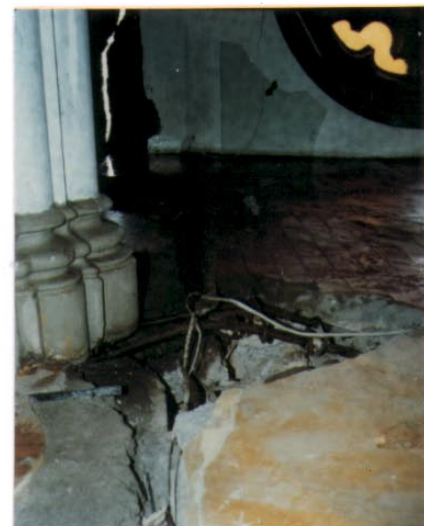
Photo 18. San Jose Church. Severe damage in the section between the Chorus and the Central Nave.
