DAMAGES TO BEAM-TO-COLUMN JOINT PANELS OF R/C BUILDINGS CAUSED BY THE 1995 HYOGO-KEN NANBU EARTHQUAKE AND THE ANALYSIS

Masaya HIROSAWA¹, Tomoaki AKIYAMA², Tatsuya KONDO³ And Jiandong ZHOU⁴

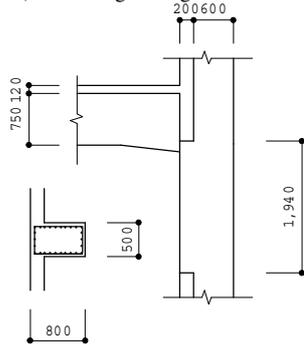
Figure 1: Details of the beam-column joint damaged by the 1968 Tokachi-oki earthquake

As shown in Table 1 and Fig. 1, the seismic damage to the school building of Hakodate University in the 1968 Tokachi-oki earthquake was the first evidence showing the effect of torsional stress due to the eccentricity on the shear failure of columns and beam-column joints. Subsequent model experiment confirmed a 40% capacity reduction due to the eccentricity. Other seismic damages associated with the torsion can be found and followed by related experiments.

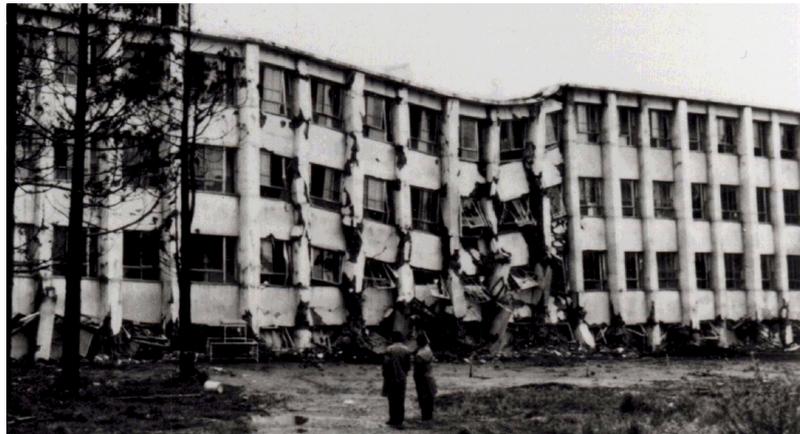
Photo 1: The school building of Hakodate Univ. collapsed by the 1968 Tokachi-oki earthquake

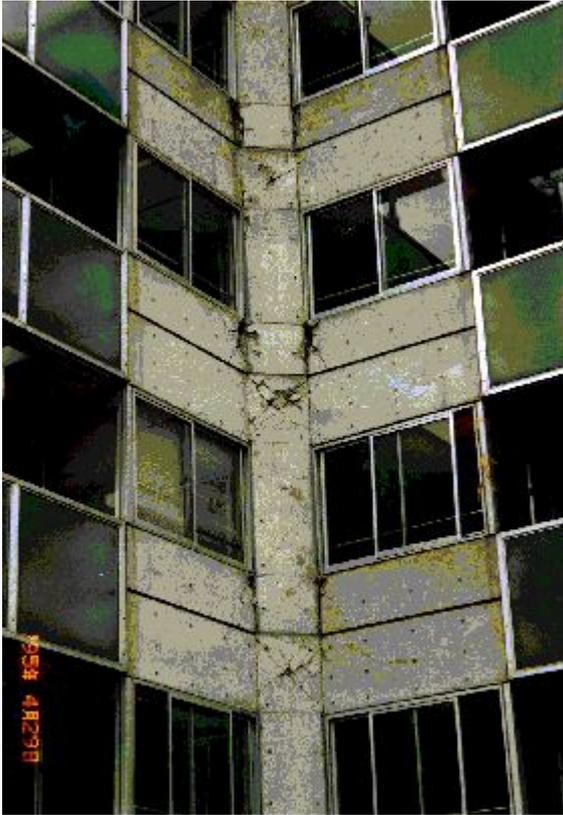
Photo 3: Cracking patterns observed in eccentric beam-column joints of a 9-story RC building (A) with $e_1=0.25$

Noticeable damages to joints in the 1995 Hyogo-ken Nanbu earthquake were associated with the eccentric beam-column joints. Examples of damage to the joint are shown in Photo. 3, a 9-story RC building ($e_1=0.25$) and in Photo. 4, an 11-story SRC building ($e_1=0.175$). Photo. 5 shows damage to concrete sampled from the eccentric joint shown in Photo. 4. The damage to joints were noticeable only in the perimeter frame where beams were eccentrically connected to columns but nearly no damage was observed in the inner frames see also Fig. 3.

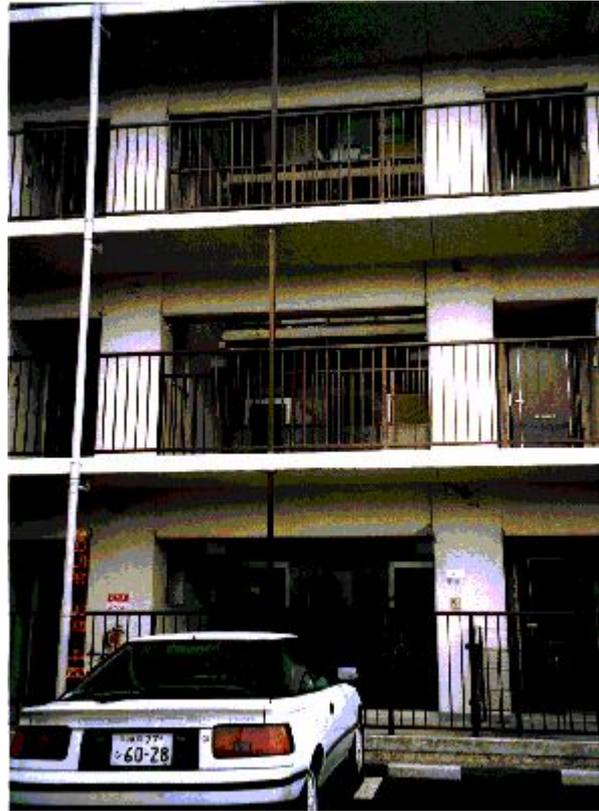
Photo 4: Concrete crushes observed at surface of eccentric beam-column joints of all story SRC building (B) with $e_1=0.175$

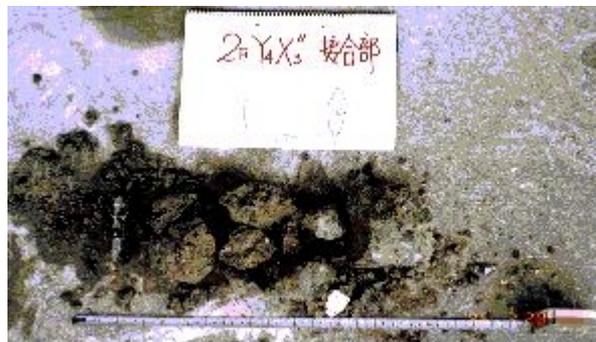
Photo 5: Concrete crushes observed in a concrete core drawn out from the damaged joint of the building B

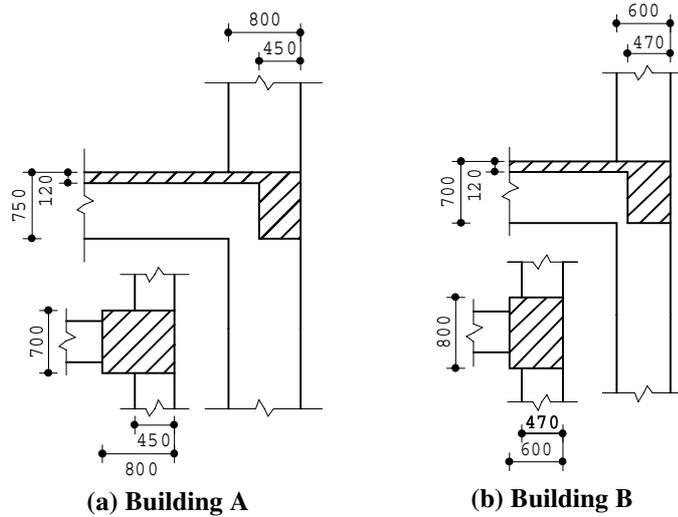
Figure 3: Details of eccentricity of beams to columns in the buildings A and B (in mm)
