AN INVESTIGATION OF THE EARTHQUAKE EFFECTS ON ARTICULATED BRIDGES LOCATED ON FAULT RUPTURES

Turel GUR¹ and Mete A. SOZEN²

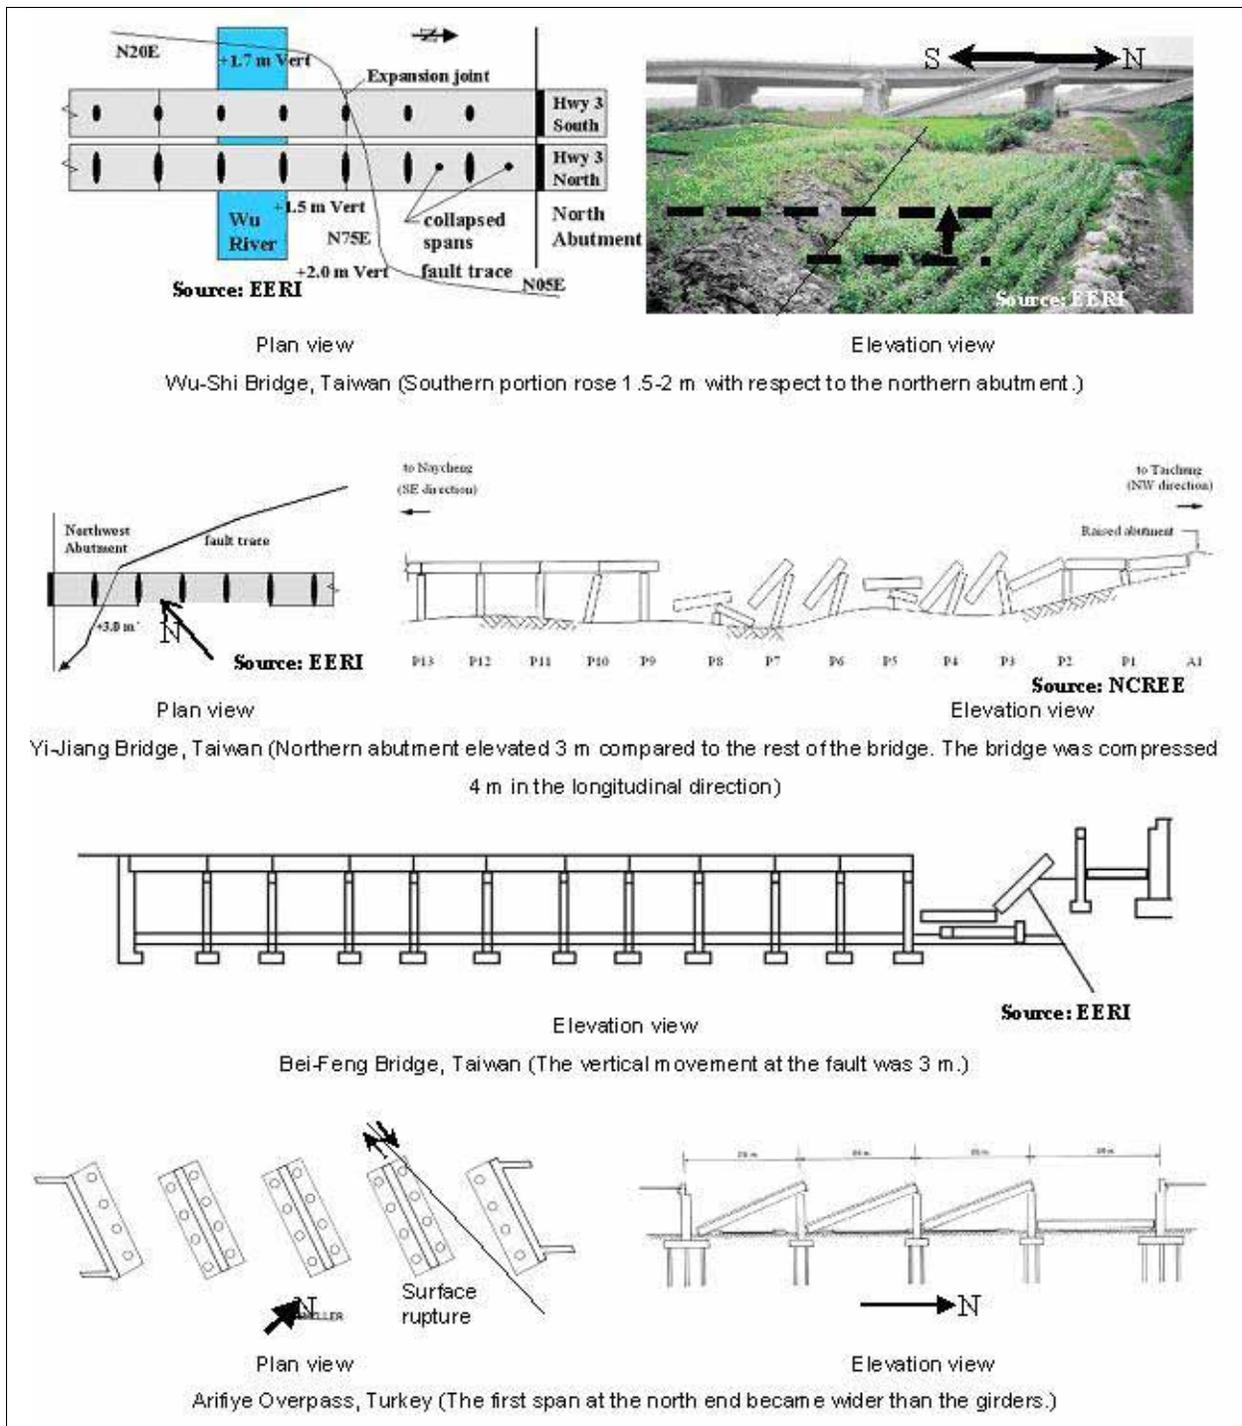
Long articulated bridges may sustain earthquake damage not only by the shaking but also by the distortion of the ground if the rupture zone is within the footprint of the structure. Recent examples of such events were provided by the 1999 earthquakes in Taiwan (921 Chi-Chi) and in Turkey (Marmara and Duzce) [1, 2, 3]. Some of these are described briefly in Fig. 1. The post-earthquake observations at these bridge sites reveal the fact that the ground deformations created a permanent relative movement of the supports with respect to each other which is not an effect routinely considered in the design. The type of the fault rupture determines the direction of the relative movement of the supports. The thrust fault rupture observed at the bridge sites in Taiwan created elevation difference between the supports leading to the collapse of the girders. The piers of these bridges were observed to be tilted during the vertical movement of the ground. On the other hand, the strike-slip type of fault rupture between the piers of the Arifiye Overpass in Turkey during the Marmara earthquake moved the supports away from each other so that the girders of the northernmost span could not be supported anymore.

Figure 1. The bridges in Taiwan and Turkey which collapsed during the 1999 earthquakes

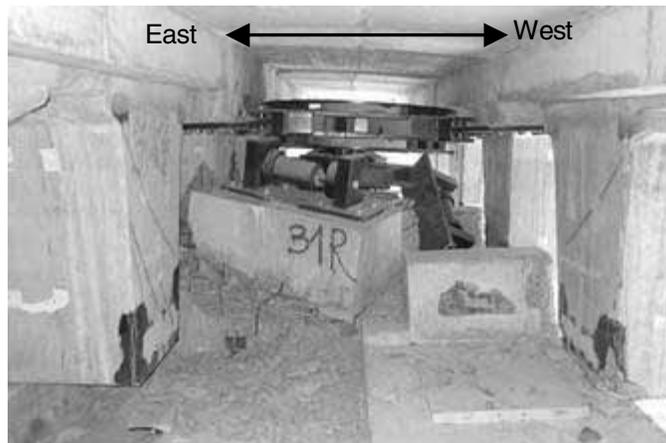
The Bolu Viaduct lies on the eastern end of the fault segment ruptured during the November 1999 event. The surface trace passed through the bridge at a 15-degree angle with the axis of the bridge. The fault slip under the bridge was measured approximately as 1.5m. The piers of the viaduct experienced permanent displacement. Because of the low angle between the viaduct and the rupture trace, the pier movements were almost parallel to the axis of the viaduct. As a result, the viaduct was shortened by 2.1 m. The shortening was concentrated at the spans next to the rupture. The foundations of the piers on the rupture trace suffered severe damage because of the 2 to 3 degree twist around their own axes. The girders displaced in both longitudinal and transverse directions. The relative movement of the girders with respect to the piers resulted in the failure of the EDU's and the ejection of the bearings under the girders. The girders impacted and destroyed the plinths, concrete blocks supporting the EDU's (Fig. 6).

Figure 6. The damage caused by the relative movements of the girders with respect to the piers

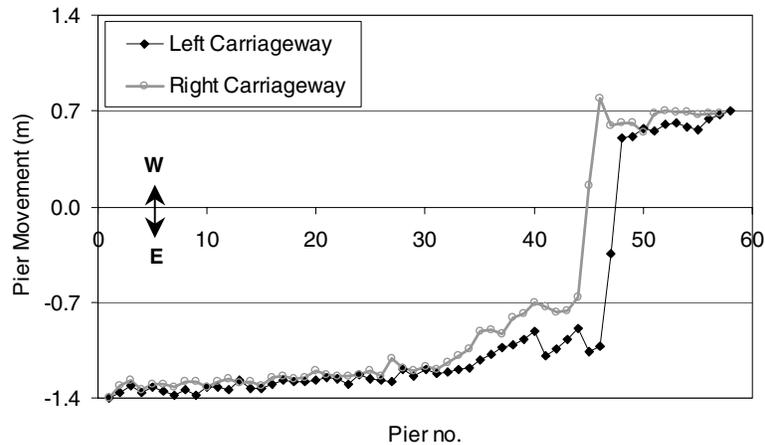
There were two types of measurements of the viaduct available: (1) the GPS measurements of the piers before and after earthquake and (2) the movement of individual girder. The former was used to calculate the change in the relative positions of the piers with respect to each other and the tilting of the piers. It was not possible to calculate the absolute movement of each individual pier because the coordinate systems of the two sets of GPS measurements were different. Based on the observations related with the movement of the plates explained above, it was assumed that the total shortening of 2.1 m was due to a 1.4 m eastward movement at the west abutment and a 0.7 m westward movement at the east abutment. The absolute movement of each individual pier based on this assumption is shown in Fig.7. Another set of data calculated from the

Figure 7. The measured movement of the piers in the longitudinal direction

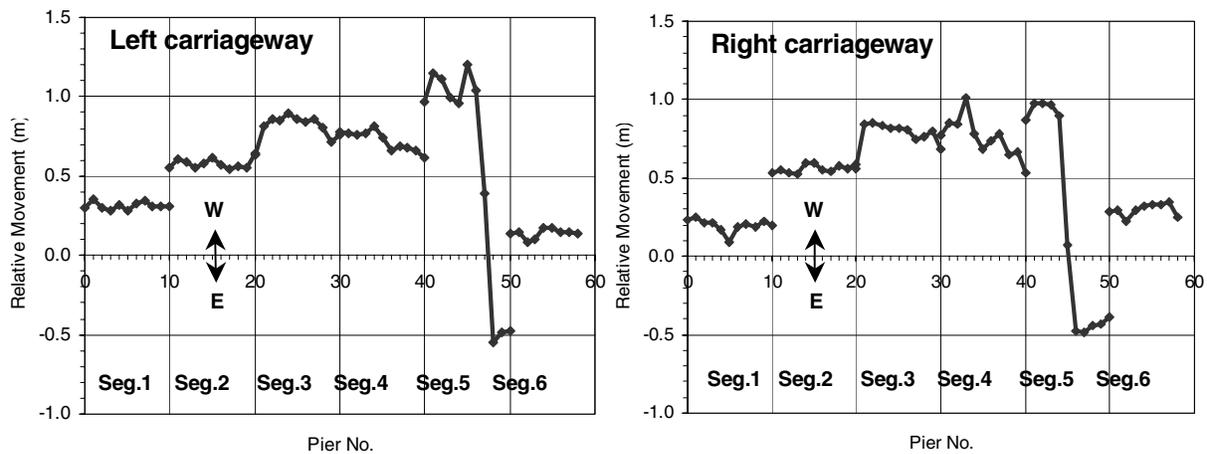
measurements of the deformed state of the viaduct is the relative movements of the girders with respect to the pier bases shown in Fig.8. As seen in the figure, the direction of the relative movement of the deck segments is consistently toward west except the eastern end of segment 5.

Figure 8. The relative movement of the girders with respect to the pier bases (ground)

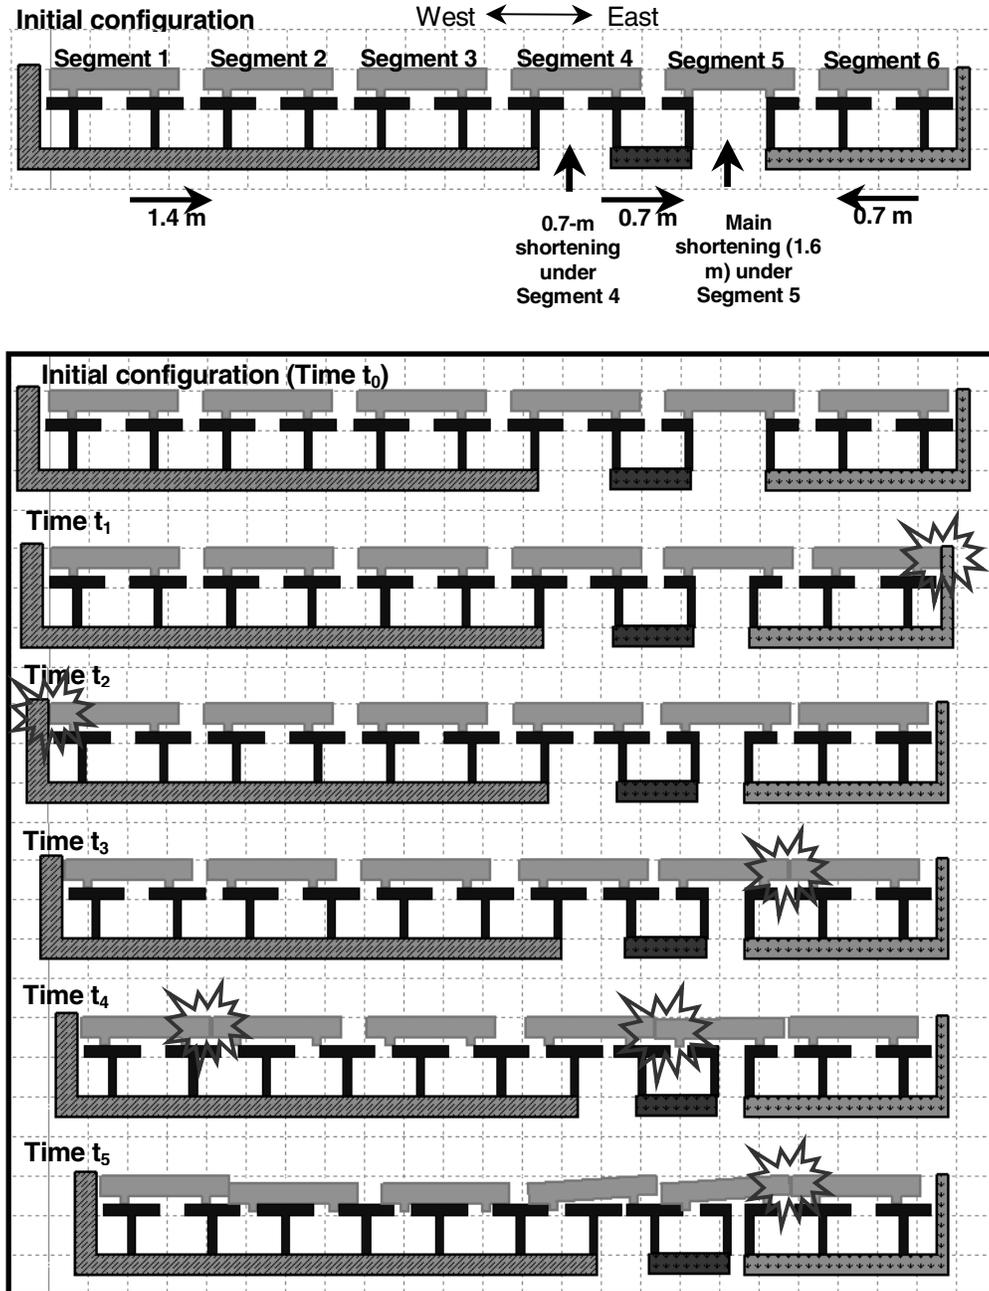
Figure 15. Illustration of the dynamic response of the viaduct to the ground deformation. Each girder shown in the figure corresponds to one 10-span segment of the structure.

The relative positions of the six segments at time t_5 correspond to the observed positions of the viaduct segments after the earthquake suggesting that the series of the events described above provides an explanation of how the viaduct responded to the ground distortion. The observed damage of the structural

components of the viaduct confirms the events in the series. This phenomenon will be analyzed quantitatively in the next section.

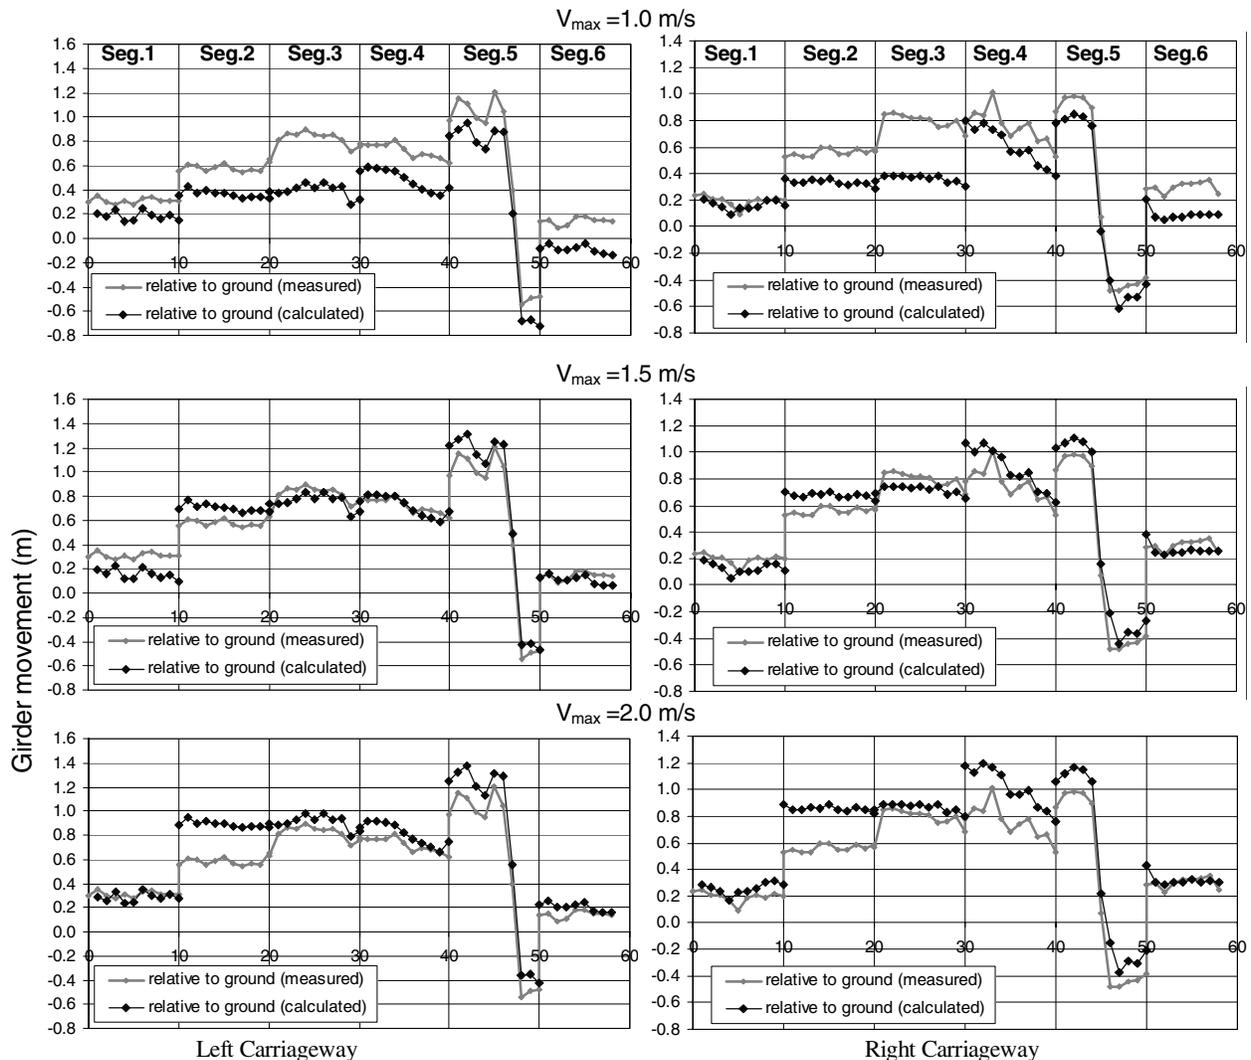
The calculated responses are presented in Fig. 16 in comparison with the measurements of the deformed state of the carriageways. The graphs present the relative movement of the deck segments with respect to the pier bases (or the ground). The westward relative movements of the piers are indicated by the positive values in the figures. The relative-movement pattern of the structure observed after the earthquake is, in general, good agreement with the results of the analysis. The maximum ground velocity selected for the ground motion in each solution changes the amplitude of the relative displacement of the segments.

Fig. 16. Comparison of the results of analyses with the measurements of the deformed state of the structure.

The best match in the analyses is obtained for the maximum ground velocity of 1.5 m/s. In the analysis for $V_{\max} = 1.0$ m/s, the maximum relative movement of Segments 2 and 3 is less than the 0.5-m initial clear distance between the girders and the plinth. Furthermore, Segment 6 does not develop sufficient westward movement to match the observed relative movement. In analyses for $V_{\max} = 1.5$ m/s and $V_{\max} = 2.0$ m/s, the calculated response is quantitatively similar to the observed state of the viaduct. The most significant difference between the two analyses is observed in Segments 2 and 4. In the analysis for $V_{\max} = 2.0$ m/s, the relative displacement of these segments is overestimated by 0.25 m.
