THE EARTHQUAKE DAMAGE CHARACTERISTICS OF LIFELINE SYSTEM IN JIASHI EARTHQUAKE (21 FEBRUARY, 2003)

TANG AIPING^[1] LU Qinnian^[1] Wen Aihua^[2]

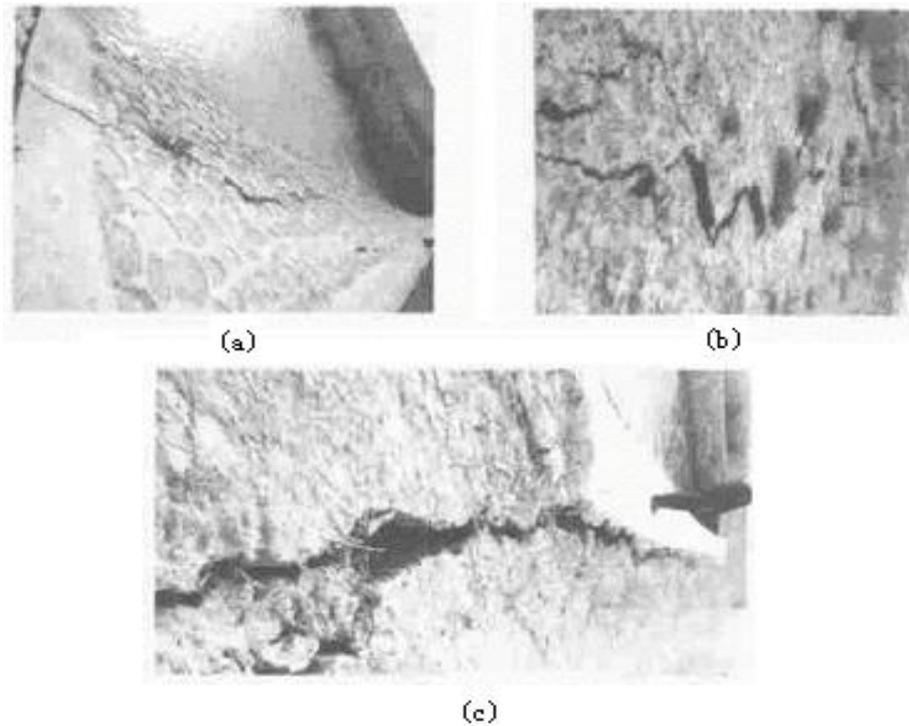
In the seismic zone, the reservoirs suffer the most severe earthquake damage in the water-supply network system. Almost all of reservoirs have been damaged; the typical damages are the split of dams, slope failure, stroke deformation and split, tube well damage, and pump room collapse and facilities damage. Particularly, there is severe seepage of the soil dam in Rongan reservoirs which was built in 1959, a longitudinal crack with the maximum width of 10mm stretches over several hundreds meters. Another soil dam in Molong reservoirs in Bacun County also suffer a severe damage, in this dam, the maximum splitting width is 10cm, a longitudinal crack with the length of 300 meter occurred, and a landslide is induced, with the length of 140 meter (Fig. 2). 1/4 of the Xiaohaizi Dam with the total length of 2000 m ruptured and seepage in 400 places took place. In the evening at 3rd, March, a 30 m length of dam occurred landslide and collapse.

Fig.2 the typical crack of the soil dam^[3]

(a: crack of the channels of water output; b: crack of dam body; c: split of the channels of water output)

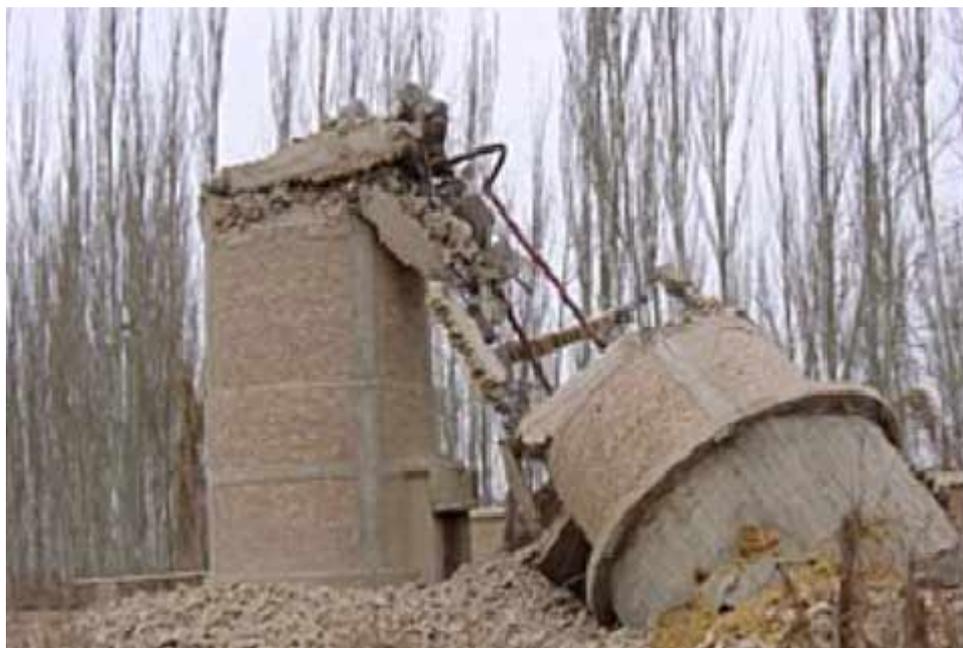
The other water-supply elements suffer damage in different degree. Two water towers collapsed (Fig. 3), and five tower crack, out of them 3 severe. Most of wells and some of pipelines are severely damaged in the zone of and . The fault ratio of pipeline is 2.92 place/ km in and , the total length is 258 km, several villages were drowning because of the crack of these pipelines. The crack of these pipelines was induced by the surface fracture and un-even soil substance because of liquefaction. The water from these pipelines exacerbated the potentials of the sand liquefaction in return. The well and other facilities were mainly damage by the building collapse and strong surface motion. Some intact facilities can't function due to the interruption of the power-supply and other related equipment of the entire water-transmit network. The length of malfunction of power line which supplies the power for water-transmit system is 4km in IX and VIII, it led to the halt of the water-supply in these area for one day.

Fig.3 the collapsed tower

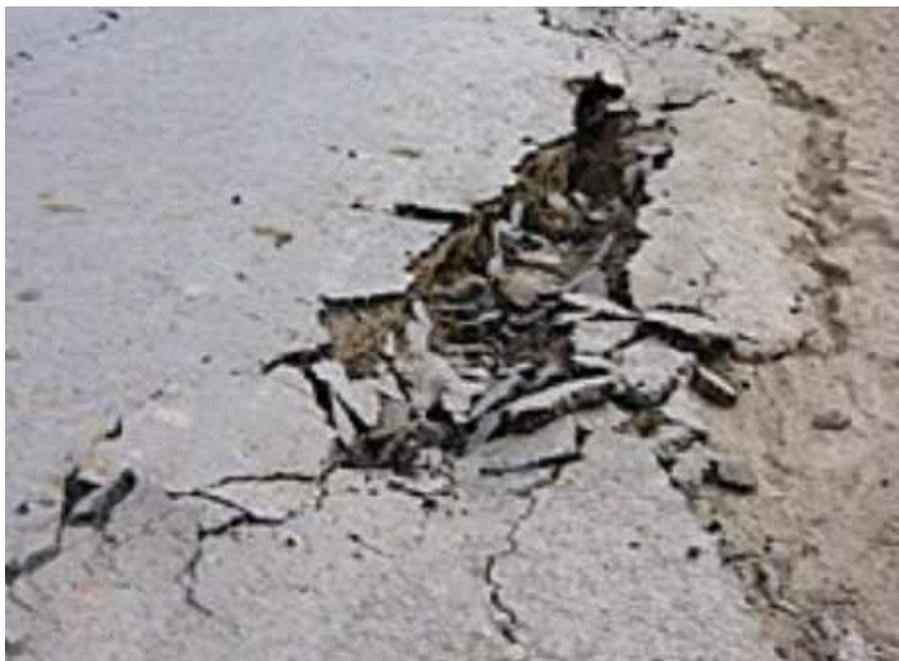
The traffic systems had suffered a severe damage in and . In Bachu County, the earthquake damage in the X602 provincial highway was severe, the splitting road surface covered over 10,000 m² (Fig.4) ,and the total length was 2km. a 1500m² road foundation slope failure took place at the X602-K6. The fault water transmit pipeline at the point of X602-K6+700 inundated the road surface for 1200m. In Jiashi Country, one 10-meter-high and one 8-meter-high arch bridge damaged, and one 10-meter-high slab bridge damaged. One 2-meter-high culvert collapsed. The split and sink of the road surface is seen everywhere. There are many kinds of highway facilities to be damaged.

Fig.4 the split and sink of the highway surface

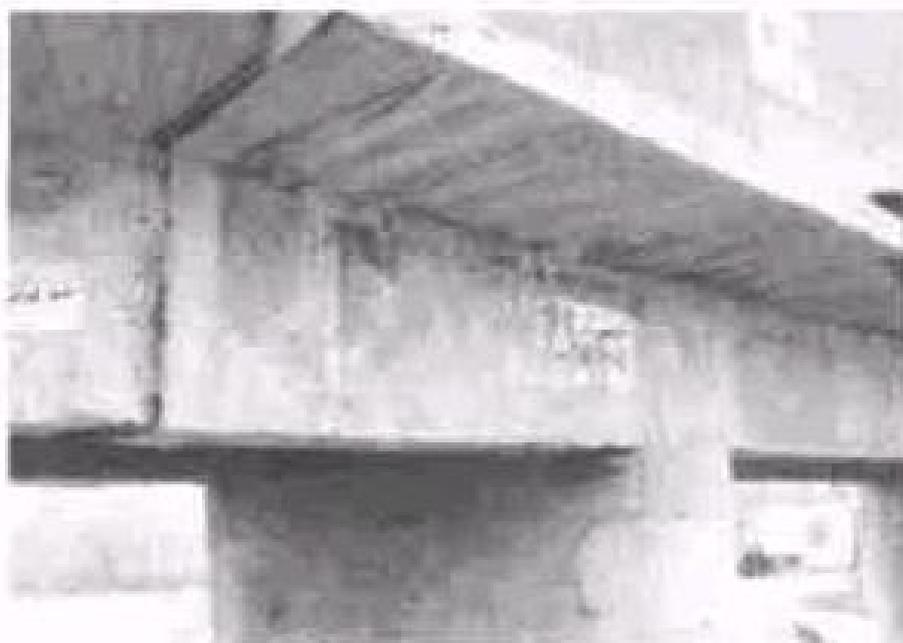
Fig.5 the split of bridge^[3]

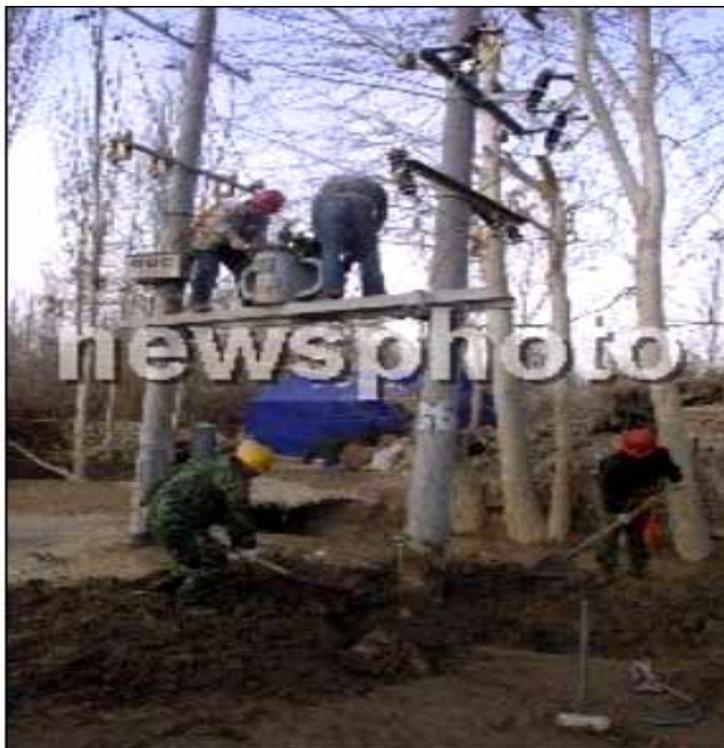
The damage of power-supply system mainly focused on the tilt and fault of the wire pole, burn of transformer (Fig.5), damage of capacitor, ammeter and switch, and the collapsed building. In the earthquake area, over 3,000 wire pole tilted and ruptured, the ratio of damage is 20 %. 48 transformers with different voltage patterns were burned. 1057 ammeters 16% building related to the power-supply system were damaged in a different degree.

Fig.6 the tilt of the wire pole and the fault of the powerline (liquefaction)

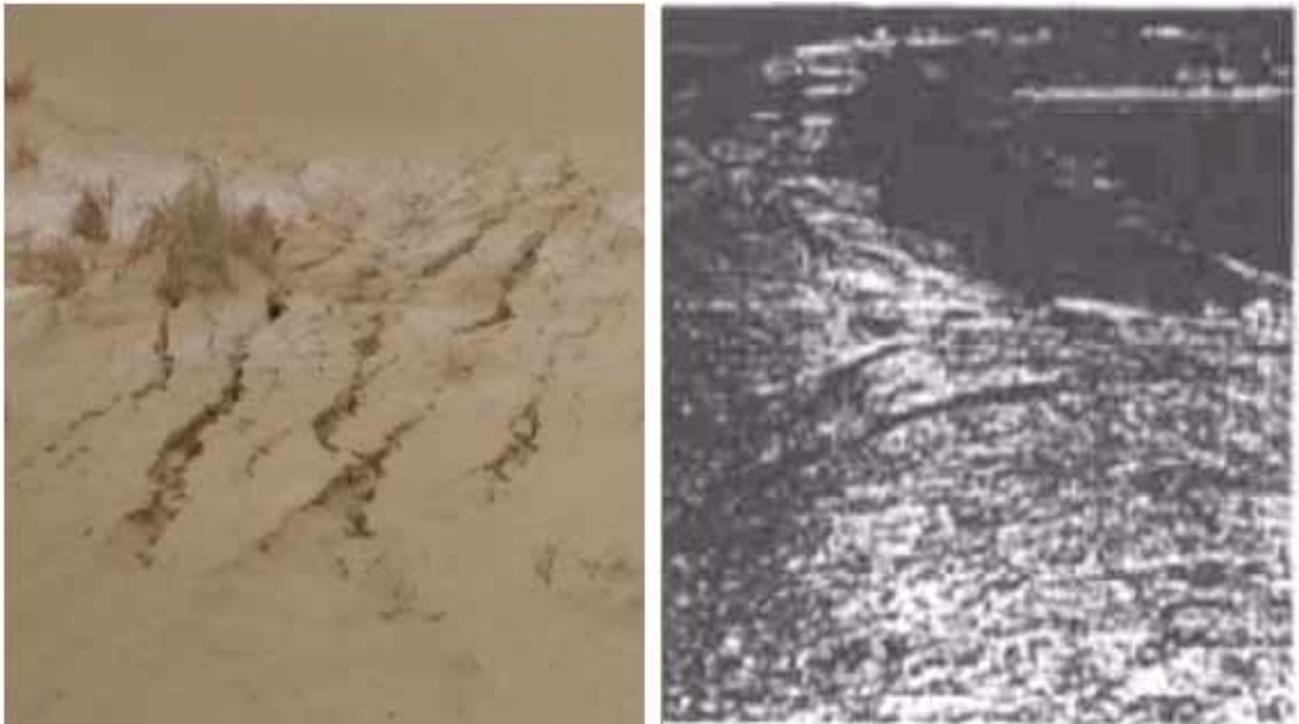
Fig. 7 the surface fracture and liquefaction

without the application of Asiemic Code is one of the important factors, the damages of lifeline systems can mostly be due to two factors, one is the liquefaction of the sand; the other is the surface fracture.

In Bachu County, the sand liquefaction could be seen everywhere in the IX and VIII, the maximum diameter of the hole of the sand eruption is 3 meter. The surface fracture can also be seen in the seriously damage area (Fig.7), the maximum crack width is over one and half meter in Bachu. The pipelines of water-supply were damage by the surface fracture and un-even soil-layer subsiding induced by the sand liquefaction.

The earthquake damage characteristics of lifeline system have ulteriorly proved that it is necessary that the application of the aseismic code is the important to improve the aseismic abilities of the infrastructures and buildings. Some new techniques should be studied to resist the sand liquefaction and surface fracture. Some practical aseismic design methods should be supplied to the poor area. The sand liquefaction where there is a large distribution of dry and loosed sands should be attached importance to. The interactions among lifeline systems could be seen during this earthquake. Fox example, one highway foundation subsided and the pavement splited because of the sand liquefaction where the pipeline of water-supply were broken and the water inundated in the dry sand layers; the telecommunication interrupted because of the power-supply failure. The power systems were also affected by the inundation induced by the break of the water-supply pipeline (Fig.6).
