## **RETROFIT OF UNREINFORCED MASONRY CLADDING FOLLOWING THE 2001 NISQUALLY EARTHQUAKE**

**Scott M. ADAN<sup>1</sup> and John G. TAWRESEY<sup>2</sup>**

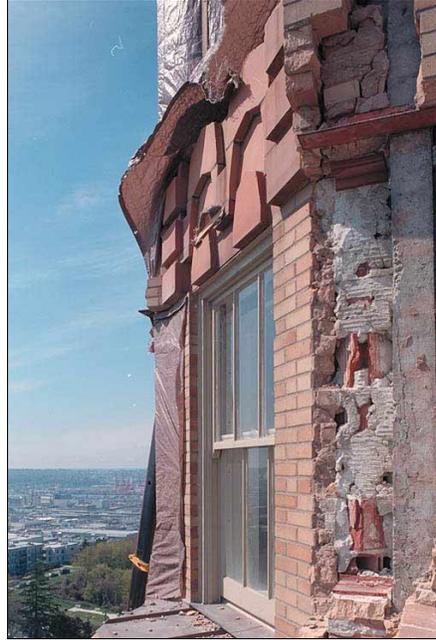
In the Nisqually earthquake, the exterior unreinforced cladding suffered substantial damage. The hollow clay tile, terracotta, and brick perimeter walls on the upper three floors were over 80 percent damaged (Fig. 2). Both in and out-of-plane cladding failures were common in this area.

**Fig. 2: Earthquake damage to exterior brick, terracotta, and hollow clay tile.**

Once underway, the retrofit required removal and reconstruction of the cladding on the top three floors of the building. More than 800 ornate pieces of terracotta were removed, photographed, documented, and numbered. Extensively damaged elements were recast to replicate the original pieces. Bricks were removed one by one to save as much of the original masonry as possible. Where that was not possible, new brick was fired to approximate the original material. Originally, unreinforced hollow clay tile walls backed the exterior cladding. The hollow clay tile backing was removed and replaced with either reinforced concrete or a steel stud backing.

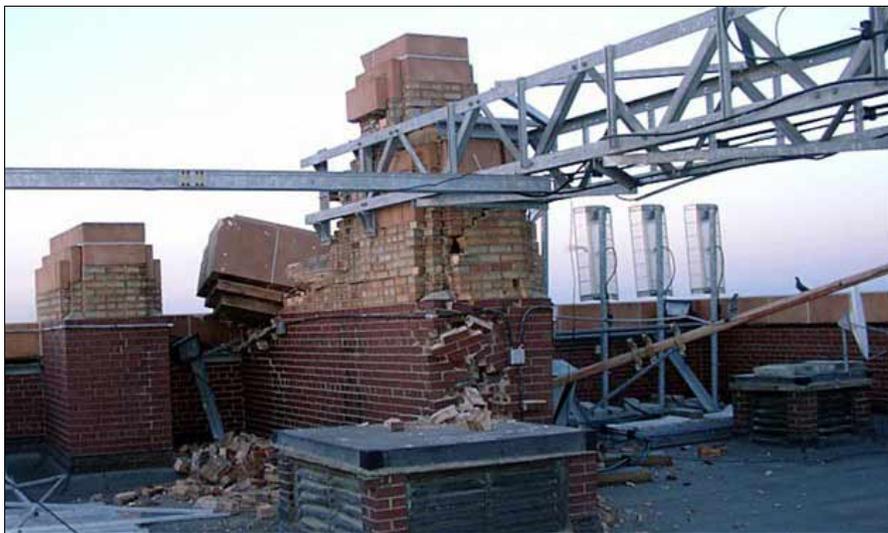
Due to the building's irregular configuration, earthquake forces created a torsional force at the top levels of the building. These forces shook the roof so significantly that one of the unanchored art deco roof pinnacles collapsed and fell through the tenth floor roof (Fig. 3). The collapse broke water lines, flooding five floors and the elevator shafts. No one was hurt.

**Fig. 3: URM roof pinnacle damage shown with temporary bracing.**

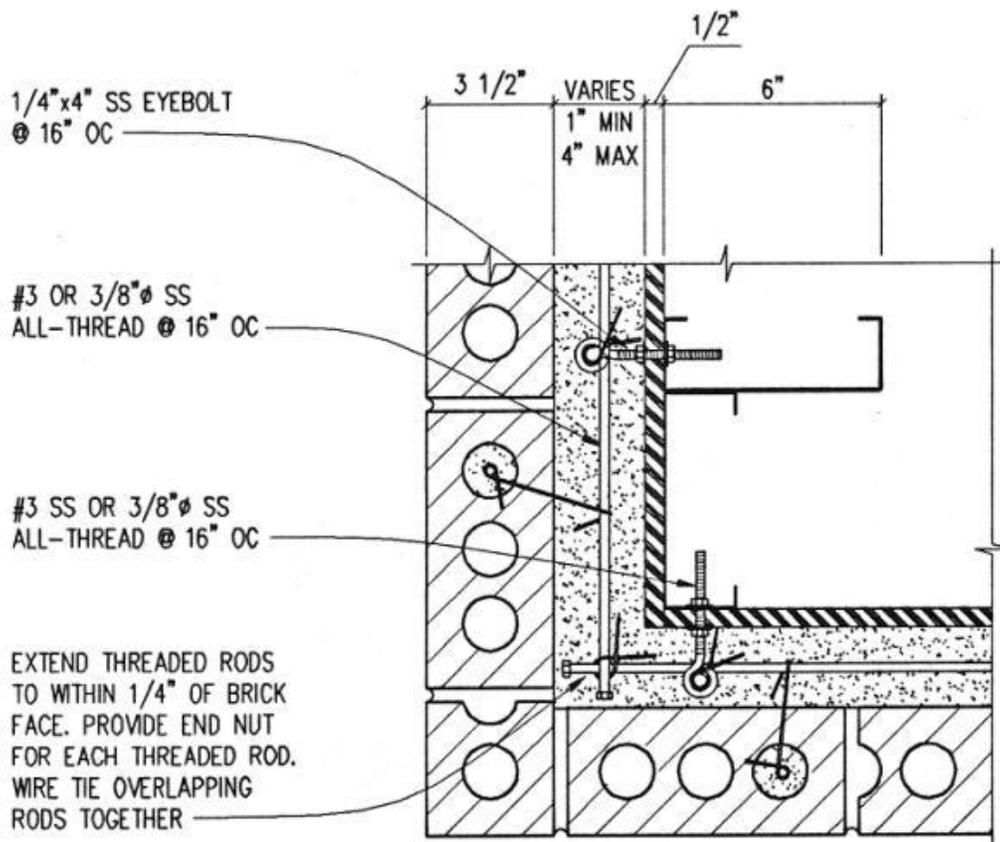
**Fig. 4: Reinforced veneer typical wall section.**

Fig. 4 shows a detailed cross-section for the reinforced veneer system. Either reinforced concrete or conventional steel studs sheathed with cement board can provide the necessary backing for the system. Reinforcement is placed in the cavity and anchored to the concrete or sheathing with fasteners. Because of the limited width of the cavity, the reinforcement size is limited to a 10 mm (3/8-inch) diameter bar. The spacing of reinforcement is determined by allowable stress design procedures in consideration of both gravity and lateral forces.

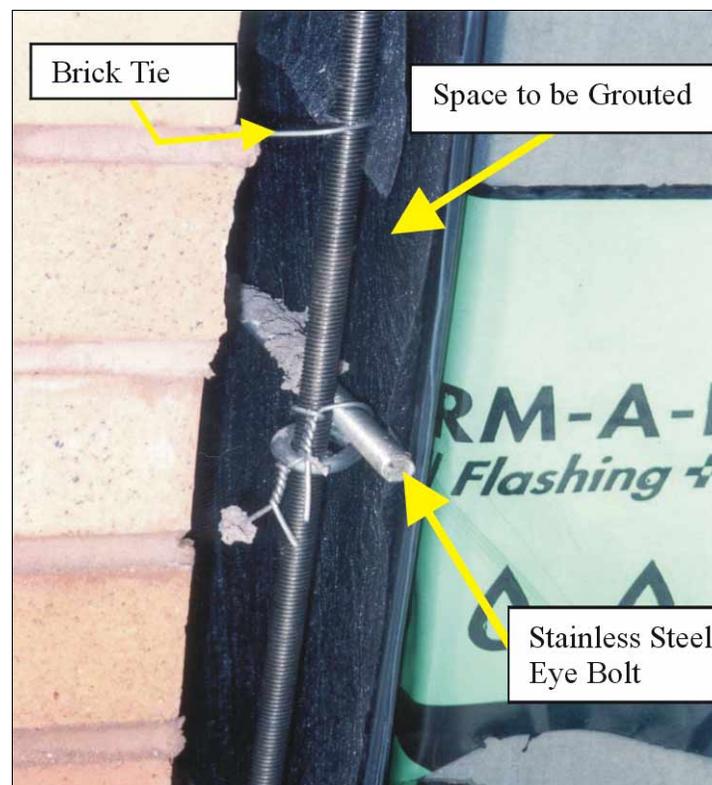
**Fig. 5: Reinforced Veneer wall section prior to grouting.**

Given that the grout space was outside the water barrier, it was concluded that stainless steel reinforcement was required to meet the 50-year design life. Deformed stainless steel reinforcement was expensive and unavailable for six months. Stainless steel threaded rod, which has many industrial applications, was readily available at a reasonable price. The brick masonry was laid and tied to the reinforcement with wire anchors (Fig. 5). The anchors were specified as 1.6 mm (0.062 inch) diameter stainless steel wire. The wire anchors were spaced at regular intervals in both vertical and horizontal directions as required for the seismic requirements. The cavity was then grouted solid.

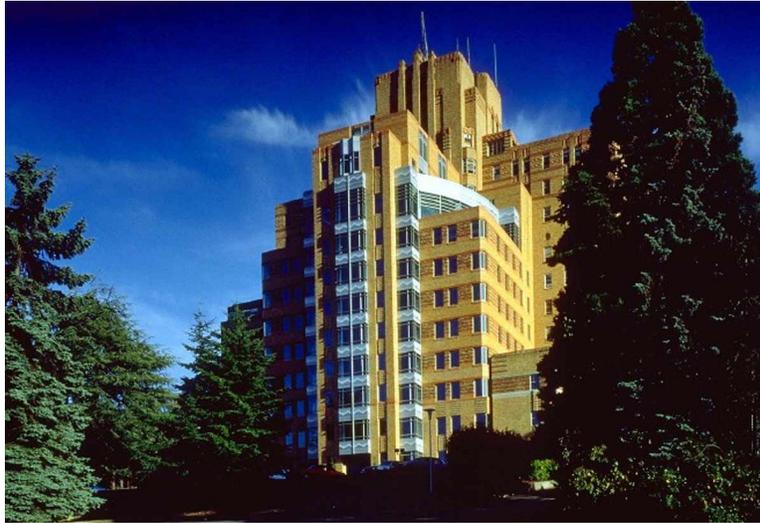
**Fig. 6: Retrofitted PacMed/Amazon building.**

To provide access for construction, the top three floors of the building were enveloped in scaffolding. Plastic coating was wrapped around the scaffolding to provide a climate-controlled working environment free of wind and rain. The entire project was completed in nine months at a cost of approximately US\$9 million. The exterior elevation of the retrofitted building is shown in Fig. 6.

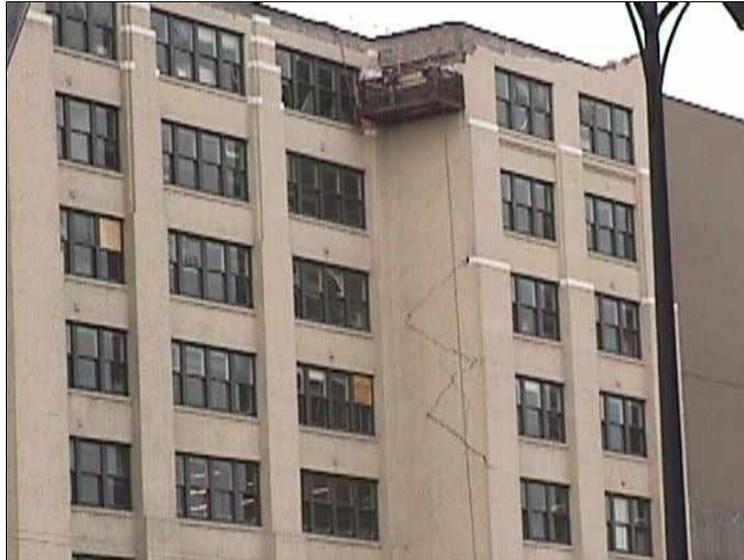
Exterior cladding failures were attributed to low mortar strength, high wall height-to-thickness ratios and inability to accommodate the movement of the supporting structural frame. In-plane shear failures were common. The veneer was attempting to support the building. It was not isolated. The diagonal or X-cracking pattern (Fig. 8) is a common result of cyclic earthquake loading. In addition, parapet walls toppled out-of-plane and cascaded more than 30 m (100 feet) onto the street and sidewalk (Fig. 8).

Although the damage to the building overall was primarily cosmetic, it was also widespread. Virtually every wall section of the exterior cladding suffered some form of cracking.

**Fig. 8. Starbucks Center building damaged URM parapet and exterior cladding, USGS [5].**

Due to the size and complexity of the retrofit project, numerous cladding retrofit techniques were considered. Initially, retrofit alternatives considered only replacing damaged portions of the cladding. Ultimately, the decision was made to replace the entire exterior brick cladding.

The majority of the cladding, up to the ninth floor, was replicated with an anchored brick veneer system over steel studs. This system was designed in accordance with provisions of the 1997 Uniform Building Code [6].

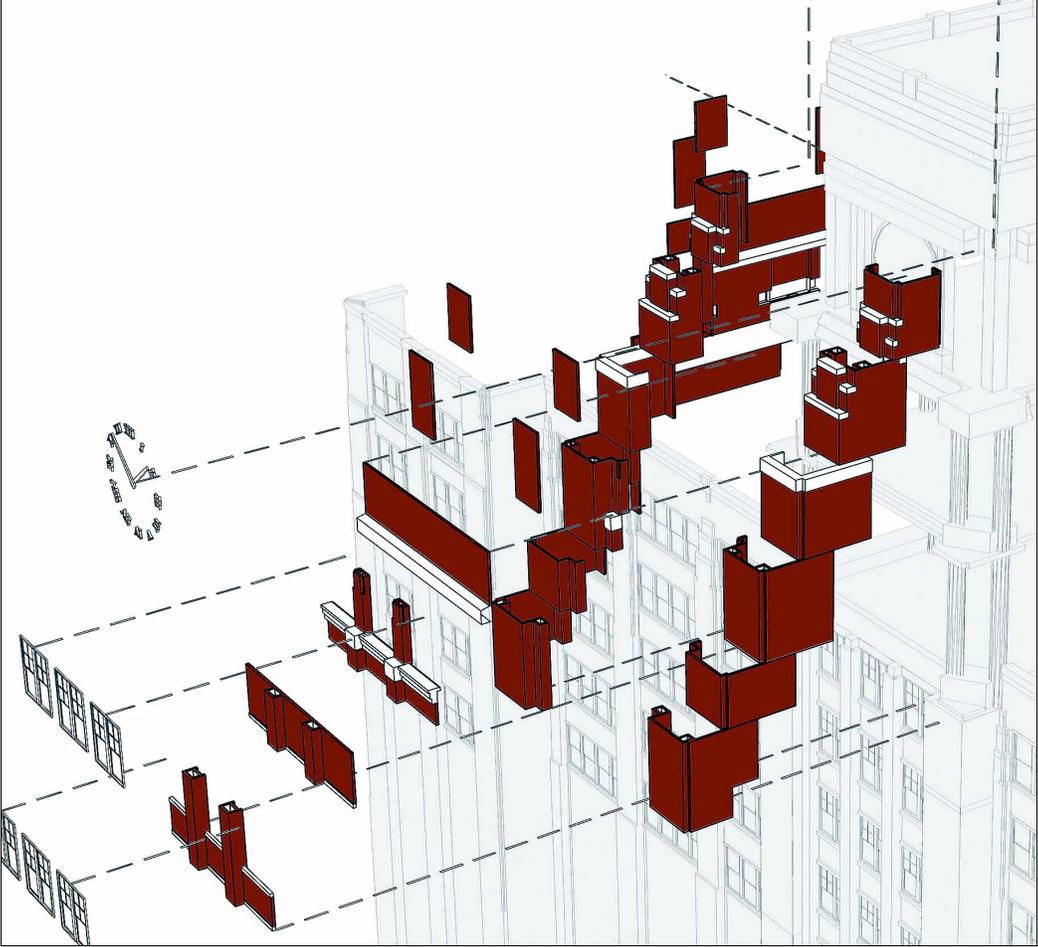
**Fig. 9: Isometric of the clock tower reinforced brick panel arrangement.**

The geometry and design for the tower panels were particularly challenging (fig. 9). The cladding was required to accommodate a 50 mm (2-inch) story drift without damage. In addition, the surface articulated in both directions. The solution was to support the cladding on corner cladding panels that were rigid with the floor. This isolation technique is sometimes referred to as the “moving box”.

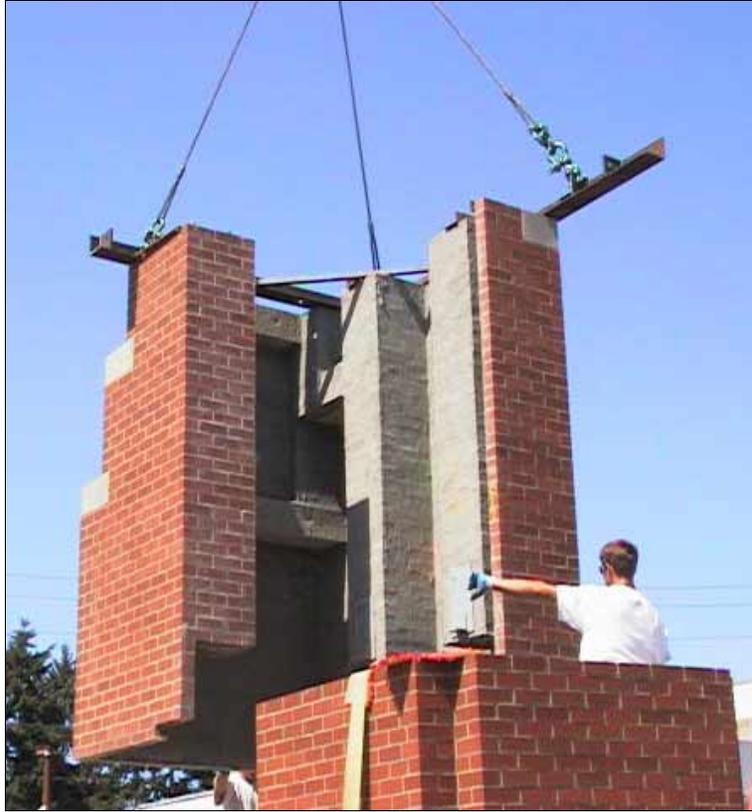
**Fig. 10: Reinforced brick corner panel in transit.**

The cladding panels for the building were fabricated 48 km (30 miles) south of the project, loaded onto trucks, transported to the project site and lifted into place with a crane (fig. 10). In-place loading was not necessarily the critical design condition. In many cases, panels were designed specifically for transportation and erection forces. Erection was challenged by the panel configuration. Pick and set points required compensation for the offset in the panel center of gravity.

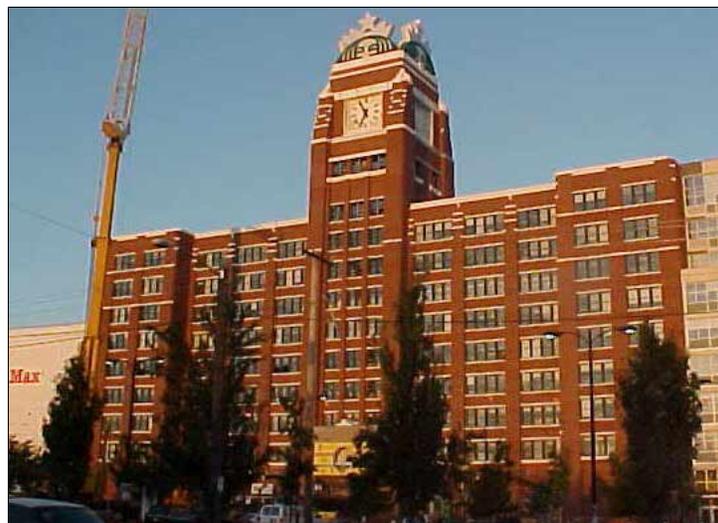
**Fig. 11: Retrofitted Starbucks Center building.**

The entire retrofit and restoration cost reportedly exceeded US\$50 million. Interior restoration proceeded quickly to allow tenants to reoccupy offices. Exterior restoration was completed in the summer of 2002, nearly 18 months following the earthquake. The exterior elevation of the retrofitted building is shown in Fig. 11.
