## ANALYSIS OF THE CUT AND COVER TUNNELS DAMAGED IN THE SOUTH-HYOGO EARTHQUAKE OF 1995

Seiji NISHIYAMA<sup>1</sup>, Itsuo KAWAMA<sup>2</sup>, Hiroshi HAYA<sup>3</sup>

### SUMMARY

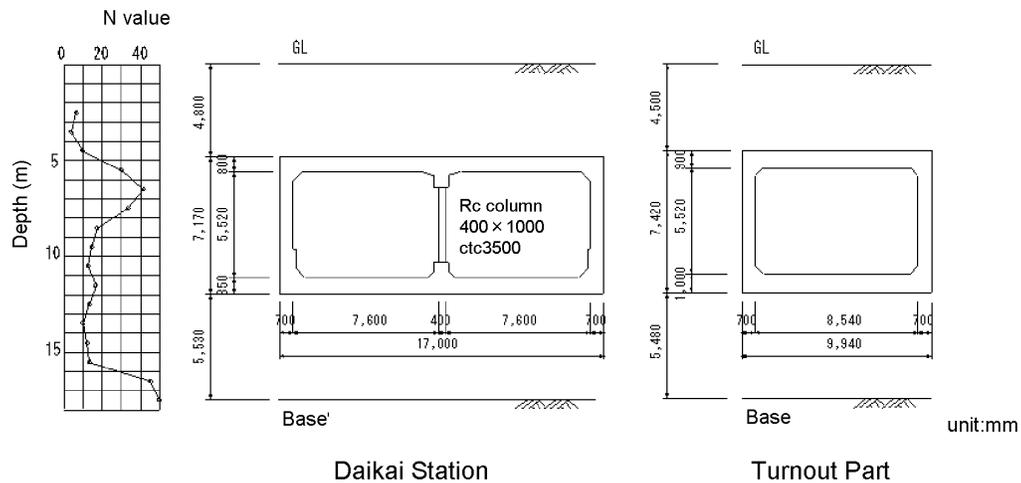
**Fig.1 Typical section of Daikai station and Turnout part**

Damage to Daikai station was the severest. Fig.1 (1) shows a typical section of Daikai station. The center RC column suffered heavily. Separation between concrete and reinforcement, which was caused by bending of the axial reinforcement, was observed. Many hoop bars broke. At the corner of sidewall, many cracks and deformation were observed, but there was no severe damage on other components such as center RC columns.

Fig.1 (2) shows a section of turnout part near the station. At this section, one-story and one-span rigid frame structure, there was no severe damage except cracks at sidewall corners. As it is located near the station, this section should have been subjected to the same earthquake motion as that for the station. However, there was no serious damage. The differences of damage might be due to structural reason.

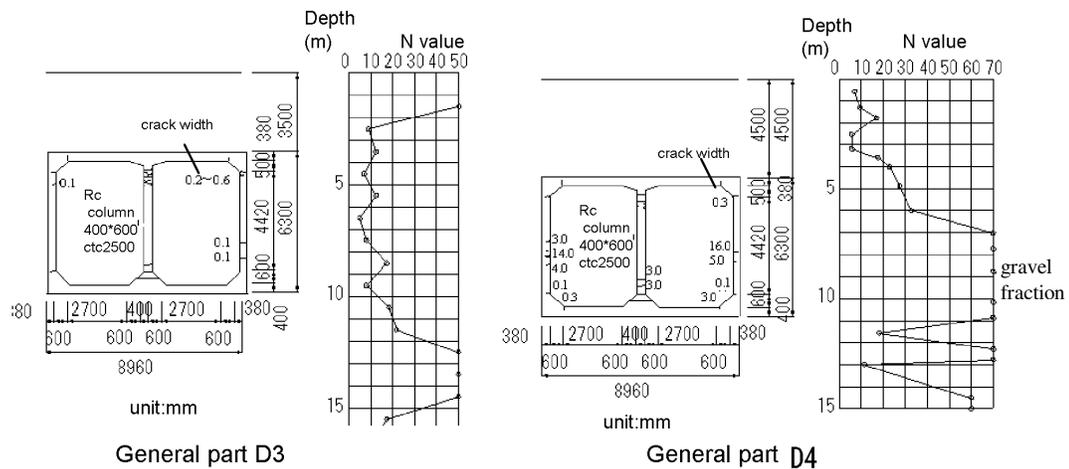
**Fig.2 Typical section of general part of D3 and D4**

Fig.2 (1) shows a section of the general tunnel part D3 for double tracks, which has a one-story and two-span rigid frame structure. Compared to Daikai station, it has a smaller section area but the structural form is similar to that of the station. However, its damage was minor with some cracks observed at center RC column and sidewall. The subsoil surrounding the structure is soft compared to that of the station, and large ground deformation should have occurred, but its damage was minor. Not all structures that have RC columns received severe damage.

Fig.2 (2) shows the general part D4 for double tracks, which has almost same structural form with D3. However, the thickness of overburden soil is 1m larger than that of D3 part. Sidewalls cracked at center, the width of crack were mostly from 14mm to 16mm (maximum 26mm). Damage to RC column was minor as same as that of D3 section.

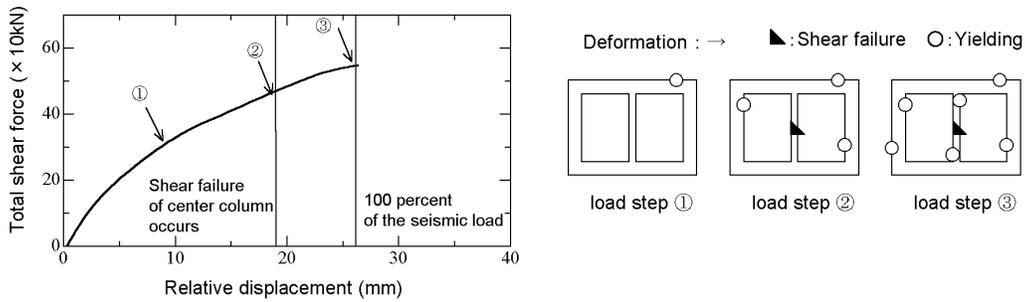
**Fig.5 The relationship between the total shear force and the displacement of the ceiling to base slab (Daikai station).**

As shown in Fig.5, the shear failure of center column occurred when the relative displacement was 2.0cm. Damage other than the yield of steel bar wasn't recognized on other members. After subsequent loading, the yield of center column occurred when the relative displacement was about 25mm, but no members were in the ultimate state. Therefore, the failure mechanism of Daikai station is thought to be as follows; the ceiling slab failed for lack of load carrying capacity of center column because of the shear failure. This result corresponds to the damage pattern observed.

Therefore, it has been clarified that preventing a shear failure is very important for seismic design.

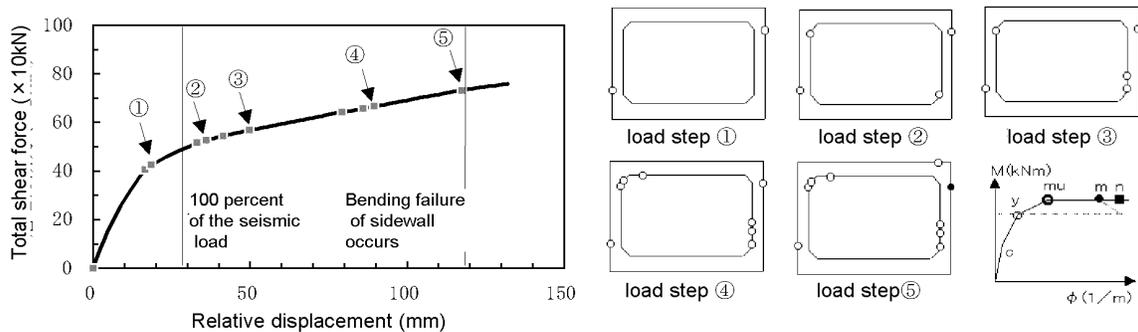
**Fig.6 The relationship between the total shear force and the displacement of the ceiling to base slab (Turnout part).**

Some yield at corners occurred when the relative displacement reaches 20mm. The deformation at the upper corner of right wall reached ultimate state (the point m) when the relative displacement was 120mm. However, no shear failure occurred at any point.

The relative displacement at 100 percent of the seismic load was 30mm. This shows the major damage of walls remain within yielding range at sidewall corners. This result also corresponds to the observed damage.

Turnout part was near Daikai station. Nevertheless, the damage was slight compared to the station. The analyses showed that RC center columns sustaining the ceiling of Daikai station were cracked in shear, while the walls of the turnout part was cracked in bending, the latter performed better in general.

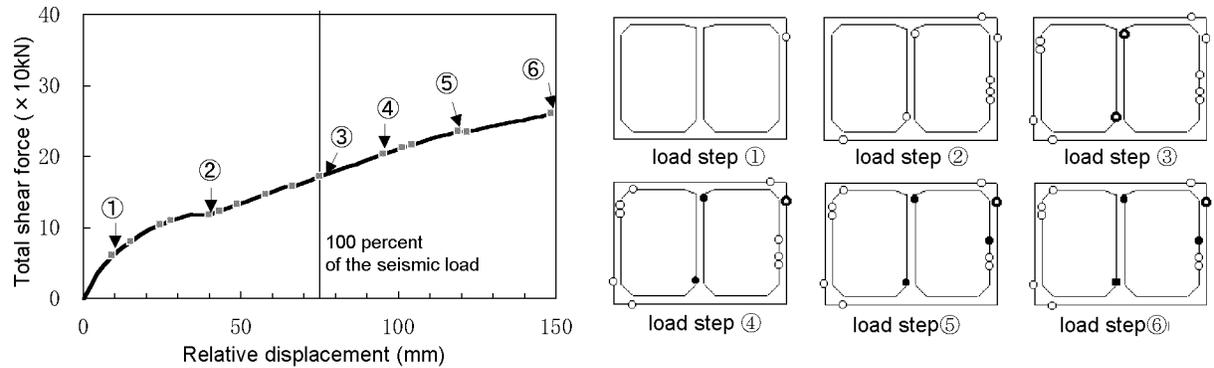
**Fig.8 The relationship between the total shear force and the displacement of the ceiling to base slab (general part D3).**

At the center RC column, yielding occurred when the relative displacement reaches 50mm. The deformation reached point mu, point m and point n when the relative displacement is 60mm, 100m and 150mm, respectively. No shear failure occurred.

At sidewalls, yield occurred when the relative displacement reaches 10mm. The deformation reached point m when the relative displacement is 120mm.

The relative displacement at 100 percent of the seismic load was 75mm. This shows the damage to center RC column does not reach point m, where cover concrete spalling. Deformation at the corner of sidewall remains the range that is a little larger than yielding. This result also corresponds to the observed damage.

The ratios of shear strength to bending strength of center column are shown in Table 1. That of Daikai station is 0.90, while the general section, D3 for double tracks is 1.45. At the center column of Daikai station, the shear failure occurred earlier than the bending failure. However, at the column of D3 section, bending failure occurred earlier than shear failure. These characteristics of center columns and the deformation capability of members would be causes of differences in damage.

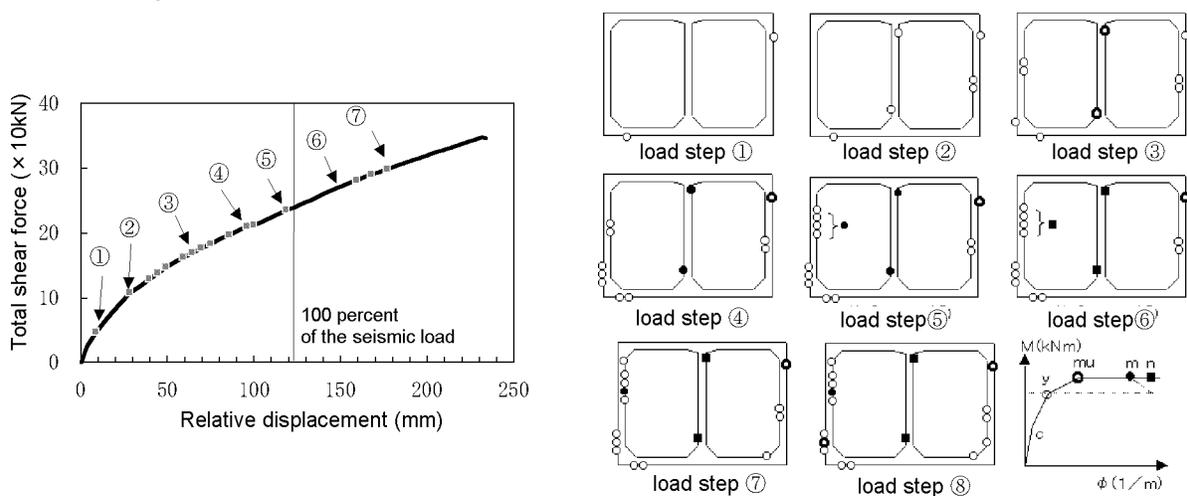
**Fig.10 The relationship between the total shear force and the displacement of the ceiling to base slab (general part D4).**

At the center RC column, Yielding occurred when the relative displacement reaches 30mm. The deformation reached point m and point n when the relative displacement is 100mm and 140mm, respectively. No shear failure occurred.

At the sidewall, yielding occurred when the relative displacement reaches 40mm, and yielding occurred at some continuous element near the center of sidewall when the relative displacement is 120mm. The total deformation calculated by sum of those of yielding elements reaches point m. This is one of possible explanation of wide crack of sidewall.

The relative displacement at 100 percent of the seismic load was 140mm. This shows the damage to RC does not reach point m, where cover concrete spalling. Sidewall at the center cracked widely in bending if the deformation of sidewall were focused in one element. This result also corresponds to the observed damage.

Table1 shows that the ratio of shear strength to bending strength at the center column of D4 section is 1.56, thus no shear failure occurred earlier than the bending failure.

The difference of damage to sidewall compared to that of D3 section is thought as follows; The thickness and reinforcement of sidewall were same with those of D3 section, but the thickness of overburden soil is 1m larger. In addition, the lateral earth pressure at that time of design was about 40 percent smaller than that used in the latest design. For these reason, Sidewall of D4 section had larger stress before an earthquake. The seismic action, such as shear deformation of ground, might enlarge the stress and deformation at the walls.

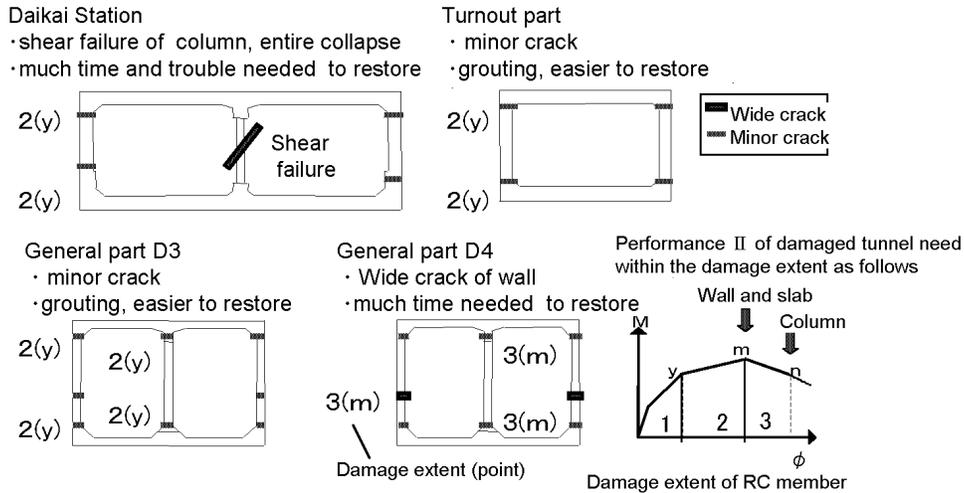
**Fig.12 Estimated damage extent to members compared to the restoration from real damage**

Table.3 and Fig12 show the analytical results summarized in terms of damage extent of member. Cracks appeared on RC center columns were categorized into two patterns; shear cracks and bending cracks. The analyses showed that RC center columns sustaining the ceiling of Daikai station were cracked in shear, while those of the general part for double tracks were cracked in bending.

Repairing shear cracks required a lot of labor and time as contrasted with bending cracks, and therefore, RC members are desirable to be cracked not in shear but in bending.

However, for sidewall of D4 section the deformation became larger, much more time and trouble were needed for repairing. As the restoration of D4 section, H-shaped beams were set along on the inner perimeter except for base slab. The bending deformation, thus, should be within an allowable limit. In this case, deformation of side wall estimated by the analysis reaches the damage extent 4, and it needed so much time to restoration. Judging from real damage, damaged tunnel belonged to the performance III, which corresponded to the proposed relation in Table 2.
