**THE BOUMERDES-ZEMMOURI, (ALGERIA) EARTHQUAKE (MAY 21,
2003, Mw=6.8):
RESULTS OF FIELD RECONNAISSANCE ON DAMAGE EVALUATION,
SURFICIAL DEFORMATION AND GEOLOGICAL SITE EFFECTS**

Efthimios L. LEKKAS¹ and Haralambos D. KRANIS²

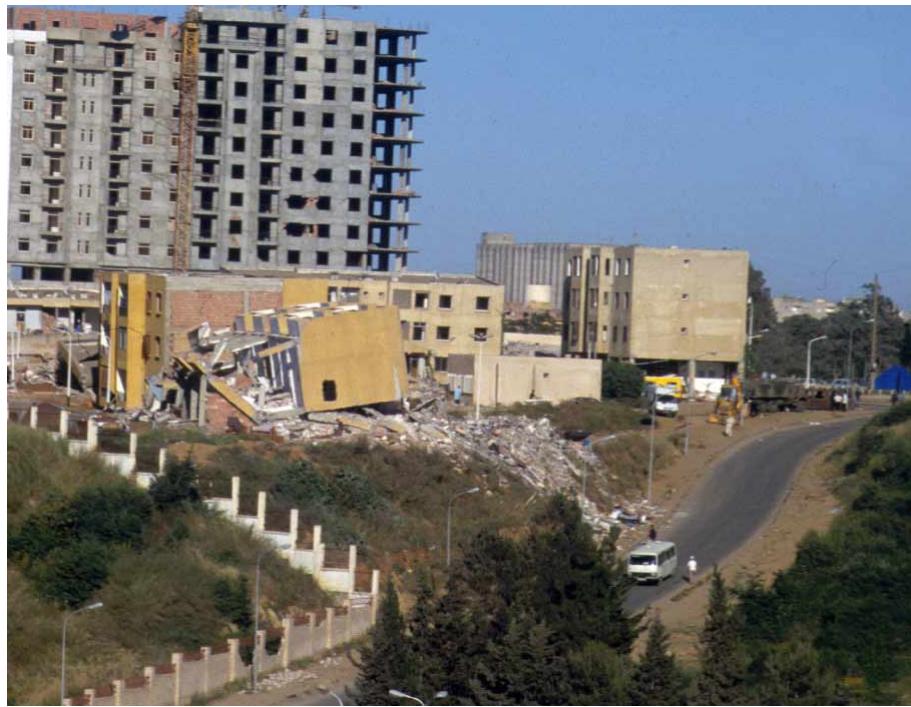
The geotechnical conditions in Boumerdes are more or less uniform, which means that they did not play any important part in the spatial distribution of damage. The foundation soil consisted of dry, compact sandy material, a fact that prevented the occurrence of liquefaction in Boumerdes. However, it is noteworthy that the morphological conditions seemed to control the distribution and severity of damage, at least to some extent. Specifically, the collapses of buildings located along, or close to natural or artificial escarpments (such as river banks) were indicative of localized increase in peak ground acceleration. This resulted in toppled buildings (Fig. 2) and massive collapses. Such case was also observed in the Athens, Greece earthquake of September 7, 1999 ($M_w=6.0$), where localized, linear development of damage was observed along the banks of Kifissos river and its tributaries (Lekkas [9]).

Figure 2. Toppled building, located on the crest of a natural escarpment in Boumerdes.

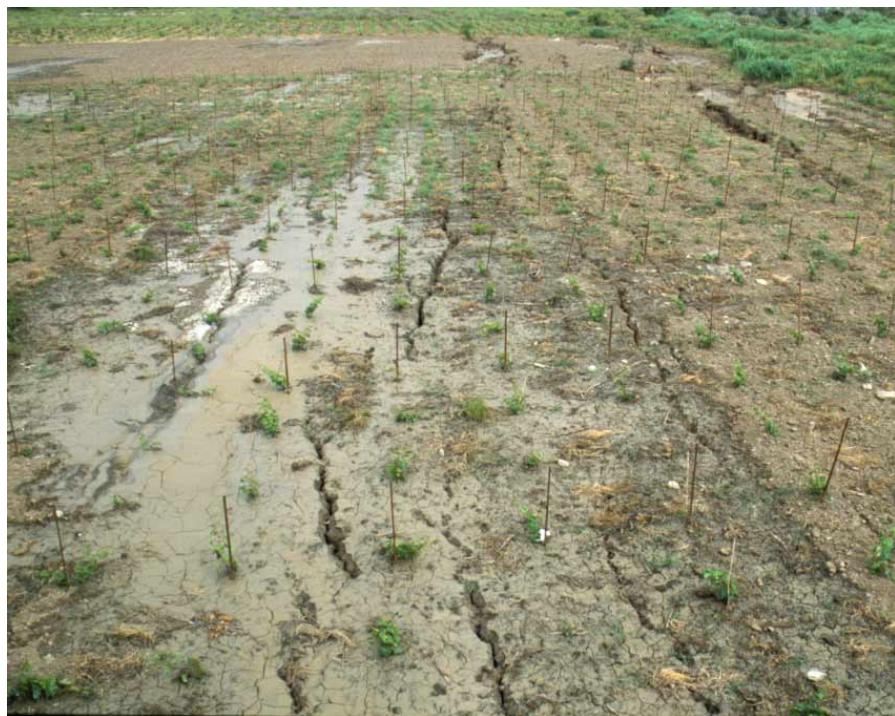
Contrary to the situation in Boumerdes, in Zemmouri, Djinet and Dellys, liquefaction phenomena were quite widespread. The effect was quite serious close to the Zemmouri and Djinet, but occurred mainly in rural, uninhabited areas. Sand was liquefied and ejected through linear ground fissures of considerable length (between a few m. and some tens of m.), trending approximately N20-40E (Fig. 3). There were also manifestations of lateral spreading on the banks of Isser River (Fig. 4). Rockfalls and other slope failure occurrences were limited in number and magnitude. Most of them took place on the coastal national road and a few along the Mediterranean coast. The former affected well consolidated but densely fractured sandstones exposed on steep road cuts; the latter were noticed on loose sand dunes. Coastline retreat and uplift of the sea floor was also observed: the magnitude of uplift ranged between 0.4-0.8 m, between Boumerdes and Zemmouri (Yelles et al. [10]).

Figure 3. Ground fissures and liquefaction close to Djinet. The trend of the fractures is approximately N35 E.

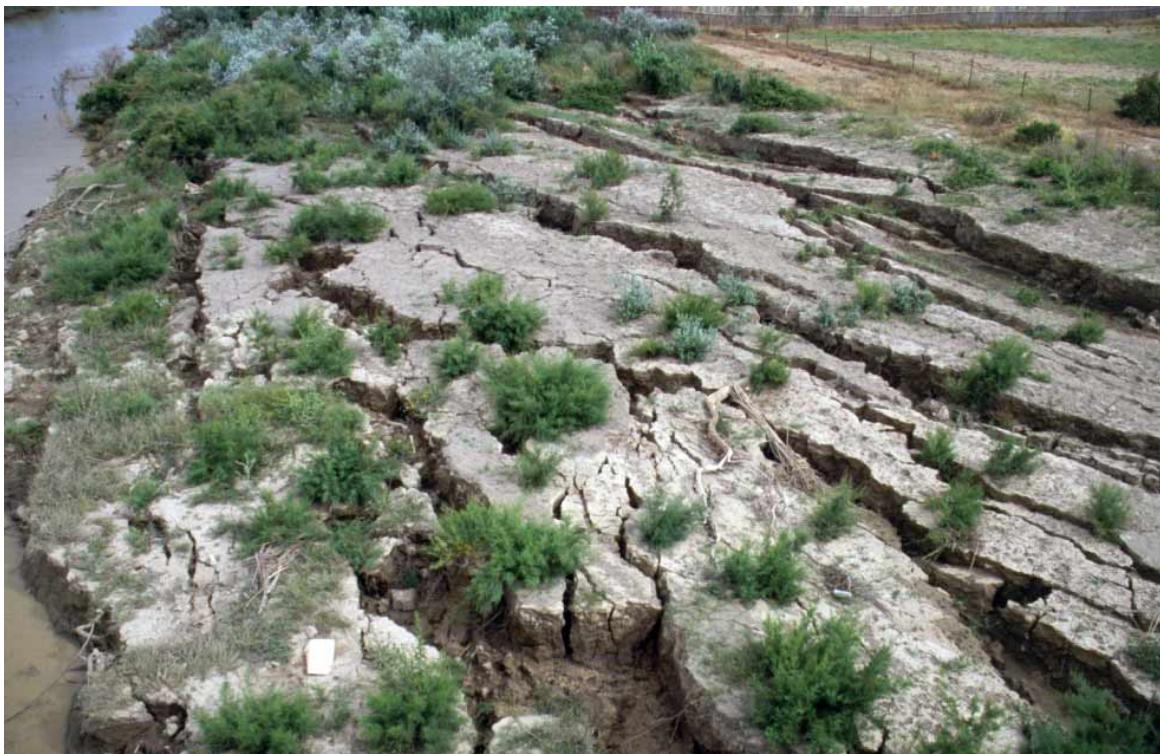
Figure 4. Lateral spreading on the banks of Isser River.

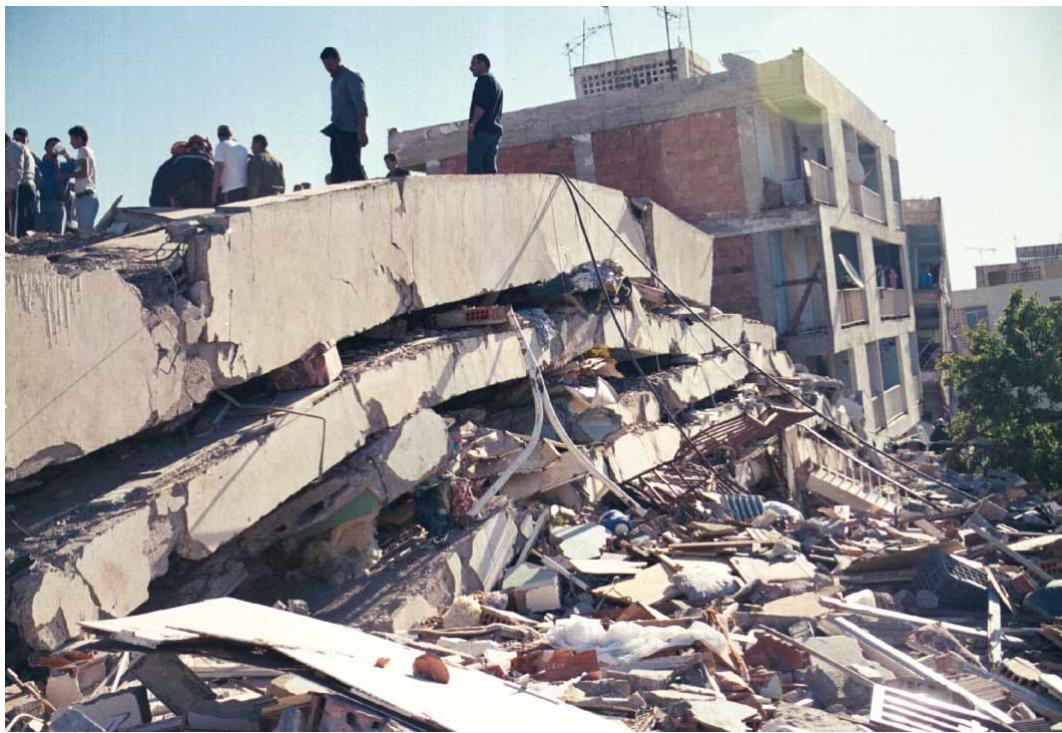
In Boumerdes, the affected buildings were four- to six-story residential blocks that housed working-class families. These constructions consisted of reinforced concrete frame with brick infill walls. Most collapses or heavy damage were due to the fact that the constructions behaved as soft first- (and/or second-) story. This is attributable to the following factors: (i) the first stories (ground floors) were had commonly very large openings, as they were used for commercial purposes and the gravity load-carrying elements of the second floor were insufficient; (ii) the exterior cavity walls consisted of an outer leaf that enveloped the R/C frame and the inner shell had usually very low cohesion with the frame. This meant that the stretcher-bond cavity walls did not play any active part in the shear strength of the buildings and the constructions were subjected to column-shearing at the tops of the first stories. The collapses were mostly sandwich-type and in a few cases pancake. (Figs. 5, 6). Also, in a few cases, as described in the previous part, localized sharp increase in PGA led to the toppling of buildings.

Figure 5. Pancake-collapse of four-story residential building in Boumerdes.

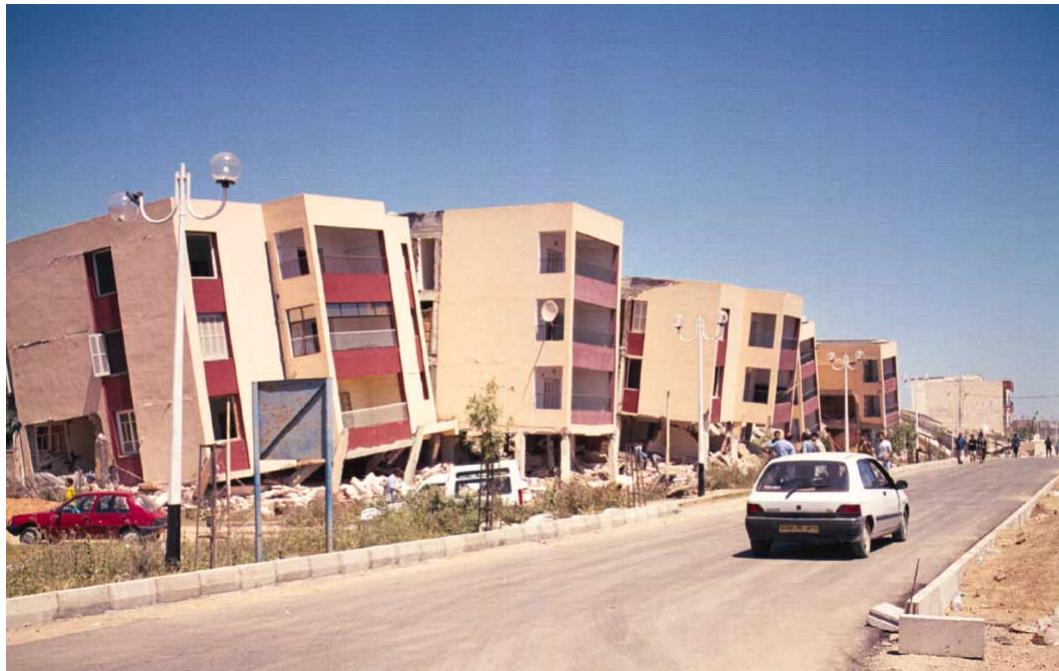
Figure 6. Soft ground floor (first story) at several residential blocks in Corso, at the eastern outskirts of Boumerdes.

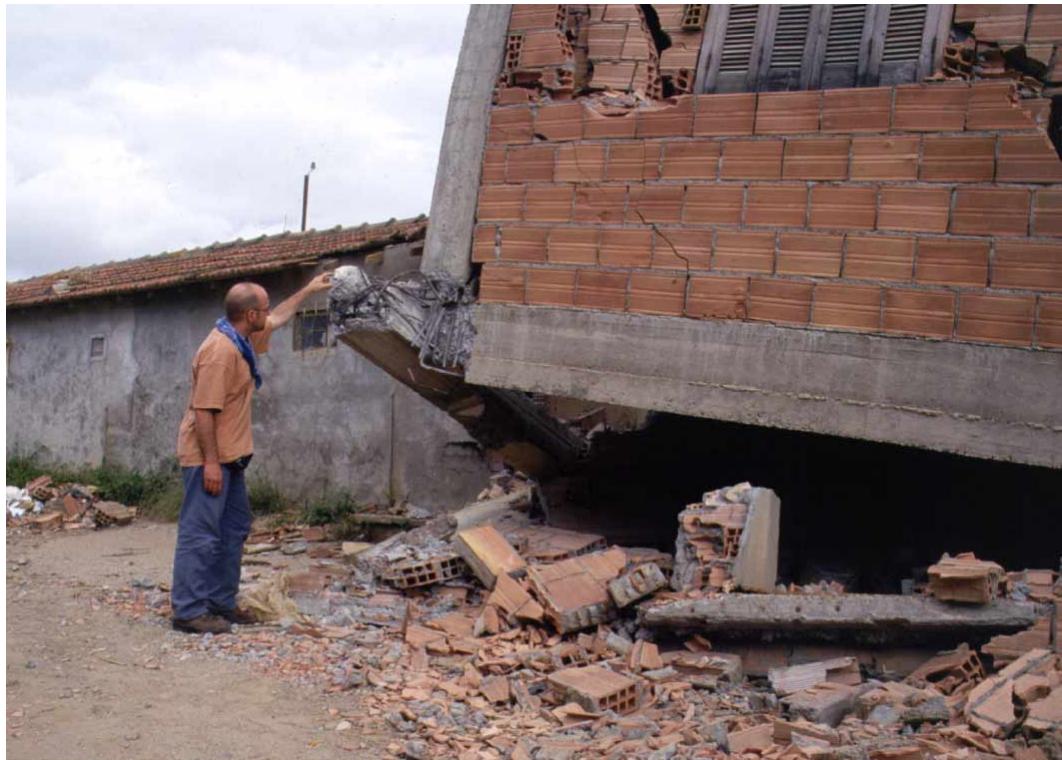
Figure 7. Column-beam failure due to insufficient seismic detailing at a private home in Zemmouri.

The town of Zemmouri, 70 km east of Algiers, was practically reduced to debris; very few buildings did not collapse, having however suffered heavy structural damage. In this town, again the construction quality privately-owned houses was poor (including low-quality materials and wrong construction -- insufficient seismic detailing in columns, strong beam/weak column, etc) (Fig. 7). However, not only private homes, but also modern, multi-story apartment blocks (most of them still under construction) suffered severe damage (Fig. 8). In Algiers, mainly the western part of the city was hit. In this case, the damage was mainly to private homes that were constructed without adhering to the Algerian seismic design code.

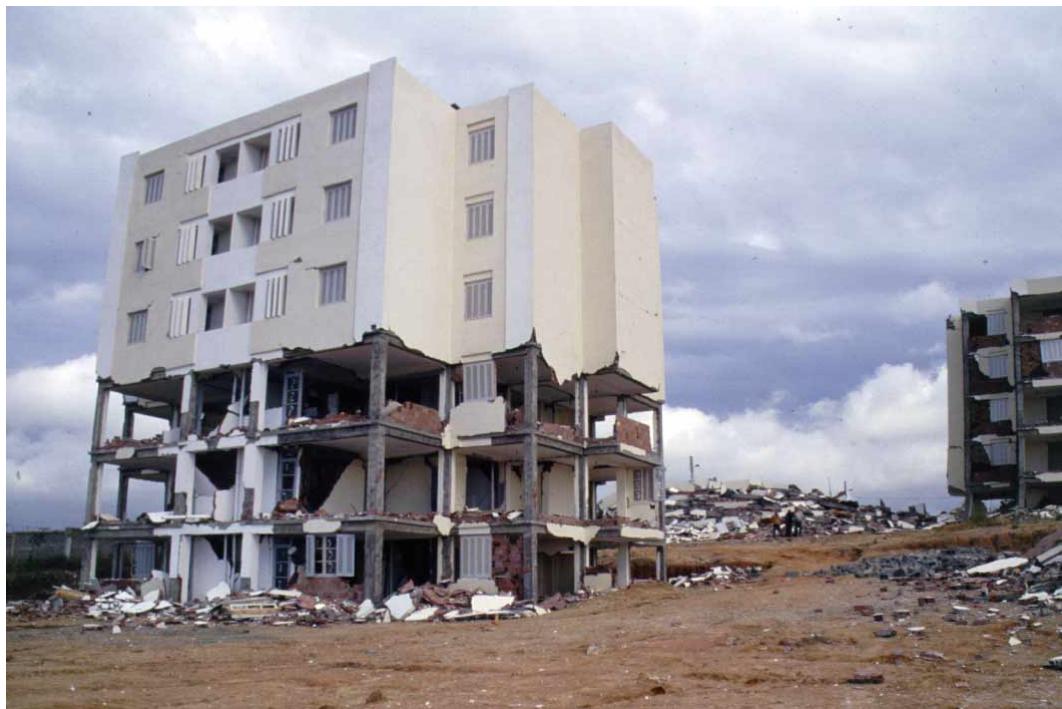
Figure 8. Loss of exterior shell (foreground) and total collapse (background) in newly-built apartment blocks in Zemmouri.
