REPAIR AND SEISMIC RETROFITTING OF HOSPITAL AND SCHOOL BUILDINGS IN PERU

SUMMARY

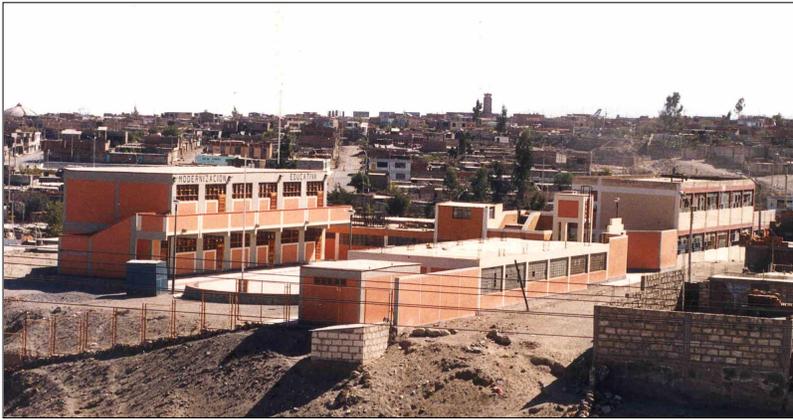
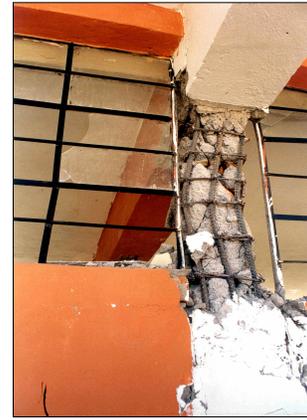
The “Casimiro Cuadros” school in Arequipa features building blocks constructed in different years, using different codes and design criteria, as well as a visible difference in quality of construction. At this site, the seismic base movement in the 2001 earthquake must have been similar for all the blocks; however, each block had a distinct behavior (fig. 1). The old blocks had flexible systems and showed the short column failure, with so much damage that the blocks had to be demolished. On the other hand, the rigid block, designed and built according to the 1997 seismic code criteria, was undamaged. What happened in the “Casimiro Cuadros” school is a good example on what could be observed in other schools buildings in the affected zone: flexible traditional blocks with shear failure in columns due to the short column problem, and rigid new blocks without any damage.

Fig. 1. “Casimiro Cuadros” school in Arequipa: old and new blocks (left) and short column failure in old block (right).

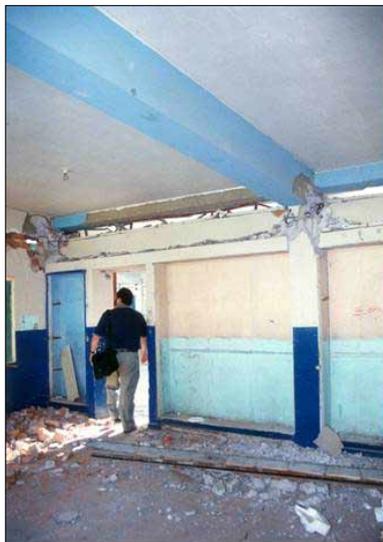
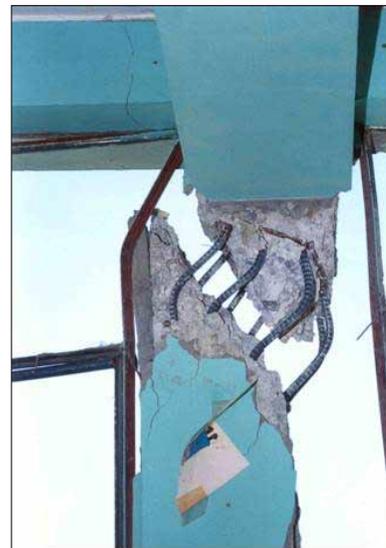
In the city of Moquegua, the “Angela Barrios” school (an older type) was one of the most affected. At the corner block, the interior columns failed due to the short column effect (fig. 2, left), losing more than 0.3m height; then, the roof fell inclined producing the failure of the exterior columns (fig. 2, right). This school is located in a sloping area, and the affected block was elevated between 2 to 4 meters above natural terrain. It is probable that a foundation problem and a bad quality of the construction may have increased the natural vulnerability of this structural system.

Fig. 2. “Angela Barrios” school in Moquegua: interior column general failure (left), and exterior column failure (right).

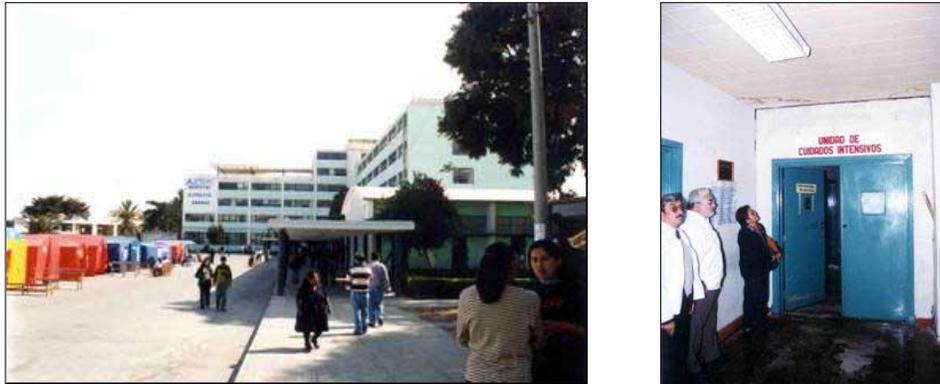
the 3 six-story buildings were evacuated and emergency constructions had to be installed (fig. 5, left); besides the non-structural walls, the sanitary installations were also damaged (fig. 5, right).

Fig. 5. “Hipólito Unanue” hospital in Tacna had damage to non-structural walls and sanitary installations.

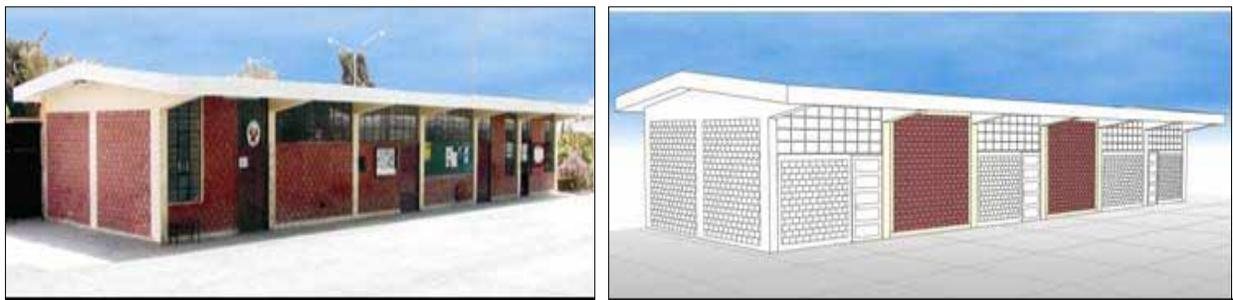
Fig. 8. One story school building damaged after the 2001 earthquake (left) and projected retrofitting in the longitudinal direction (right).

For one-story buildings, usually masonry walls were included, along with concrete confinement columns of the existing frames and new beams on the roof. In figure 8 an affected one-story building and the retrofitted structural system are presented.
