## **IMPACT OF KUTCH EARTHQUAKE ON NON-STRUCTURAL ELEMENTS AND APPENDAGES OF BUILDINGS**

### **SUMMARY**

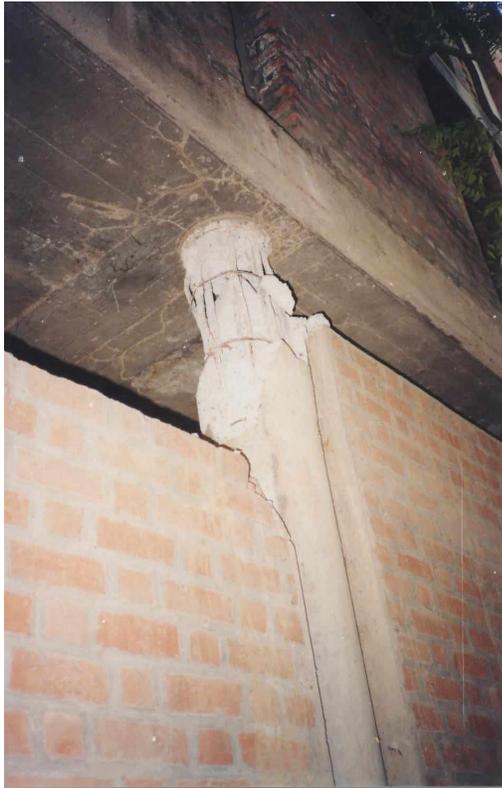
**Fig. 1: In IIM Building presence of partitions wall converted the column into short column leading to the sever structural damage of column**

Non-load bearing walls, both external and internal, are inevitable components of any building. The flexibility available to the user by RC frame structures have shaped the evolution of building forms and increased the use efficiency of the building functions. Problem arises when these non-structural walls are positioned in places of torsion and/or stress concentration, without taking these factors into consideration. Placement of these walls in-between columns may apparently look safe and innocuously harmless, but during an earthquake, these harmless partition walls becomes responsible for inducing short column effect. Figure 1 show one such example, where the partition walls lead to the failure of column Figure 2 shows the failure of non-structural exterior wall of a school building at Gangarampar in Gujarat. The cause of the collapse of the wall may be attributed to the fact that during earthquake the wall was subjected to a distortion and was not in a position to adjust to loads caused by the deflections of the core structure.[2] This phenomenon, along with the practice of not tying the wall appropriately with the main structural frame of the building, is very common in India, and Kutch earthquake has demonstrated the high vulnerability of these buildings.

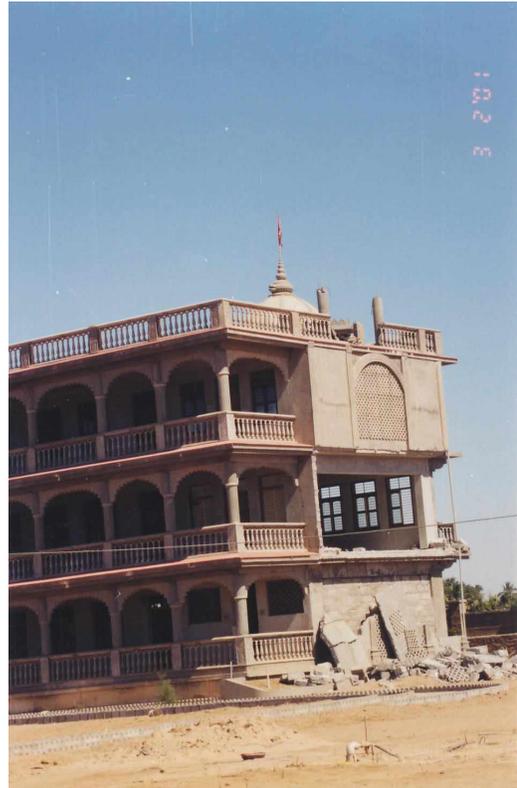
**Fig. 2: Non-structural wall of first floor over turned and fell on the ground, as it was not properly connected to the main structural system**

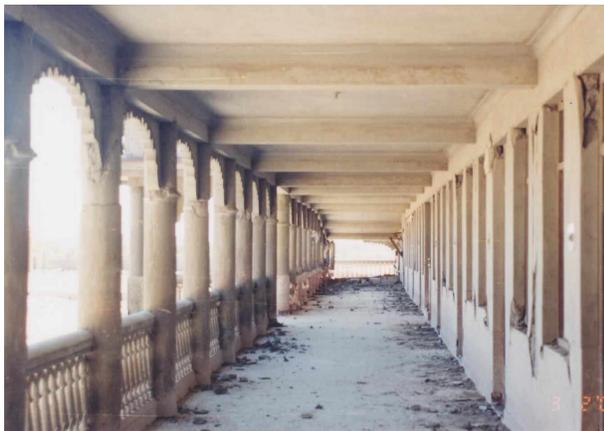
The residential school building had a simple rectangular architectural shape with single loaded wide corridor, having three wings in C formation. This three-story building was made of RC frame. Non-load bearing partition walls were used to create classrooms and other usable spaces as per the needs of the school. The finishing specifications of the building were very rich and non-structural architectural detailing of corridor railing and arched façade were exquisite Figure 3.

**Fig. 3: School building with long corridor having rich and non-structural architecture detailing of corridor railing and arched facade.**

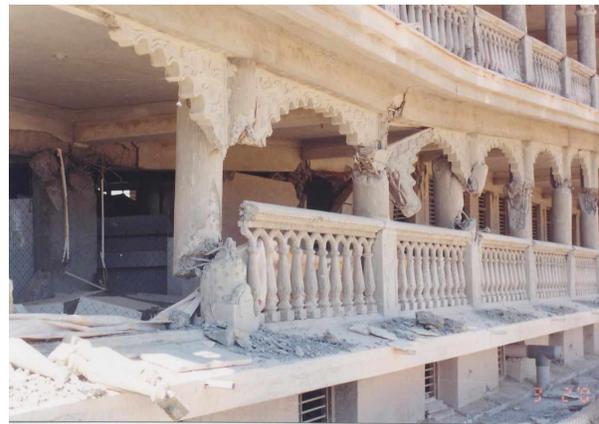
**Fig. 4: Sever damage to columns due to non-structural elements in the form of heavy railing and arched façade.**

On January 26, 2001, when the earthquake hit the region, it did not differentiate between structural and non-structural elements of the building.[2] Architectural features of the building in the form of corridor arches and railing modified the response of the structural system (columns), which proved to be detrimental to the safety of the building. Columns, in between the floors, were stiffened at top and bottom at almost 1/3<sup>rd</sup> distance due to arches on the upper part and railing on the lower part. This led to failure of the column due to shortening effect and associated concentration of stresses Figure 4.

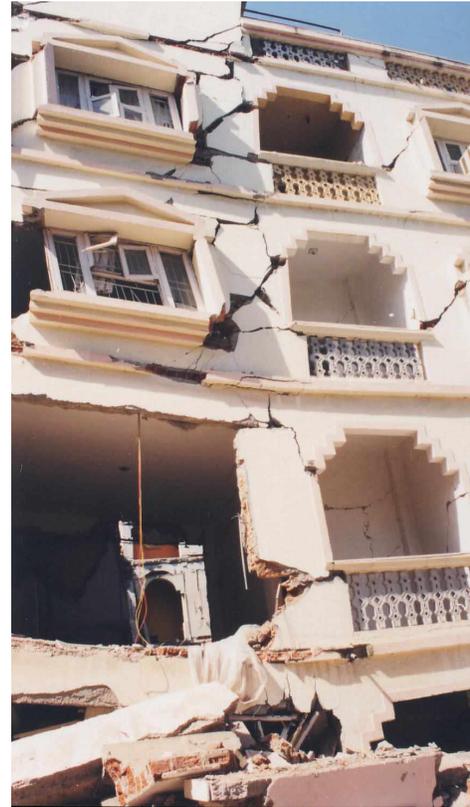
A complex consisting of multi-story residential apartments were located in Ahmedabad. The complex consisted of different towers, with similar architectural plan and structural system, but oriented at right angle or parallel to each other. The buildings were of RC frame structure, with stilts on ground floor for parking and housing other services. Façade of the buildings had lot of mass and heavy projections to serve as, besides architectural feature, shade from rain and sun Figure 5. These heavy features, having weight more than the wall itself on which they are stuck, added additional weight to the wall. The loads due to these features, on the outer face of the building, have not been considered while designing the structure. Moreover, these appendages were not tied with the main structure of the building. During the earthquake, these non-structural features behaved independently and not in consonance with the structure of the building, thereby contributing its share in damaging itself and the building beyond repairs.

**Fig. 5: Heavy appendage in the form of architectural façade, not tied with the main structural system of the building.**

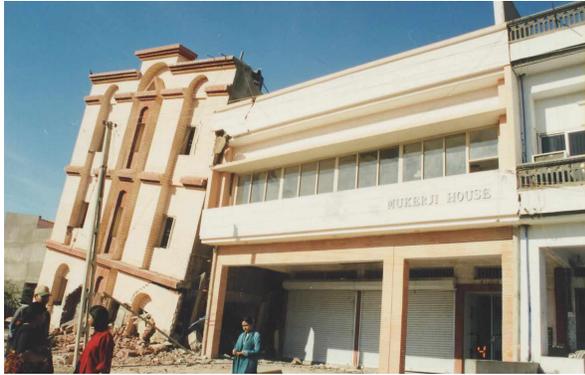
**Fig. 6: Two adjacent buildings of different heights and structural systems. The taller building got damaged due to pounding and open ground floor. The water tank kept eccentrically on top of the roof collapsed and fell on the lower building.**

A row of 2 and 3 story buildings, facing a wide road and a park in Gandhidham was an ideal setting for the existing buildings. Apparently there was no problem and most of the buildings performed fairly well during the earthquake. The problem arose for two buildings of different heights, adjacent to each other Figure 6. The lower 2 story RC frame structure was well designed and properly built, but the adjoining structure was a 5 story residential apartment building, with stilt floor for parking. Each floor had 3 residential units, totaling to 12 units on 4 floors. This structure had a rooftop RC water storage tank for all the 12 units, measuring 2 m.X2m.X3m. The tank was placed eccentrically at the front right corner, adjacent to the 2-story building.

The design and placement of this concrete tank was an after thought. Obviously, therefore, it was not properly tied with the main structural system of the building to take care of the dynamic forces due to earthquake. When the earthquake took place, lower building performed very well, like most of the building in the vicinity. There were minor damage to non-structural components, like glass walls and

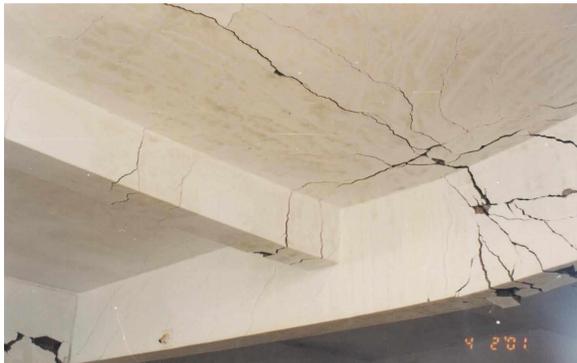
**Fig. 8: The beams of ground floor roofs were heavily damaged due to fall of filled water tank from the roof of the adjacent building.**

interior objects like computer etc. that fell down. But the building was subjected to a heavy impact on the roof due to fall of water filled tank from a height of 9 meter from the adjoining building Figure 7. The tank pierced through the RC roof of the building and damaged the structural beams of ground floor roof Figure 8.

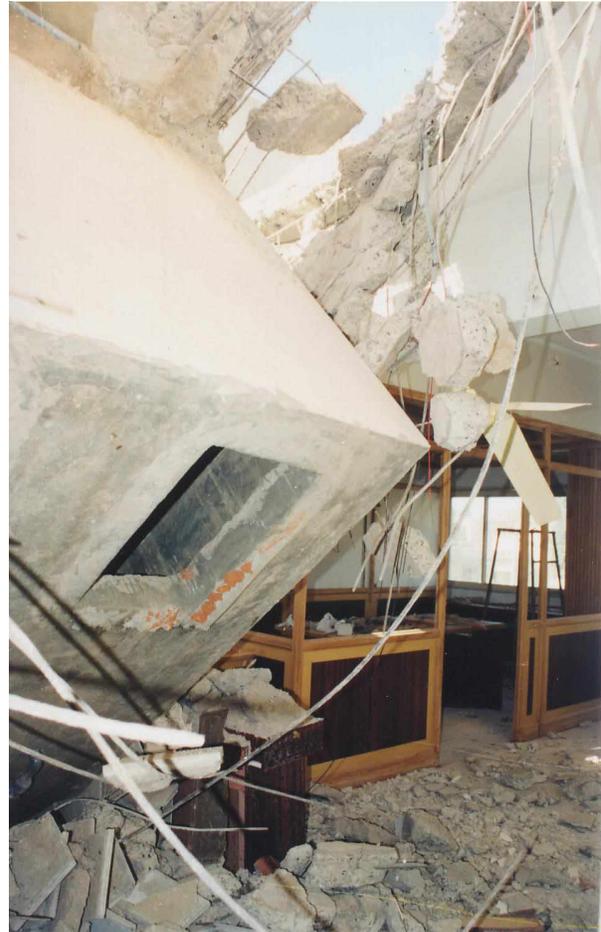
**Fig.7: The water tank pierced through the roof and fell on the first floor, damaging the structural members of the building beyond repair.**

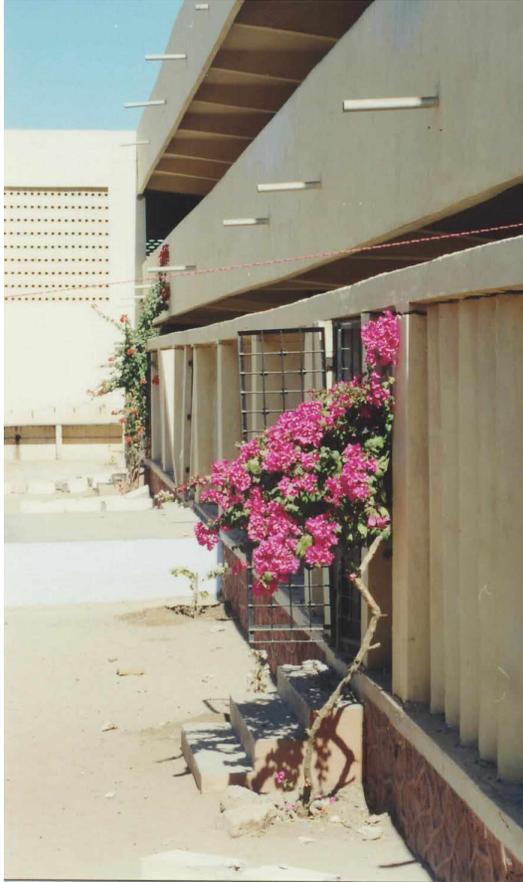
The building has a plinth height of 60 centimeters. It had an open corridor with structural columns at a distance of about 5 meters. Young children of lower classes of the school used to jump from the corridor and play during recess time. Couples of children, while playing, were hurt and the management of the school decided to put barriers to stop children jumping from the corridor. What they did was ridiculous. Concrete piers of 40cm. X 40cm. section were placed at the edge of the corridor to act as barrier Figure 9. These heavy piers were inserted without any tie at the top or bottom. When these piers were subjected to dynamic forces due to earthquake, they could not resist and fell down, snapping its nonexistent ties with the structural system of the building Figure 10 and 11. Children of the school were very fortunate, as they were celebrating Republic day celebrations in the open ground of the school, when the earthquake hit the school building. If they had been in the corridor many of them would have been hit and crushed by these heavy concrete piers. A school building, which was otherwise well built, became vulnerable to earthquake forces because of wrong decision and insertion of non-structural components at a later date, without considering its behavior during earthquake.

**Fig. 9: Concrete piers, inserted as barrier at the edge of the corridor, to stop junior inmates of the school from jumping from the corridor.**

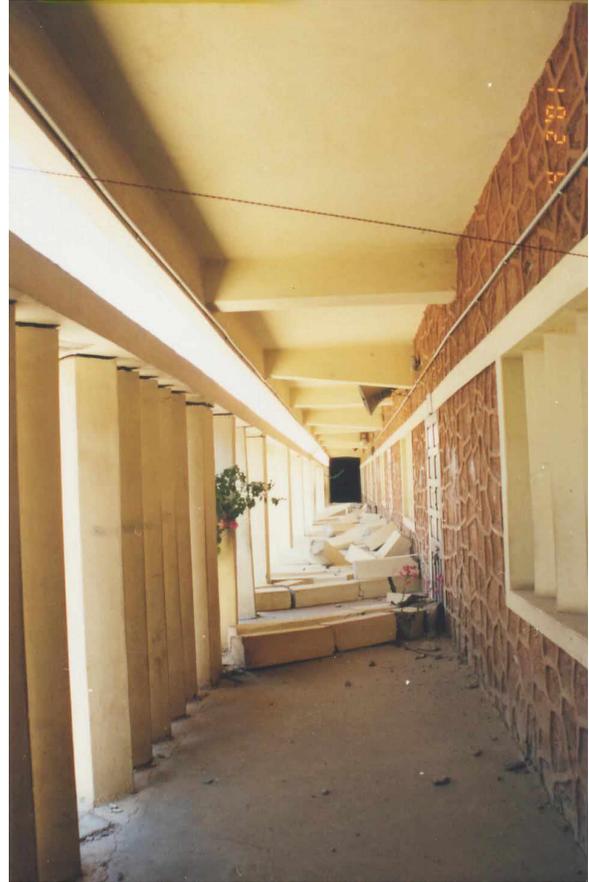
**Fig. 11: 26 January 2001 was lucky for the Children of the school, because they escaped unhurt in spite of heavy non-structural damage to the concrete piers, which fell in the corridor due to earthquake.**

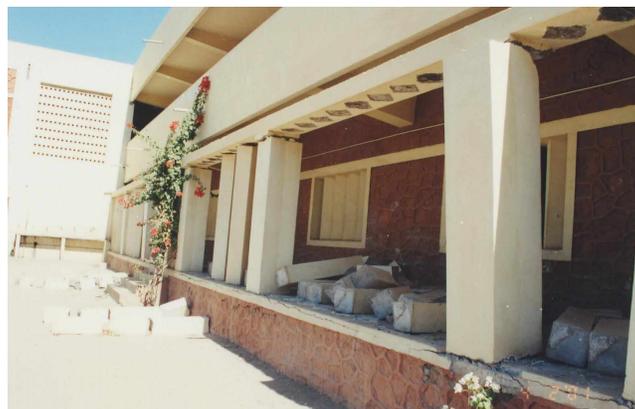
**Fig. 10: Concrete piers fell on the corridor due to poor detailing of fixing with the structural system of the building.**

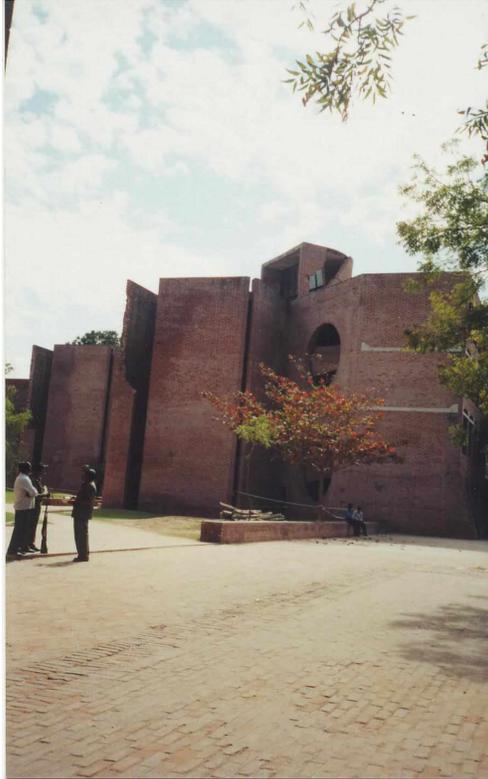
Vertical projection on the roof could be the parapet or any other appendage. They have both utilitarian as well as aesthetic role to play in the building. Indian Institute of Management (IIM) Ahemadabad, a famous academic institution campus, designed by world-renowned architect, Louis I Kahn, was constructed in 1960s. The buildings of the campus were not subjected to earthquake forces during its existence of almost four decades, till January 26, 2001, when an earthquake, epicenter of which was more than 250 kilometers away, hit it. Non-structural components, mainly parapet walls and staircase mummy of the buildings were heavily damaged or collapsed. Parapets and high walls, without any lateral supports, were subjected to great accelerations. Fortunately, the failure of these components did not cause any casualties, nevertheless there were lot of non-structural damage, and the debris of the damage fell from a height of more than 10 meters Figure 12.

**Fig. 12: Damaged parapet wall and mummy of the staircase in the academic block of Institute of Management, Ahemadabad.**

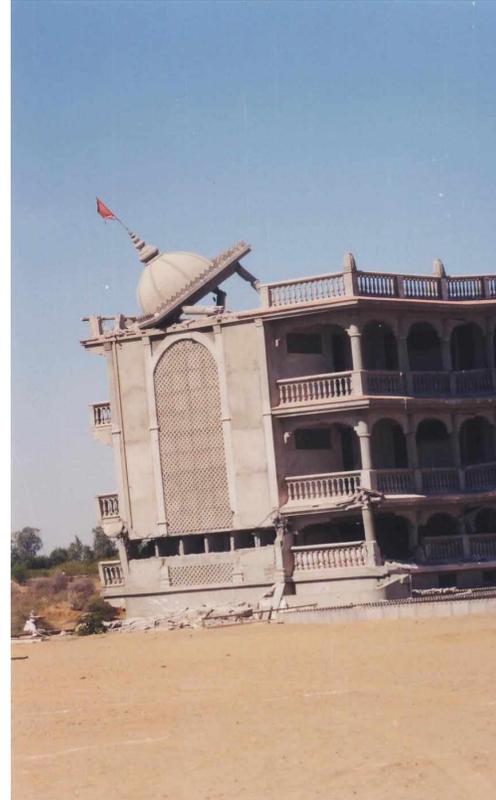
Another such appendage on the roof was observed at Gangarampar in the residential school building. Decorative domical non-structural features adorned all the corners of the building; this is an example of symbolism par excellence, which is commonly used in important public buildings in India. Problem with these non-structural architectural features are that they are not usually tied with the main structure, and are designed for self dead load only. The behaviors of these appendages during an earthquake are generally not considered. The result of one such feature is shown in Figure 13. In this case also, like in the IIM building, the appendages experienced great acceleration at the top and the fragile support of the domical member were not strong enough to resist the forces generated by the acceleration. Result was obvious. Only consolation in this case was that it did not fall on the ground, thereby sparing the lives of inmates of the school.

**Fig. 13: Toppled decorated dome due to high acceleration and poor connectivity to structural system of the building.**
