## ASSESSMENT OF DAMAGE AND REHABILITATION OF SMALL AND MEDIUM EARTH DAMS

**D.K. PAUL<sup>1</sup>**

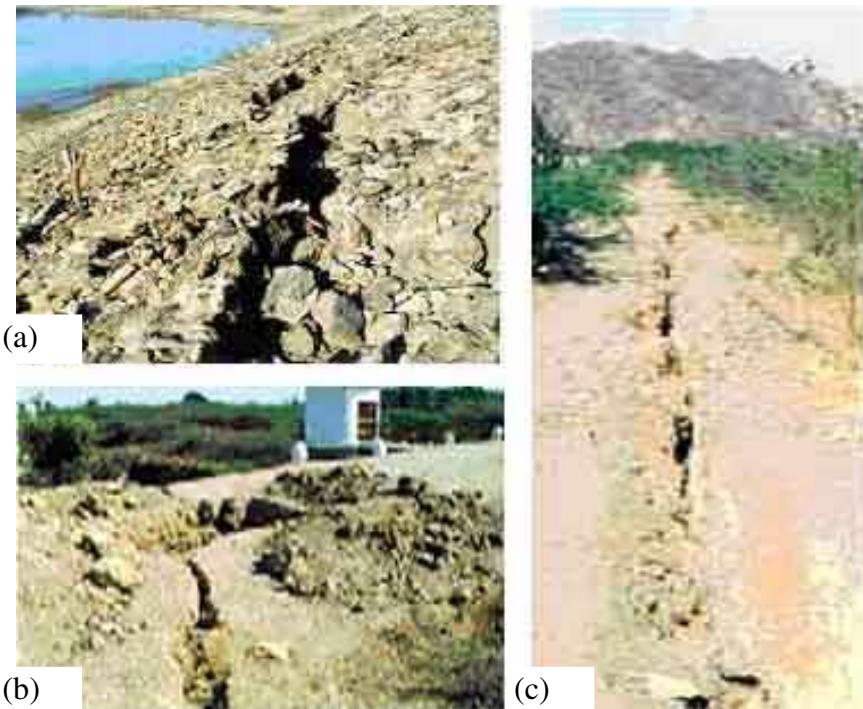
3. Slippage of the u/s slope as observed in many dams. In some cases leakage is also observed. Longitudinal cracks were also observed on the u/s slopes in the casing zone (Fig.2(a)). Sometimes there were series of parallel longitudinal cracks on the slopes. Most of the earth dams were badly

5. The longitudinal crack at the dam crest, which was very deep in regions of high intensity of ground shaking (Figure 2(c)).
6. The transverse cracks in some of the dams are more serious as they may result in leakage and failure (Figure 2(b)).

**Fig.2 (a) Wide craks on the slope (b) Transverse cracks on the the dam crest, (c) Longitidinal cracks on the dam crest**

Longitudinal cracks to be excavated in the form of deep trench up to appropriate depth and back filled with selected soils and compacted. Figure 3 shows trenching of cracks, watering, and compacting. A 15 cm thick layer of shell material to be provided on the top surface of the earth dam throughout the length to take care of invisible cracks if any and to prevent infiltration of rainwater. Shallow sinkholes where found to be excavated upto a depth of 0.3 m and backfilled with selected soil and compacted. Rich cement mortar slurry to be poured in the gap between the left bank wing wall and the Non-overflow dam section. Surface cracks in the wing wall are to be repaired with rich cement mortar. Figure 3 shows the treatment of longitudinal crack at the dam crest.

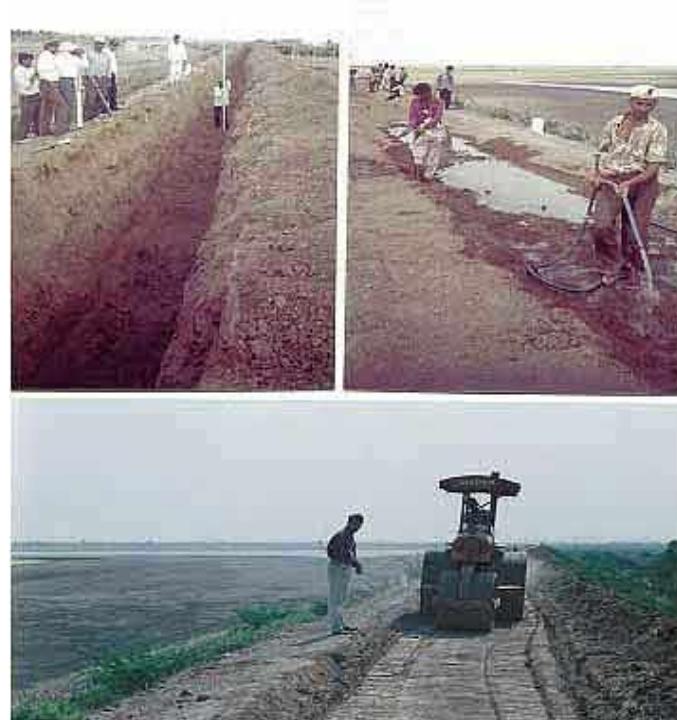
**Fig.3 Treatment of longitudinal crack at dam top**
