## **EVALUATION OF HOUSING LOSSES IN RECENT EARTHQUAKES IN LATIN AMERICA**

**Mario RODRÍGUEZ<sup>1</sup> and Marcial BLONDET<sup>2</sup>**

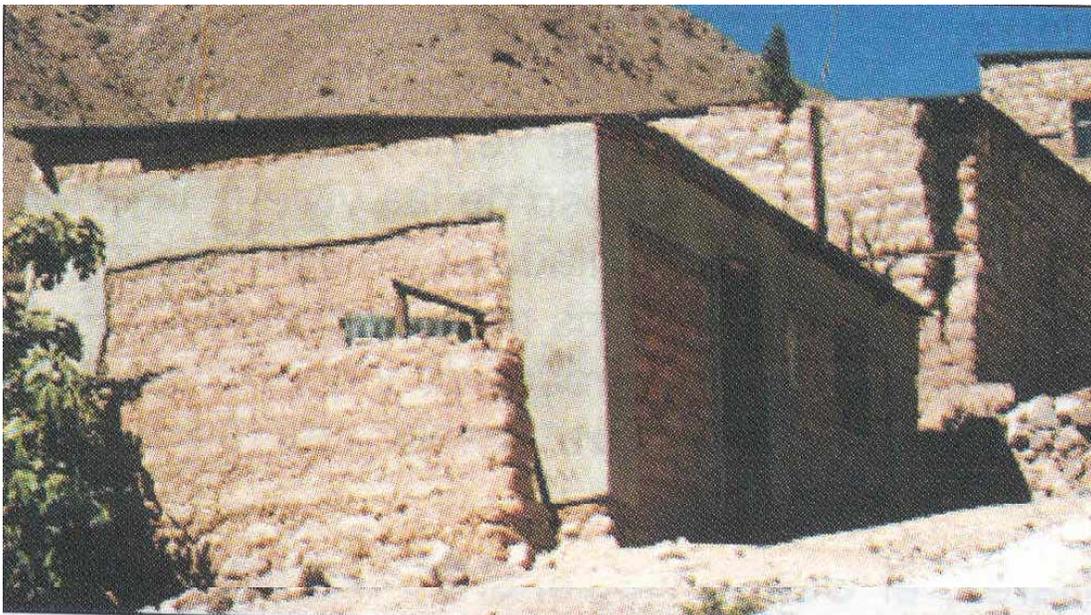
Some adobe dwellings, however, had good seismic performance during the 2001 Arequipa earthquake. Several adobe houses were retrofitted before the earthquake with steel wire mesh and mortar forming vertical and horizontal bandages as shown in Figure 4 (Zegarra et al., 2001). These reinforced houses did not suffer any damage, while conventional, unreinforced, adobe dwellings nearby showed structural damage, or collapsed.

**Figure 4. Adobe dwelling rehabilitated before the 2001 Arequipa earthquake with steel mesh and mortar forming bandages which resisted this earthquake without damage (Zegarra et al., 2001)**
