SEISMIC VULNERABILITY OF CUZCO CATHEDRAL, PERU

**Ricardo PROAÑO¹, Miguel TORRES², Carlos ZAVALA³, Zenón AGUILAR⁴,
Jorge OLARTE⁵, Hugo SCALETTI⁶, Martín RODRIGUEZ⁷**

SUMMARY

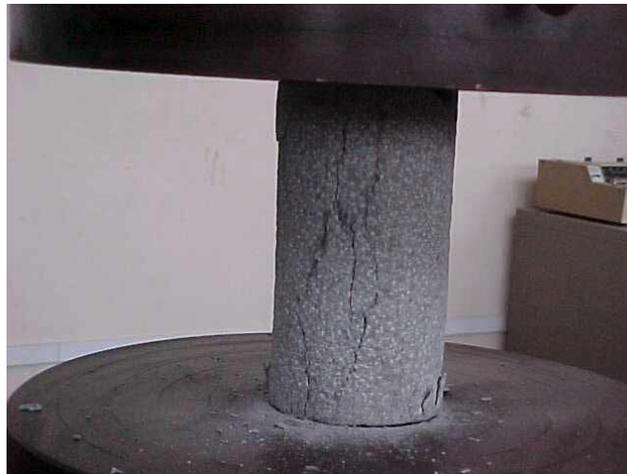
Figure 2 shows the force deformation relation obtained from the samples. The way of the compression failure is typically in tension in the transversal direction. After apply low level of stresses (30% and 50% of its resistance) we observed the first cracks in longitudinal direction. They will propagate and appear un the axial direction and finally opened because transversal tension producing a pattern like the observed in Figure 3.

Figure 3: Faillure on stone sample.

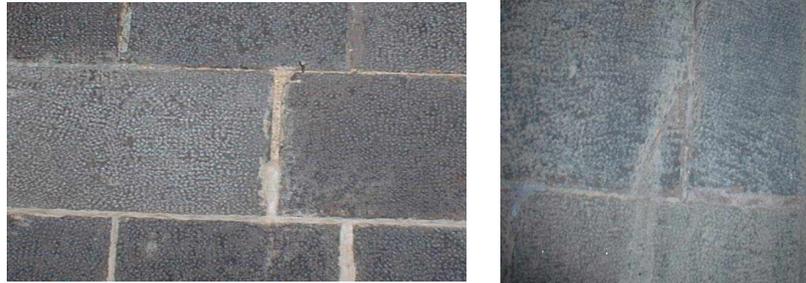
The main damage presented in the structure appears in the columns. In Figure 6 it is possible to see the vertical cracking in the stones. Also it is possible to observe the damage on the borders of the stones. In the right hand side picture is possible to observe the horizontal shift of the blocks which represents an unlinegment on the border and surfaces of the stones.

Figure 6: Damage on stones on columns

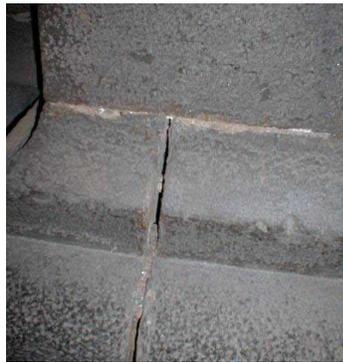
Figure 7 shows the state of the down part of the column. Here is obvious the vertical opening between stone blocks. Figure 8 shows the cracks in the stone in vertical pattern. It could be attributed to excessive stress on the section or a possible interaction from the upper part of the structure coming from domes and arch reactions over the column.

Figure 7: Opening on column base

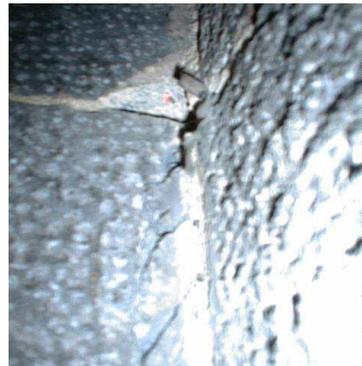
Figure 8: Vertical cracking

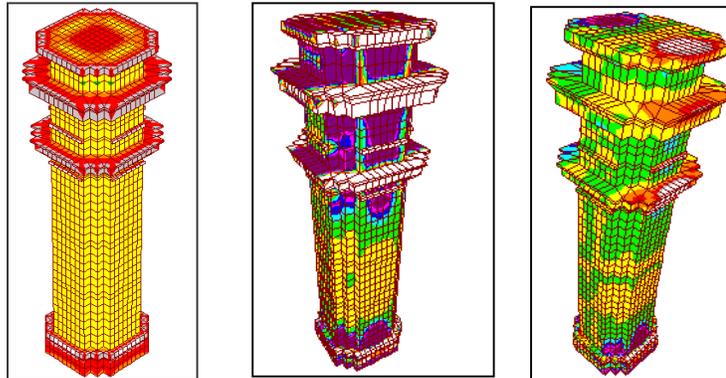
Figure 11: Stresses in column model

In Figure 11 is possible to see in the left figure the vertical stresses due to gravity load, where a stress concentration because the load of domes and arch is supported by the external ring of the column compose by stone blocks. The central figure shows horizontal stresses due to permanent load. Its explain why the stones separated from each other because the filled mortar can not take this level of stresses. The right figure presents the vertical stresses due to seismic loads. Here reverse stresses appears in down part of the column and stress concentration appears.

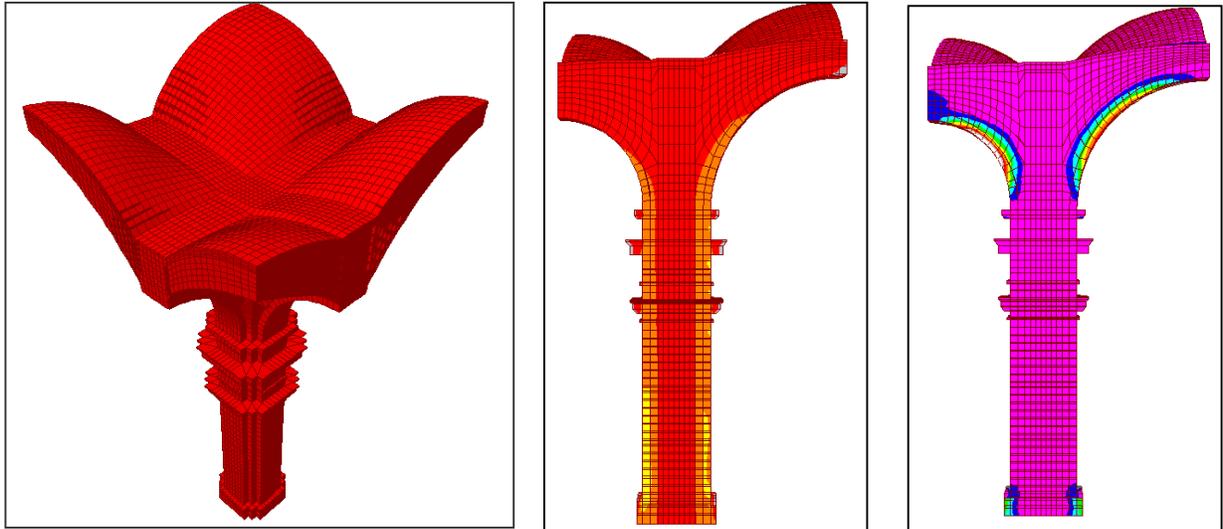
Figure 12: Arch – domes – column model

Figure 12 presents the model and stress which consider the arch – domes – column interaction. Here the left introduce the finite element model. The central figure presents the vertical stresses due to gravity loads. Here the normal in horizontal direction are less tha 0.1 Mpa in columns. In domes and arch the stress level in tension are in the order of 0.1 Mpa and compression in the order of 0.75 Mpa. The right hand side figure shows the shear stress concentration on arch because seismic loads, the ones are in the order of 6.5 Mpa in the start of the arch. Also in columns the shear stress level reach a value of 3 Mpa. In the face of the columns and 0.5 Mpa in the nucleus.
