SEISMIC UPGRADE OF CHIMNEY STACK AT LIONS GATE HOSPITAL IN NORTH VANCOUVER, CANADA

This paper outlines the evaluation and cost comparison of six different retrofit options, and the details of the design, construction, and cost aspects of the selected option.

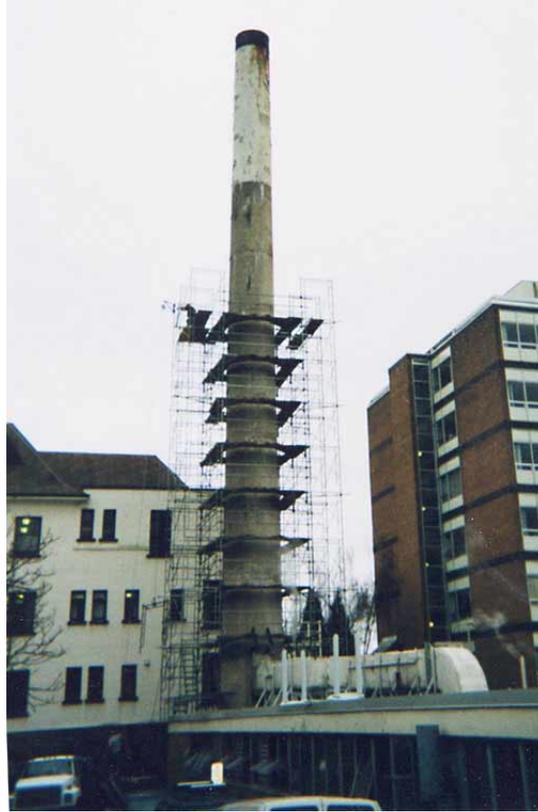
A photograph of the chimney before the seismic upgrade during the early stage of the upgrade work is shown in Figure 1.

Figure 1 Lions Gate Hospital Chimney prior to Upgrade

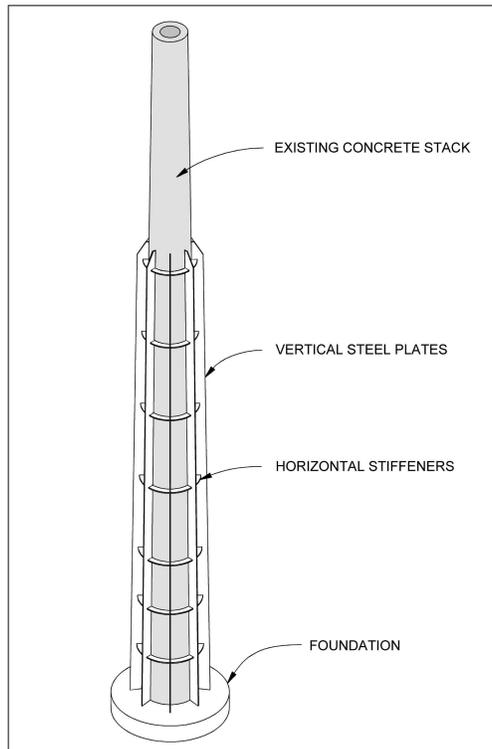
Figure 2 Isometric Sketch of Retrofit Concept 6

Retrofit concept 6 consists of installing a new structural steel “enclosure” outside of the existing stack, made of vertical steel plates perpendicular to the surface of the stack with horizontal stiffeners. This option would not involve any modifications to the existing stack surface as the enclosure is not bonded to the existing stack. One advantage of this option is the minimum amount of dust and noise compared to the other retrofit concepts because the majority of steel work could be done offsite. If this option is selected for the detailed design, analysis will be required to determine the deformation compatibility of the ductile steel enclosure relative to the "brittle" stack structure. An isometric sketch of this concept is illustrated in Figure 2.

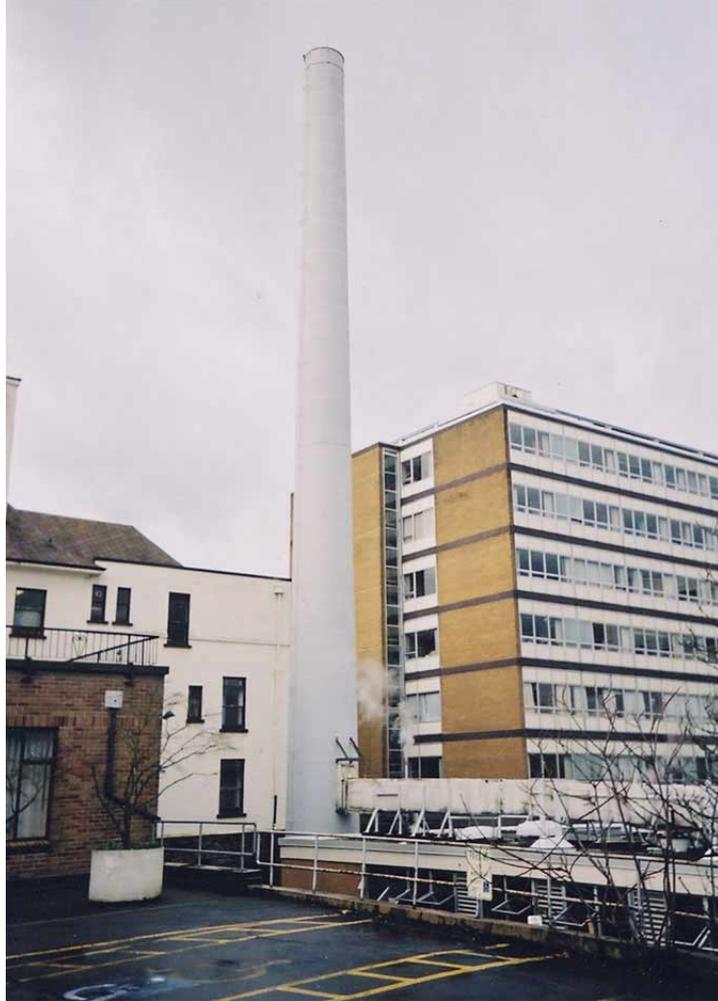
Figure No. 3 shows a photograph of the stack after the upgrade.

Figure 3 Overview of the Chimney after the Upgrade Work

Among the retrofit concepts that provide 100% of the current seismic code requirements, the Option 1 reinforcing the stack with FRP was selected. Although potentially slightly higher in cost than option 3, it was selected due to lesser construction impact with regards to noise and duration. Detailed design followed and the upgrade of the stack was built accordingly.

From an aesthetic point of view, the FRP option resulted in a final appearance nearly identical to the existing stack (only millimetres thicker than the original structure).
