SEISMIC UPGRADE OF BC HOUSING'S 20 STOREY NICHOLSON TOWER IN VANCOUVER, CANADA

SUMMARY

Nicholson Tower is a twenty story concrete residential building with a one level underground basement. The building, located in downtown Vancouver, was designed in 1968.

In 2001, Sandwell Engineering Inc. was retained by BC Housing to carry out a seismic evaluation and upgrade project for the facility.

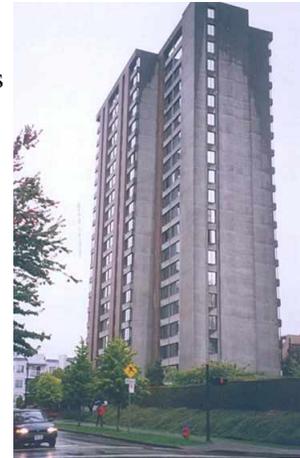
**Figure 1 Original Building
General View**

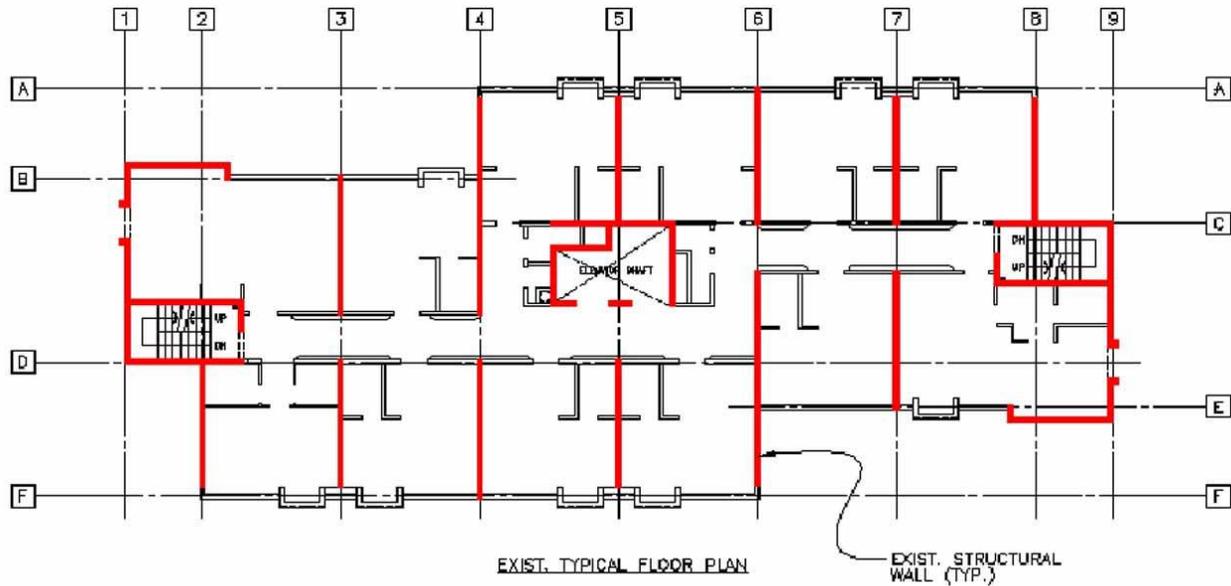
Figure 2

The structural system, as illustrated in Figure 2, is summarized below:

- 6" thick concrete slabs supported on concrete walls (which carry both gravity and lateral loads).
- Stairwell concrete walls are 8" thick throughout.
- Reinforced concrete shear walls 10" thick at ground and 12" at basement; majority of the other walls are 8" thick from 2nd floor to 9th floor, 6" thick above 9th floor.

- The concrete walls in North-South direction are well distributed along the length of the building.
- A stairwell at each end of the building and an elevator shaft are the only lateral load resisting elements in East-West direction

- Five of the shear walls in the N-S direction have a "soft story" at the ground floor due to door openings; similar openings exist in the basement.
- Walls are supported on narrow strip footings of unreinforced concrete (exterior walls) and of reinforced concrete (interior walls).

- 4" thick unreinforced slab on grade in basement.
- Top three floors have utilized semi-lightweight concrete.
- Reinforced concrete elevator penthouse.
- 6" thick, 3 feet high reinforced concrete parapets around the roof perimeter.

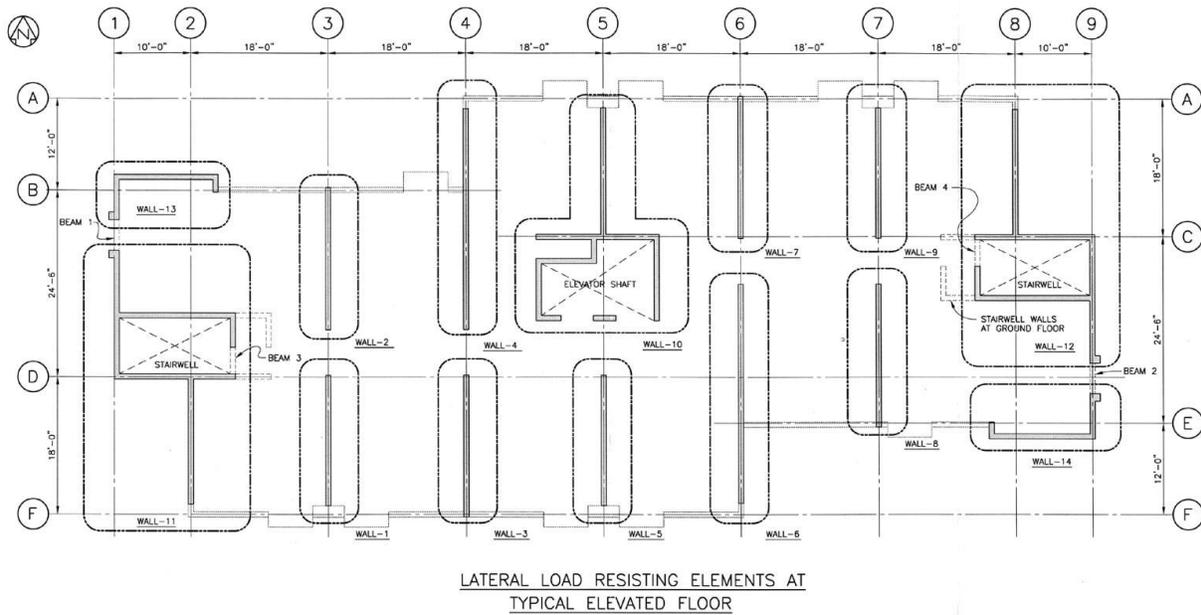
Figure 3 is a key plan correlating the numbers used in the report to identify the single or combined wall sections that behave as lateral load resisting elements. The capacity of the seismic resisting elements as a percentage of the code specified seismic demand is presented in this section to illustrate the location of the deficiencies and indicate the extent of upgrade required to bring the building to a life safety level. The information given in this section is related to the structure in its original state before the seismic upgrade.

1. Insufficient bending capacity of walls 11, 12, 13, & 14, beams 1 and 2.

These elements consist of large combined wall segments that are coupled by beams 1 and 2. These walls are stiffer than the other interior walls and as a result attract a major portion of the base shear. They also attract more torsional loading because of their location at the two extreme ends of the building. The combination creates large bending forces and axial forces (due to coupling) for which the walls and beams were apparently not originally designed.

2. Inadequate overturning (or up-lift) capacity at the footings of walls 10, 11, 12, 13, 14.
3. Lack of sufficient bending capacity in walls 10, 11, and 12 for loading in East-West direction.

4. High local stresses at points of vertical discontinuity such as:
 - Stairwell walls adjacent to door openings at level-2; due to significant discontinuity at one end.

- Walls 3, 4, 5, 6 and 8 at ground floor (where openings exist)
5. Lack of sufficient shear reinforcing in the elevator shaft and the stairwell walls.
6. Strip footings were not designed for the high local bending at the locations of wall openings at basement.

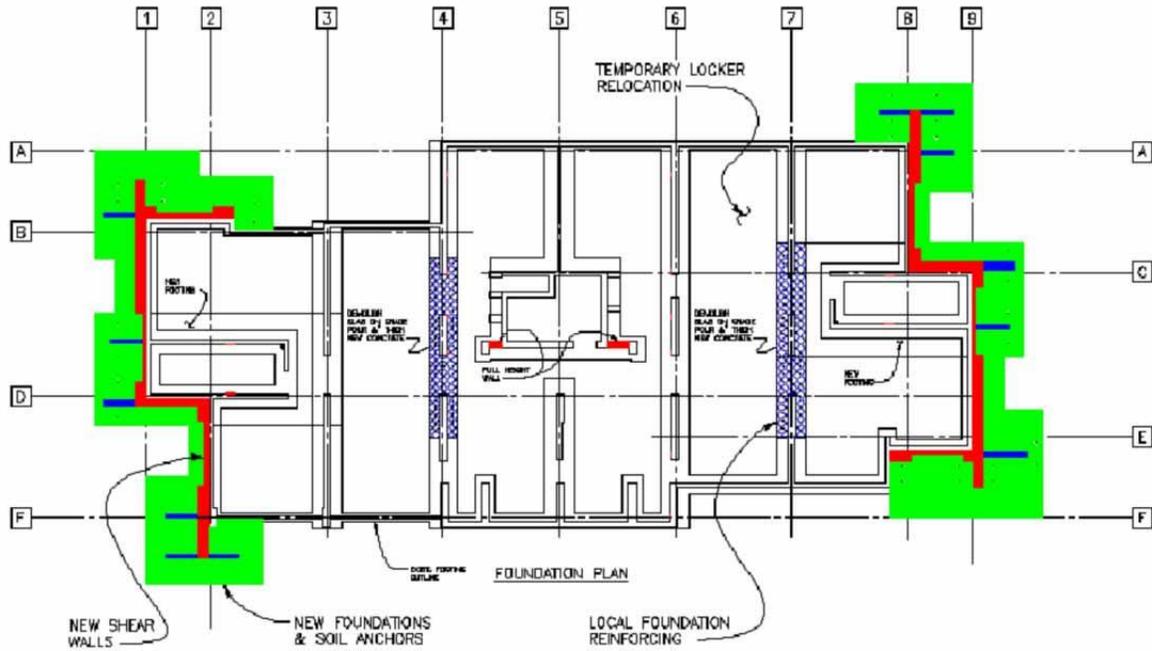
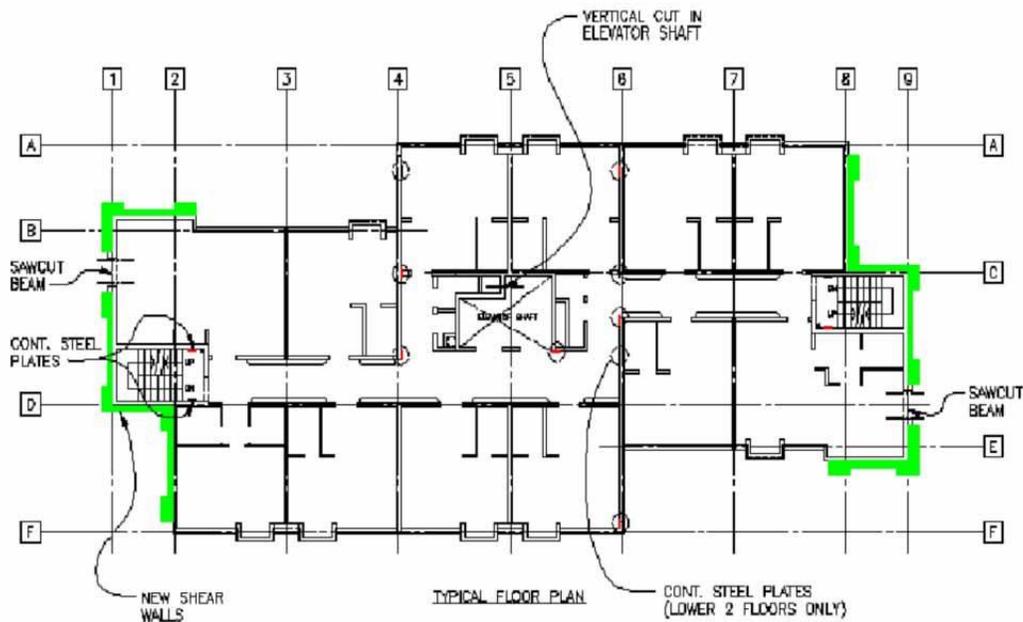
Figure 4 and 5 illustrate the basic concepts of this seismic upgrade.

The seismic upgrade scheme to achieve a performance level consistent with 100% of NBCC 1995 seismic provisions includes:

1. Improve the foundation capacity by adding soil anchors at the four corners of the building (foundations of walls 11, 12, 13 & 14) and the foundations of stairwells and elevator core (wall 10), to improve their base fixity to be consistent with the desired load path.
2. Increase the tension capacity of the connections of North-South walls at second floor to the walls below where openings exist (walls 3, 4, 5, 6 & 8).

3. Improve the bending capacity of the elevator shaft (wall 10) by adding steel plates dowelled into the existing walls (from foundation up to L-6).
4. Improve the tension capacity of the 4 ft long wall segments beside the stairwell door openings (in walls 11 and 12) using steel plates (from L-2 up to L-10).

5. Add transfer beams under the walls mentioned in item 4 at level-2, where the walls are discontinuous.
6. Isolate the 3 ft high up-stands under the window openings on (beams 1 and 2) from the adjacent walls to eliminate the coupling of the adjacent walls. This will:

1. Add a new reinforced concrete shear wall to the exterior of walls 11, 12, 13, 14 and dowel into existing walls at floor levels, from foundation to L-10. Foundation work will be required.

2. Retrofit of walls 11, 12, 13 & 14 up to L-16.
3. Additional external steel plates at the ends of the walls 3, 4, 5, 6 & 8, from foundation to level-3, to enhance flexural capacity.

4. The walls of the elevator shaft were cut to reduce stiffness and therefore to reduce the forces acting on these walls to the level where upgrade to these walls was not required. The new external shear walls were designed to take the forces released from the elevator shaft.

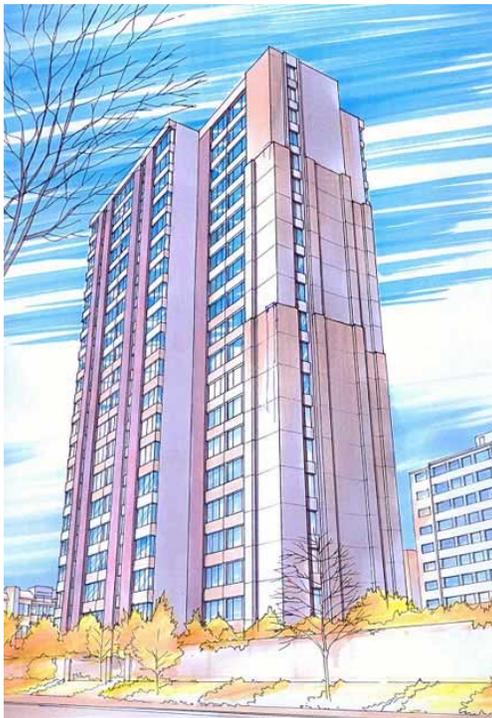
Figure 6 Upgraded Building Overview as envisaged by the Architects

5. Figures 6 and 7 illustrate the building with the additional walls attached to the existing walls. Figure 8 shows the original walls with the dowels required to transfer the seismic forces to the new shear walls.

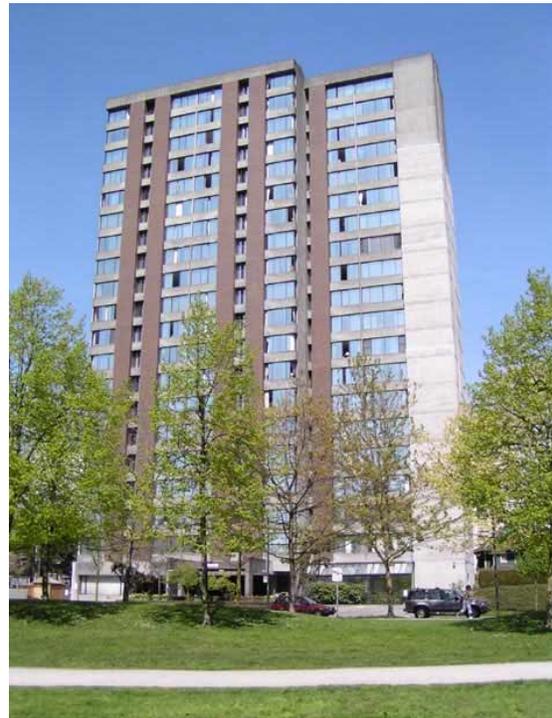
Figure 7 Upgraded Building Completed

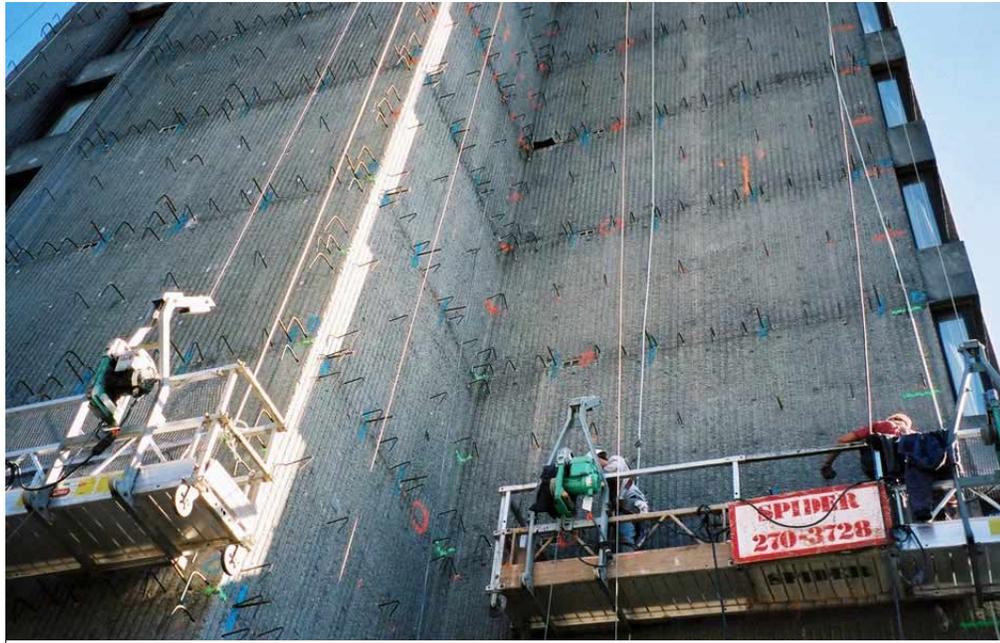
Figure 8 Existing Walls and Dowels
