Performance of Traditional Arches and Domes in Recent Iranian Earthquakes

T. MAHDI¹

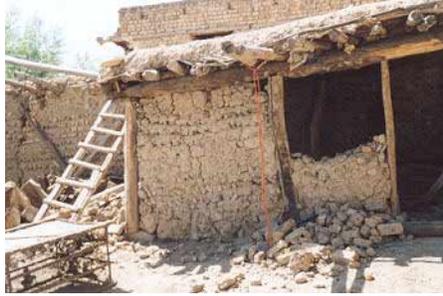
- (3) A system similar to that in (2) but roofs are fixed to wooden columns within the wall. This system has some similarity to the confined masonry wall system, which consists of tie columns and beams. This system has proved its ability to resist earthquakes in the past. As shown in Figure 2, even by using thin irregular members, this system has prevented the collapse of the roof. However, and to have an ideal system, it is quite vital to provide suitable connection details. This system is mostly used in the mountainous areas and in some special buildings in large cities.

Figure 2: A typical traditional building with wooden beams and columns in western Iran after the 2002 Avaj's earthquake.

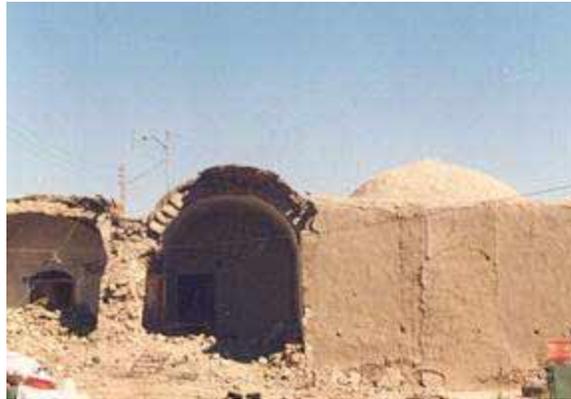
The two main types of vaulted roofs in the earthquake-stricken area were domes and barrel vaults. These roofs are shown in Figure 3. Adobe bricks and mud mortars with thickness not less than 25 cm were used to build the vaulted roofs. In some cases, and as has been reported by Hankuno [5], the thickness of some vaulted roofs were more than one meter. Burned bricks were also used for some vaulted roofs in the area. In a circle of 16 km radius around the village of Ardekul, where the earthquake had its highest intensity, adobe houses with vaulted roofs were also suffered heavy damages. Most of these failures were due to the weakness of wall-to-wall and wall-to-roof connections. However, and as reported by Hakuno [5], some of these buildings had remained stable and the vaulted roofs had not been collapsed. This phenomenon was also observed in other villages in the southern part of the earthquake-stricken area [5].

Some of rural houses in the area had barrel vault roofs. Such a vault is usually restricted to a relatively narrow width as shown in Figure 3. In traditional buildings, and due to the lack of ring beams between roofs and walls, walls carry all vertical and horizontal forces. As the finite element analysis shows, the failure of these types of structures is resulted when excessive displacements perpendicular to the vault generator occurred.

Figure 3: Typical adobe buildings with vaulted roofs in eastern Iran.

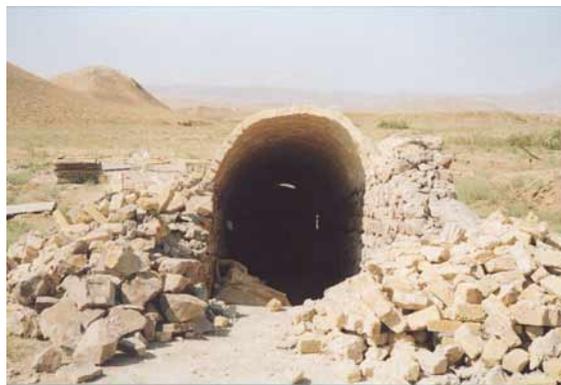
Although most of the buildings in this mountainous area having flat roofs, the existence of masonry buildings with vaulted roofs had also been observed. As an example, Figure 4 shows a brick masonry storage building with vaulted roof that is situated three kilometers from the surface faulting. In this

particular case, the lateral load direction was parallel to its generator (longitudinal direction) and the performance of this roof was excellent. Beside residential and storage buildings, the domes of many mosques, holy shrines, and towers were among the affected buildings by this earthquake.

Figure 4: A masonry barrel vault, 3 km from Avaj's fault, western Iran

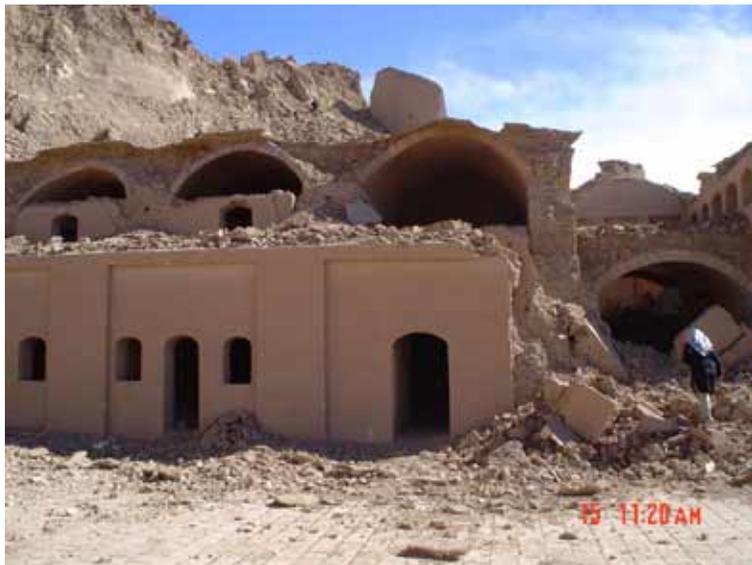
resultant forces within the central part. It is clear from Figure 7 that this later condition has not been met. Many of the buildings that survive the earthquake have successfully fulfilled these rules as shown in Figure 6.

Figure 6: The north-south wall of the military barrack in Arg-e-Bam.

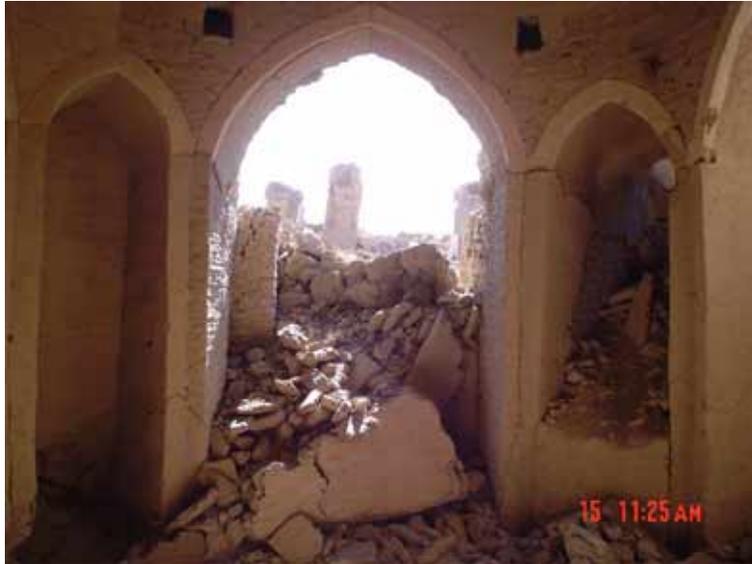
The arch can have many architectural and structural functions. In the traditional Iranian architectural system, arches are used to face the central courtyard of the building, as shown in Figure 5. The small arches shown in this figure is merely a facade that is hiding the real structure behind it and merely worked as a shear wall. For the arches perpendicular to this direction, a complete separation between the facade wall and original structure had occurred, which led to partial failure of these walls as shown in Figure 6. As a structural component, and as shown in Figure 7, arches are used to transfer loads from a dome to its pillars. In this structure, arches of different sizes and shapes have been assembled to fulfill this function. It is clear from this figure that earthquake forces had led to serious sliding and opening of joints in the pillars. This partial failure was caused by the unbalanced thrust transmitted from the adjacent arches. This problem was observed in single-span vaulted roofs as well. To resist the horizontal seismic movement, the joint between the arch and the pillar must be inclined and the pillar must have enough width to keep the

Figure 7: Arches used to transfer loads from a dome to its pillars.

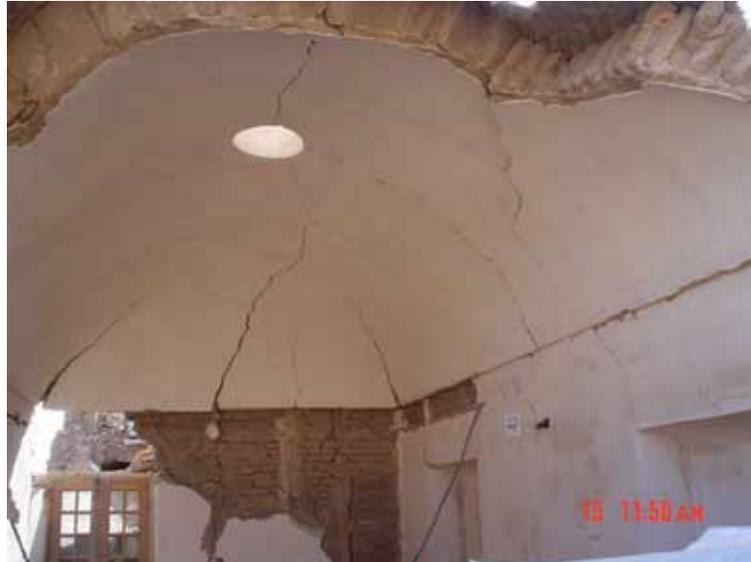
The surviving roofs can be seen all over the city and even at short distance from epicenter. In Arg-e-Bam, many barrel vaults were destroyed in the earthquake. However, others had shown good behavior even when the direction of the movement was perpendicular to their generators. Although it is very difficult to understand the reason of this good behavior, it has been noticed that the thickness of buildings' roofs inside Arg-e-Bam is much less than the corresponding ones inside the city. Other reasons like site effect may also be responsible for this behavior. Figure 8 shows another example of such roofs. It can be seen from this figure that bearing walls had minor cracks compared to those appeared in the roof. The pattern of cracks in the roof indicates clearly that some vertical forces were applied to it. That can be explained by the high vertical acceleration component of this earthquake. Furthermore, some new masonry buildings in the city of Bam had been constructed using barrel vaults as their roofs. These roofs were connected well with the wall by ring beams. With the exception of minor failures and some cracks, these roofs performed satisfactorily. The failures and cracks observed were mostly concentrated at regions in the neighborhood of the intersection line of the barrel vault with the end cap.

Figure 8: A barrel vault with cracks in Arg-e-Bam

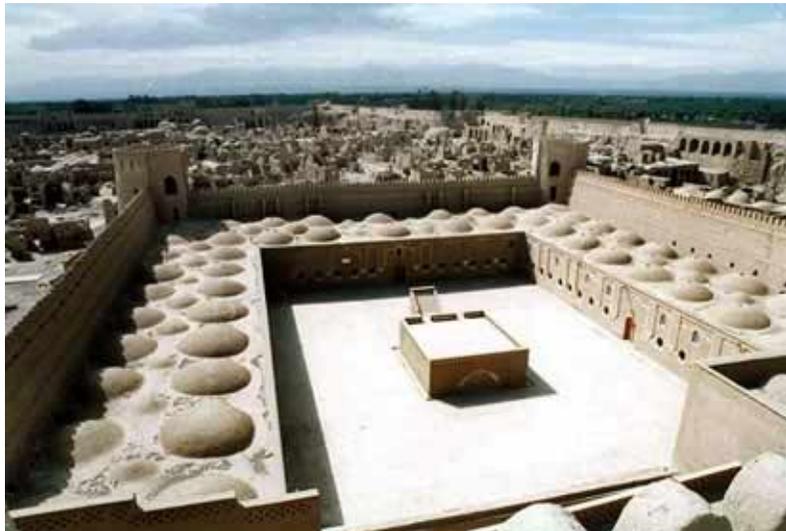
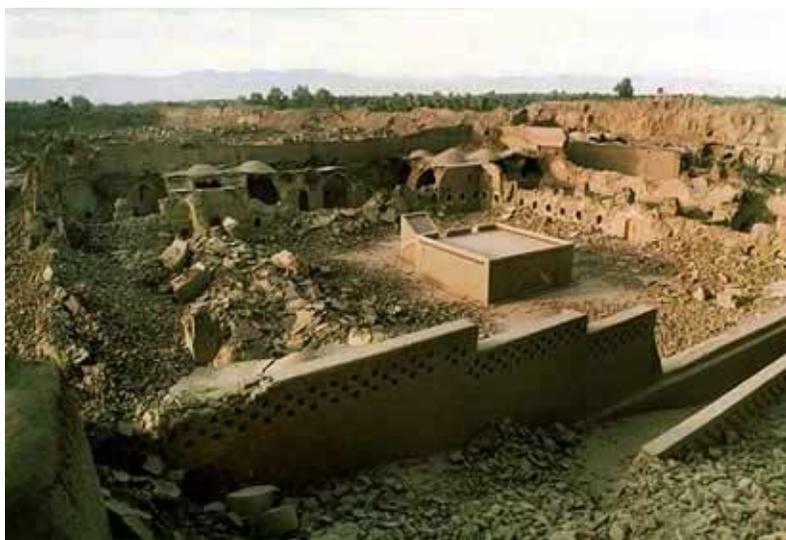
In the majority of cases, a complete destruction of adobe buildings including their domes was observed. An example of such destruction is shown in Figure 9. This figure shows the stable courtyard inside Arg-e-Bam with many surrounding buildings that have a large number of domes, before and after the earthquake. The majority of domes shown in Figure 9a were destroyed completely as shown in Figure 9b. Supporting walls were also destroyed partially or completely. Although such walls had very small openings, it was the normal forces to the wall plane that had caused most damages. However, it is interesting to note that parts of these buildings that are located in the right corner of Figure 9 had survived the earthquake by taking advantage of their adjacency to two relatively rigid walls. In the author's opinion, the reaction applied by these two walls during the earthquake had increased the capacity of these parts to resist vertical forces applied by the vertical acceleration component. Prominent among the surviving domes in Figure 9, are those shown in Figures 10 and 11. The vaulted roof shown in Figure 11 has been used to support some of these domes. In this figure, additional arched panels had been added to this structure in order to relieve the bearing walls from parts of their loads. Accordingly, each dome is supported on two arches and two walls. In Bam's earthquake, the forces applied were perpendicular to the arched panels and parallel to the wall. Arches in this case had fulfilled the role of bracings in inactive walls and distributed the loads between active walls to prevent partial failure. The dome-arched panel system shown in Figure 11 is quite similar to that shown in Figure 10. The direction of movement during this earthquake was also parallel to the walls and perpendicular to the arch panels. As it is clear from Figure 11, one of the arches had suffered minor failures. This failure reflects the disability of the arch panel to transfer forces between active walls.

Figure 9b: A courtyard in Arg-e-Bam after earthquake.
