THE LIQUEFACTION AND FLOW OF VOLCANIC SEDIMENTS AT HANOÇAYIRI INDUCED BY THE MAY 1, 2003 BİNGÖL EARTHQUAKE

Reşat ULUSAY¹, Ömer AYDAN², Masakatsu MIYAJIMA³

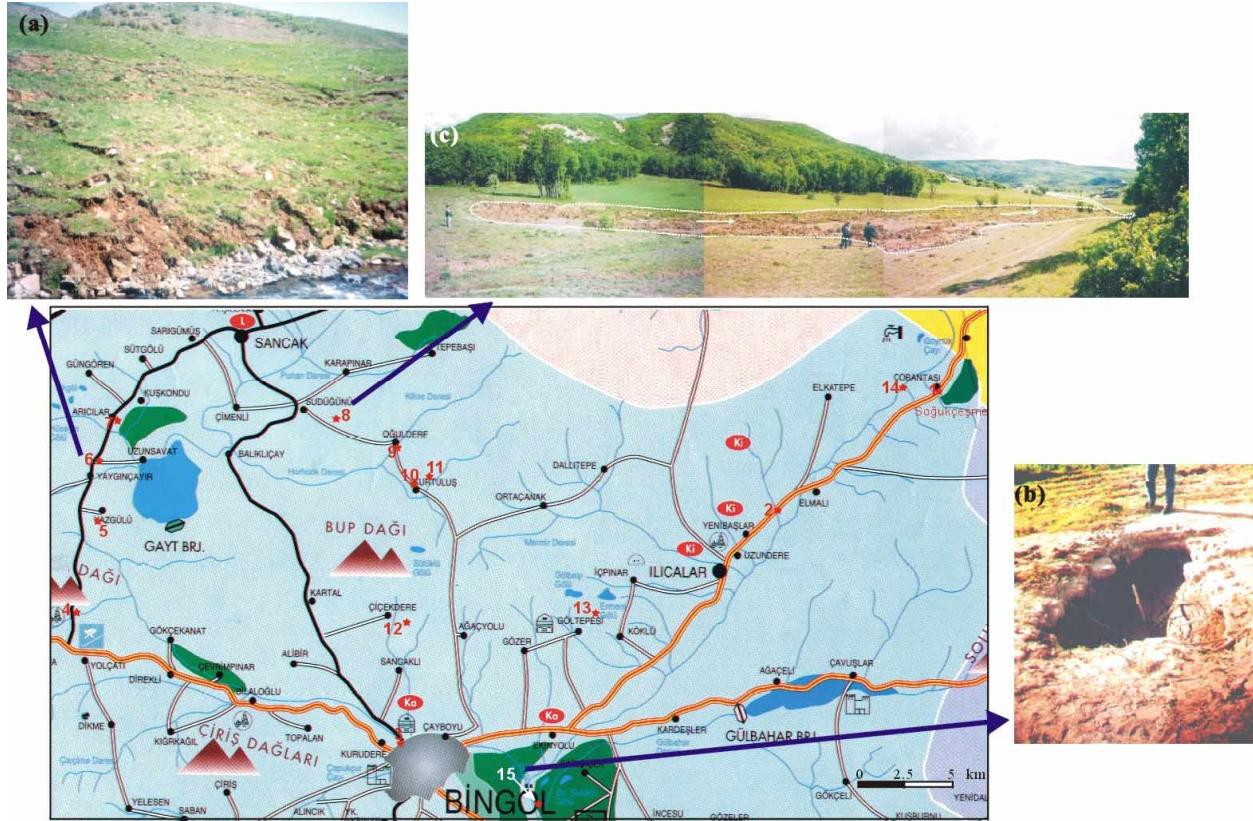
Since these deformations occurred in rural areas, they did not cause any structural damage. A small lateral spreading near Yaygınçayır village occurred on a stream bank with an inclination of about 10° - 15° (Figure 2a). The failure pattern and a local sand accumulation suggested that this failure could probably be due to liquefaction. At this location, the displacements due to lateral spreading in three zones with a total width of 60 m ranged between 16.5 cm and 30 cm, respectively. Very local sand boiling also occurred at Bingöl Plain at a field consisting of alluvial deposits (Figure 2b). The second but a significant lateral spreading occurred at a location called Hanoçayırlı, which is located very close to the epicenter of the earthquake (Figure 2c). It was typical and interesting particularly due to type of the failed material, which is the weathering product of tuffs. In this study, this ground deformation is described evaluated. In addition to deformation measurements taken at the site, two geotechnical boreholes were drilled and goemechanical laboratory tests were performed both on the ejected and flowed materials, and SPT samples. Back analysis of the liquefaction was carried out to estimate the minimum value of the a_{max} which might have caused to initiate liquefaction.

1,2,3,5,9: Rotational slide; 4,7,10,12,13: Rock fall; 6,8: Liquefaction and lateral spreading; 1,14,8: Flow; 15: Liquefaction
Figure 2. Locations of the liquefaction and liquefaction-induced ground failures: (a) lateral spreading near Yaygınçayır village, (b) liquefaction at Bingöl Plain, and (c) lateral spreading and flow failure at Hanoçayıri.

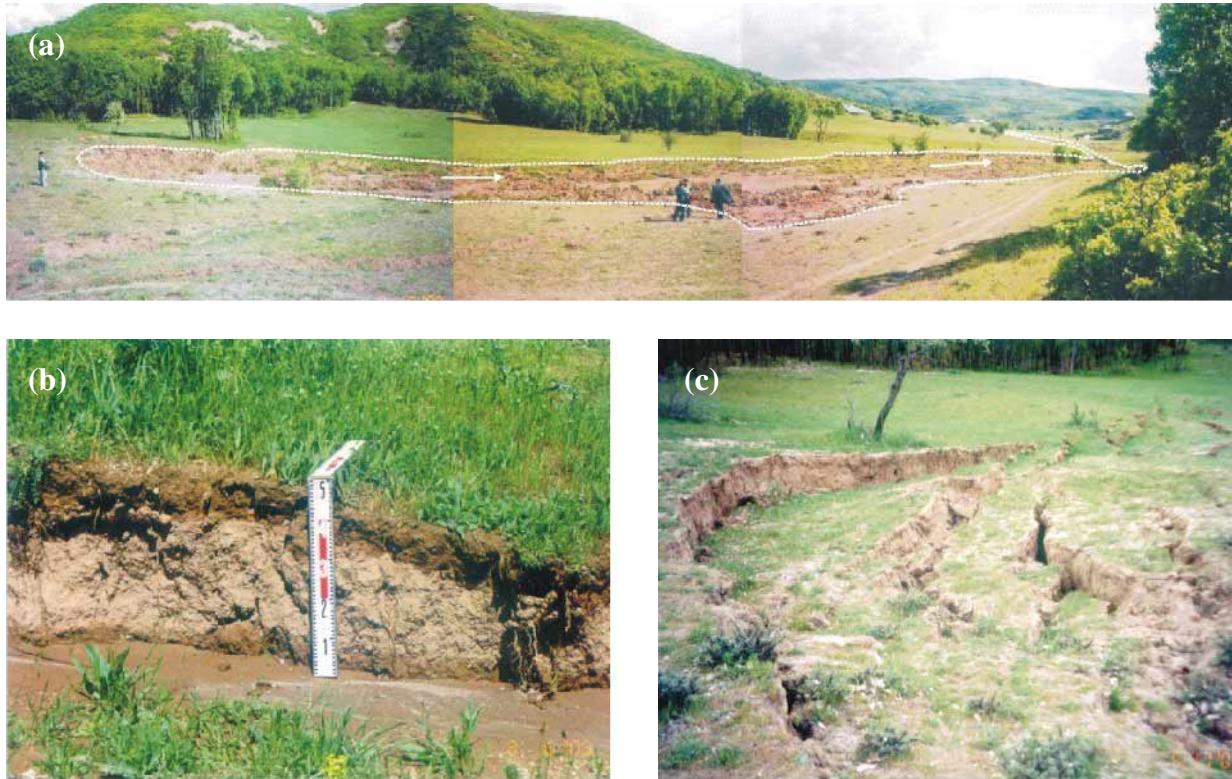
During the 2003 Bingöl earthquake a lateral spreading occurred at a location called Hanoçayırı, which is very close to the epicenter. It is surrounded by topographical undulations consisting of white-to-beige colored tuffs. Silt and sand sized loose surficial material, which is the weathering product of the tuffs, cover the lower altitudes. The presence of this shallow-seated, silt and sand sized, non-plastic material and shallow groundwater table, which was evident during site observations at a water well very close to the failure, resulted in highly susceptible environment to liquefaction. Inclination of the ground was about 3^0 - 4^0 , where liquefaction-induced lateral spreading was transformed into a flow type movement (Figure 5a). The loose surficial material, which was saturated due to heavy rains occurred within two weeks just before

the earthquake, transformed into a flow and flowed down in S55W direction about 300 m and then directed towards SE. A set of ground fractures associated with lateral spreading, which was resulted in 30-35 cm vertical drops (Figure 5b) and separations of 10-20 cm in the ground behind the crest and near the flanks of the failure (Figure 5c), was observed. The total amount of the fracture separation was estimated about 1 m from the measurements taken at the crest and its vicinity. The length, width and maximum depth of the flow were approximately 600 m, 35 m and 3 m, respectively. Traceable sand accumulations, observed near the eastern flank of the failure and in the lateral spreading area, were evaluated as the indicator of liquefaction.

Figure 5. (a) A general view of the lateral spreading and flow at Hanoçayırı, (b) vertical drops and (c) separations due to lateral spreading.

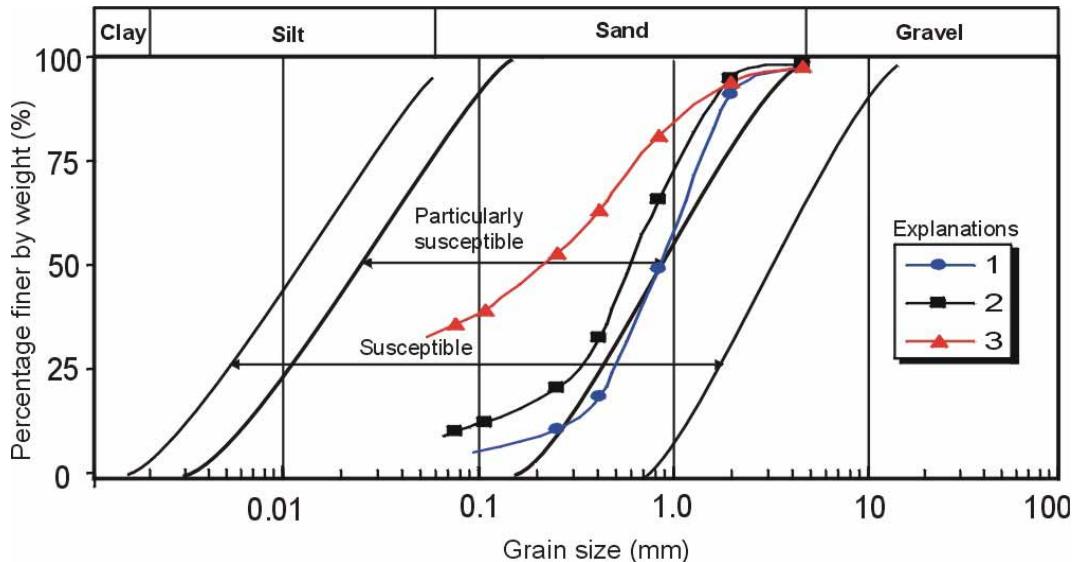
Specific gravity of two ejected and one flowed soil samples was obtained as 2.5 and 2.4, respectively. Grain size distribution curves of these samples were plotted onto the grain size distribution of liquefiable soils proposed by Japan Port and Harbor Research Institute [11]. It is evident from Figure 6 that sand sized material with fines content of 7-12 % (SP group soil) is dominant in the liquefied soil, and the flowed surficial material involves slightly greater amount of fines (SM group soil). However, all the samples fall into the limits designated by most liquefiable. Three specimens prepared from each sample obtained from the surface were tested in shear box at a shear strain of 0.25 mm/min. Failure envelopes of

Figure 6. Grain size distribution of the ejected (samples 1 and 2) and flowed (sample 3) material.

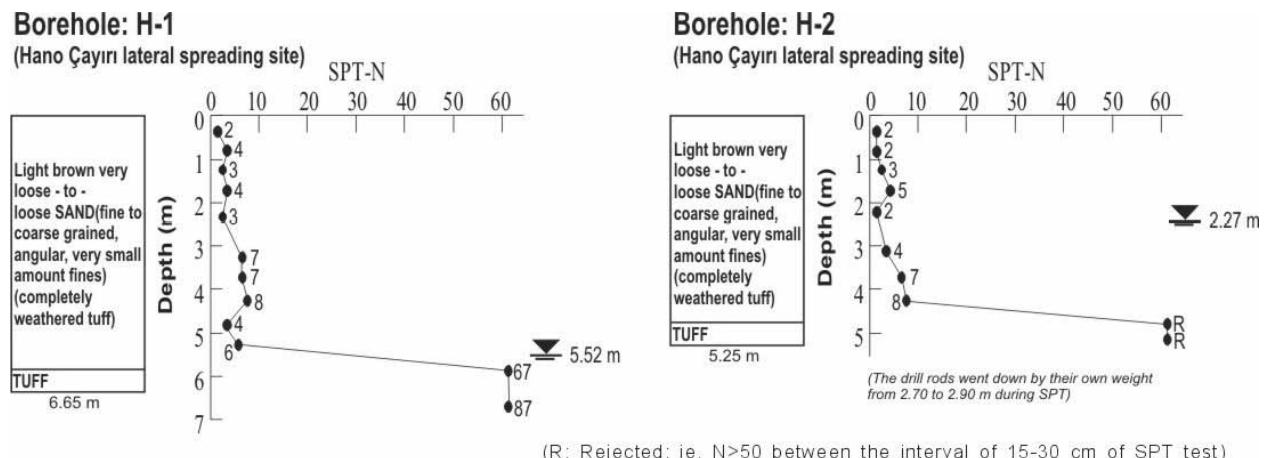
As noted from the simplified geotechnical borehole logs (Figure 7), the uppermost level of the sequence, approximately between 0 and 5.5 m, consists of light brown-to-beige, very loose-to-loose sand size material originated from the tuffs. This material is moist-wet, fine-to-coarse grained, and involves angular-sub angular grains with some fines. SPT tests were carried out at every 50 cm interval throughout both boreholes. In this material, very low SPT-N values, which ranged between 2 and 8, and generally between 2 and 4 near to the surface, indicated a very loose state suitable for liquefaction. The bedrock (fresh tuff) lies about 5 m from the surface. The groundwater table was 5.5 m and 2.25 m at the time of drilling (4 weeks after the earthquake) at the locations of boreholes H1 and H2, respectively. If the relative elevations of both boreholes and topographical inclination are considered, it can be concluded that position of the groundwater table was nearly parallel to the surface at the time of drilling. However, it is expected that depth of the groundwater table could have been shallower during the earthquake than that measured from the boreholes, probably due to heavy rains occurred within two weeks before the earthquake.

Figure 7. Simplified geotechnical borehole logs at Hanoçayı.

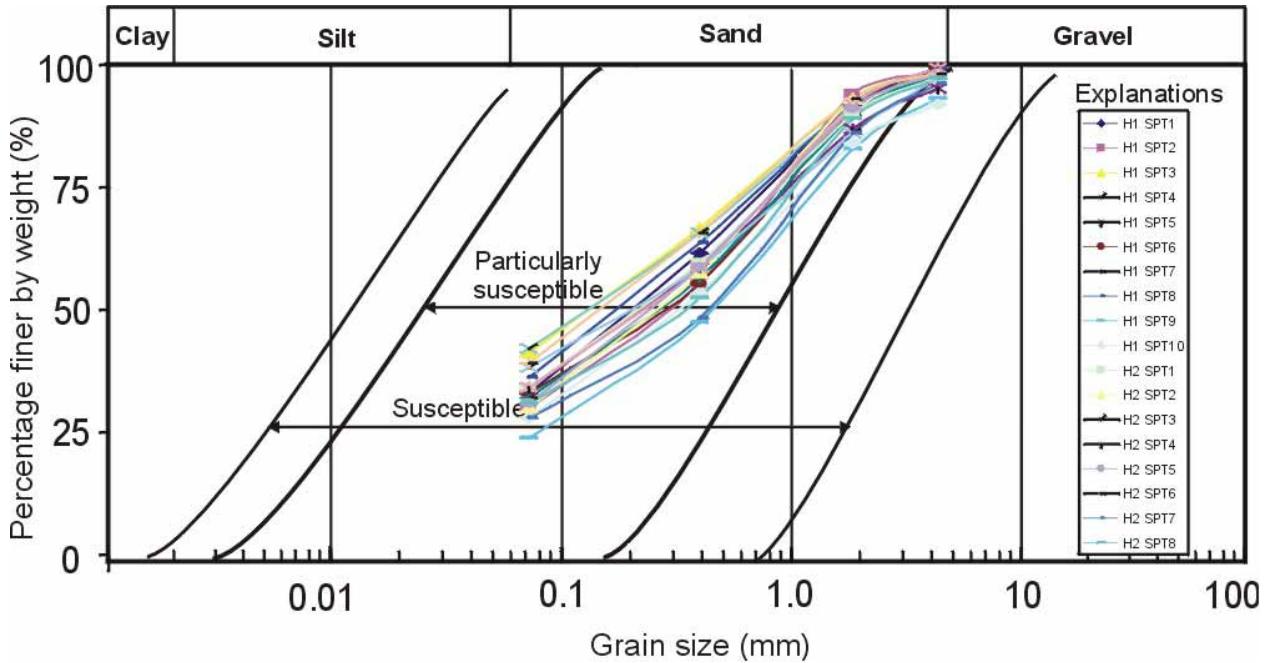
The laboratory soil classification tests on the SPT samples suggest that the loose and shallow-seated material overlying the bedrock falls into SM group, which is defined as silty sand. This material also includes silt and clay sized fine grains in the range of 24-43 % with ignorable amount of gravel, and shows a close similarity to those of the soils collected from the ejected and flow materials. Figure 8 depicts the grain size distribution range of the SPT samples from both boreholes. These samples fall into the limits designated by most liquefiable.

Figure 8. Grain size distribution of the SPT samples.
