RECONSTRUCTION, SEISMIC STRENGTHENING AND REPAIR OF THE ST. ATHANASIUS CHURCH I LESHOK – CASE STUDY

SUMMARY

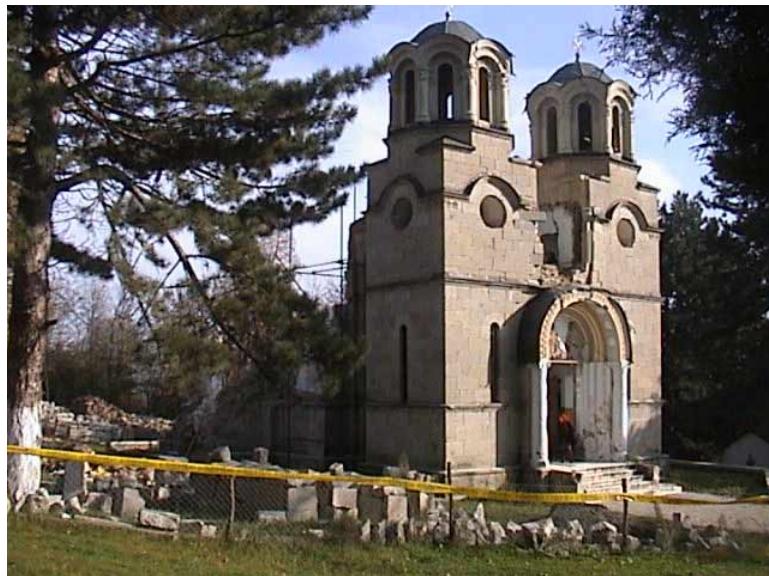
The armed conflicts that took place on August 21, 2001 led to almost complete destruction of the part of the naos with the two side conches (main central part), the altar part and the part of the narthex over the terrain level, with some remains of the facade walls, whereas the part with the belfry still exists but is characterized by severe structural and nonstructural damage, (Fig.2).

Figure 2. Damage to the belfries, northwest view

The vaulted structure over the gallery area is completely torn down, while the only remains of the floor structure are the timber floor beams with visible deformation of wood. In the part of the two preserved belfries, there are visible large cracks along the height of the bearing walls, in the staircase area, the walls of the tambours and the domes with a width of over 2 cm (Fig. 2 - 4).

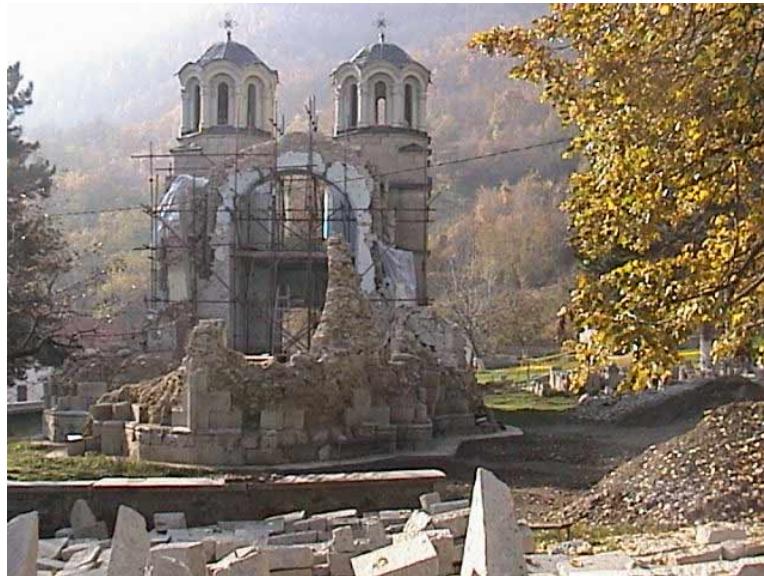
Figure 3. Damage to the vault in the narthex

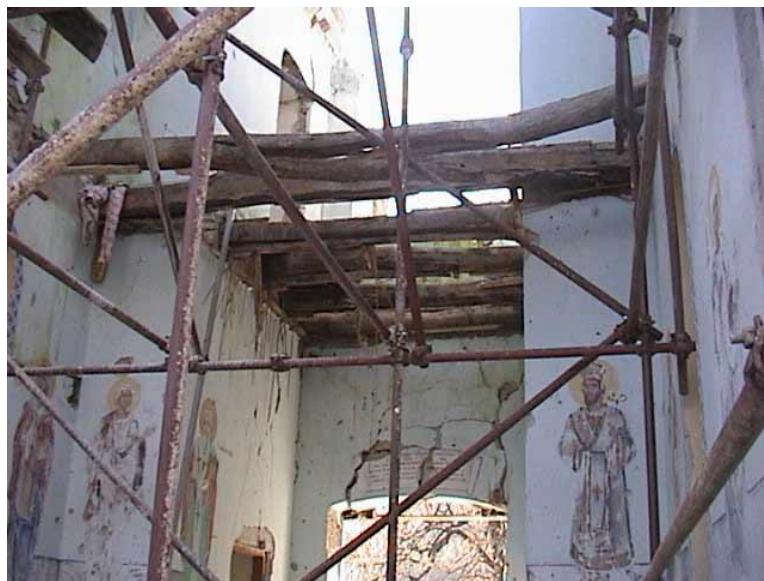
Fig. 4. Damage to the floor structure

1. For the damaged existing part of the structure, a *concept for repair and structural strengthening* up to the necessary level of seismic safety has been adopted considering the purpose of the structure and the justification (architectural-conservatory) of preservation of its integrity. The solution for repair and structural strengthening anticipates (i) injection of all the cracks and (ii) incorporation of strengthening elements (vertical RC jackets along the inner side of the walls of the staircase core and the columns of the tambours, horizontal RC belt courses at the level of the floor structure and at the base of the domes, RC slab below the floor level, as well as steel ties besides the timber beams in the floor structure of the gallery, (Figs. 5 and 6);
