THE 1ST OF MAY 2003, BINGOL, TURKEY, EARTHQUAKE, A STUDY OF THE PERFORMANCE OF THE BUILDING STOCK

SUMMARY

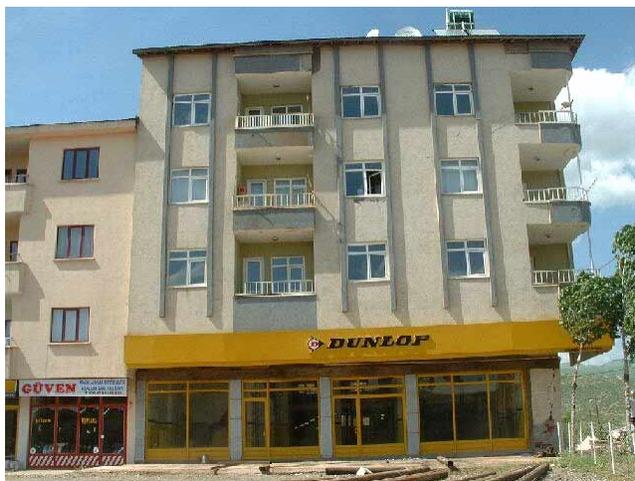
The lack of ductility of the constructions was evidenced by the general lack of significant cracks in the reinforced concrete elements. Fully developed plastic hinges were noted only sparingly, as they seemed to be preceded by shear cracking. This is also a direct consequence of the detailing practice adopted for the reinforcing stirrups in the columns, which offered only light confinement to the core concrete. These therefore failed in a brittle shear mode and were prone to catastrophic failure. Only in a few buildings did the ground storey columns sustain significant shear and flexural cracking together, such as the construction shown in **Figures 8-11**.

Fig. 8 The Dunlop building appears undamaged from the façade

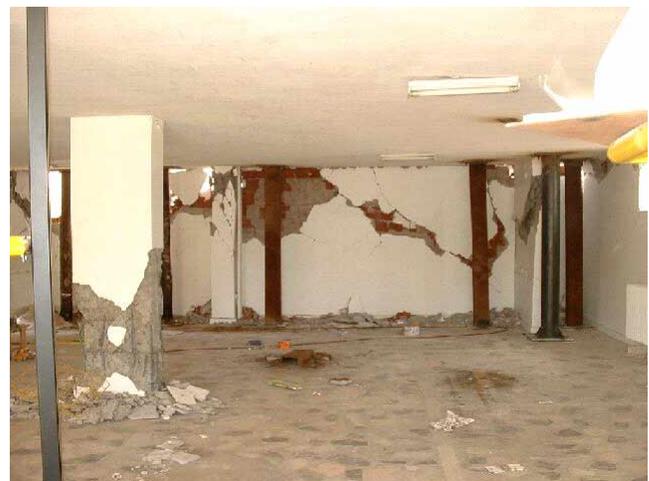
Fig. 9 Shear failure in a column partly due to inadequate reinforcement

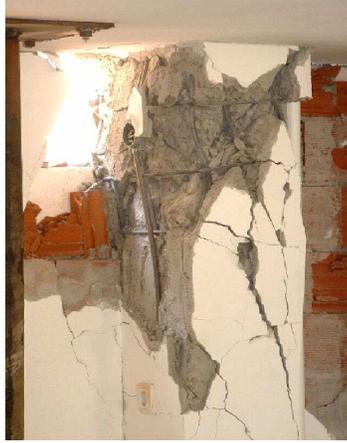
Fig. 10 Short column effect resulting in explosive shear failure

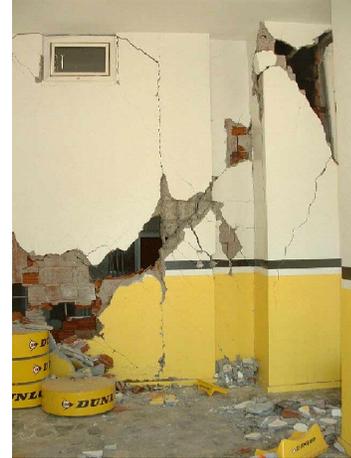
Fig. 11 Shear failure extending from the infills right across the column

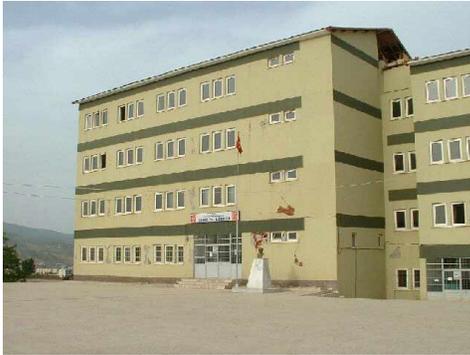
Fig. 12 Bingol Lisesi school

The presence of reinforced concrete shear walls generally ensured that buildings suffered much less damage than for constructions without them, especially when these were combined with small room spans and a regular structure. In Bingol Lisesi school (**Fig. 12, 13**), where the shear walls were used in conjunction with large beam spans and room layouts, they attracted a lot of damage and emphasized the

weak concrete used there, though probably they saved the rest of the building from added damage. Though many government buildings suffered severe damage, as evidenced by the number of schools and police stations rendered unusable, general concrete quality and on-site attention to detail did appear to be better than for the typical beskat.

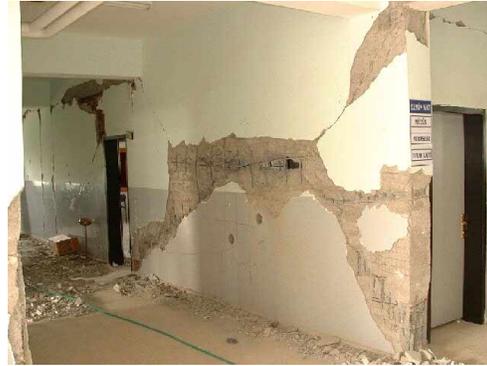
Fig. 13 Damage to the shear wall at Bingol Lisesi
