RECENT EARTHQUAKES IN INDONESIA AND JAPAN: OBSERVED DAMAGE AND RETROFIT SOLUTIONS

H.K.Miyamoto¹, and A.S. Gilani¹

ABSTRACT :

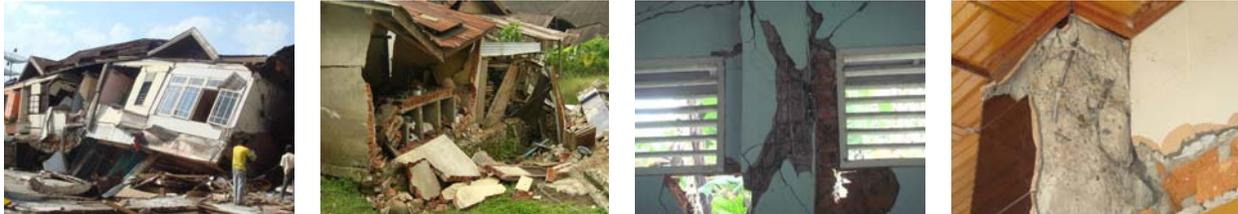
Figure 2. Residential and commercial building damage

URM buildings performed poorly and sustained severe damage and collapse. Concrete bond beams and columns typically occur on the two ends and top of URM infill walls. These concrete members are small and lightly reinforced with smooth bars. They have minimal transverse reinforcement, use poor joint detailing, and do not confine the infill URM. The URM walls do not have out-of-plane connections to roof or floor diaphragms. The wood-frame buildings fared relatively well because they are a lightweight building system. The major issue for wood construction was collapse induced by soft-story response of the first story. Reinforced concrete moment frame structures exhibited shear failure, spalling, and failure at the joints.

Figure 2 shows typical modes of failure observed from this event. They consist of:

- Soft story collapse when the first floor lateral-story stiffness and strength were significantly less than those of the upper floors.
- Out-of-plane failure of URM walls due to lack of adequate floor diaphragms and poor anchorage of the

- walls to perimeter concrete bond beams and columns.
- c) Captive column shear failure resulting from the URM infill reducing the clear height of the columns from story height to the height between solid infill and preventing development of full flexural capacity and inducing brittle shear failure.
 - d) Beam-to-column joint failure due to the lack of ductile detailing (the reinforcement steel not extending sufficiently into the joint, not having adequate development length, and joint not confined).

a. Soft-story collapse b. Out of plane failure of URM walls c. Short column shear failure d. Beam-to-column joint failure

Because this area experiences frequent large earthquakes and because many buildings are constructed near or on the fault line, it is imperative to develop rapid, reliable, and cost-effective seismic retrofit strategies for the typical buildings. Conceptual recommendations are outlined here. For the URM infills and concrete bond beams, it is recommended to strengthen the beam-to-column joints. This will avert the brittle shear failure at the joints and will allow the concrete elements to provide some confinement to infills. Most importantly, they will carry the gravity loading and mitigate the building collapse. To alleviate soft-story and torsional response of mosques and other commercial buildings, either braces or dampers can be added to the first floor of the building. For bridges that are supported at the abutments on inadequate bearing pads, seismic isolation pads provide an attractive replacement alternative. This isolation system will serve to reduce the inertial forces transferred to the substructure. Additionally, a well-designed system with adequate transverse shear keys would prevent the type of failures observed during this earthquake.

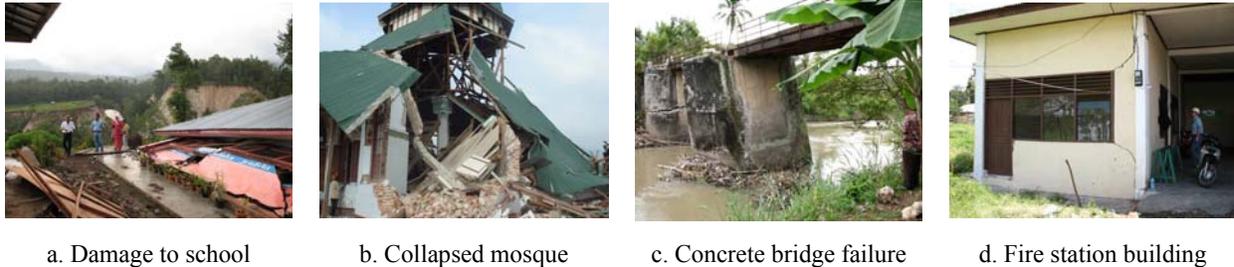
Figure 3. Observed damage to schools, mosques, and lifelines

The earthquake caused substantial damage to school buildings. These buildings used URM wall framing and thus experienced many of the failure modes observed in residential structures. URM school buildings are the most vulnerable structures. More than 700 school buildings were damaged, including more than 300 collapsed buildings. Of these, over 65% of damage was classified as either major or moderate. Foreshocks saved many students' lives. However, two teachers were killed. School buildings sustained structural and nonstructural damage. Figure 3a shows out-of-plane collapse of URM walls. The walls were not adequately anchored to the foundation or roof diaphragm to restrain the URM walls. The Sumatra Fault is shown in the near distance. The roof diaphragm, perimeter concrete beam, and columns were weak. School buildings also sustained nonstructural damage. Some school buildings did not sustain any structural damage, however, the ceiling and soffit collapsed due to the lack of proper design and anchorage and caused life-safety hazards.

Indonesia is the world's most populated Muslim country. Mosques are common in Indonesia. Typical mosque structures use concrete framing consisting of tall, slender columns. URM infills are placed on one (back) side of the building. As such, these buildings experience torsional-translational coupled response. More than 950 mosques were damaged in the earthquake. Approximately 65% of these buildings sustained medium or heavy damage. Had the quake occurred during prayer time, it would have resulted in substantial casualties. Spalling of concrete from tall, slender column at the first-story level and shear failure of the interior URM wall were common failures. Figure 3b shows the collapse of a mosque. The URM walls on the extreme edges of the building collapsed due to the torsional motion.

In this part of Indonesia, many bridges cross the Great Sumatra Fault. Bridges are very important lifelines. After earthquakes, operational bridges are required for emergency access. A two-lane steel bridge close to the epicenter had slid off its bearings at the abutments. The superstructure did not sustain any damage. However, the bridge had an inadequate transverse shear key, and its abutment bearings had insufficient movement capacity. The steel members in this bridge appeared to be undamaged. A three-span concrete bridge close to the epicenter was near collapse after the earthquake. Figure 3c shows failure of piers for the concrete bridge. A heavy deck and bents contribute to high seismically induced force experienced by the bridge, which caused the brittle shear failure in one bent and rocking at another. This bridge is near collapse, and traffic has been redirected.

None of the hospitals was severely damaged during the earthquake. However, a fire station sustained significant damage; see Figure 3d. This one-story building had URM infill and concrete bond beam framing. Because of the damage, the firefighters had to erect tents for shelter.

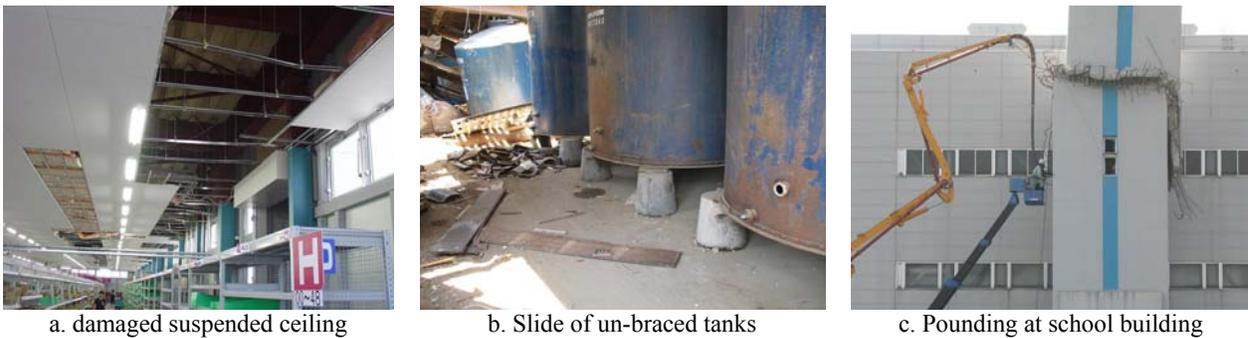
Figure 5. Structural and nonstructural damage to industrial buildings

The Paltac industrial building is a major chemical distribution center. The building is located approximately 30 km from the epicenter. There was no structural damage to the building. The unbraced suspended ceiling system at the third floor sustained significant damage, see Figure 5a. The lay-in acoustic panel fell; the grid system buckled; and connections came loose.

much of the equipment was anchored and performed well. The equipment that was not anchored did sustain damage. As shown in Figure 5b, the storage tanks slid off their supports. Piping and catwalks also were extensively damaged. Many crates of sake tipped over, and full bottles broke. Structural and equipment damage at this facility caused the brewery to lose 50 percent of its production capacity for the remainder of 2007.

The stack of the Kashiwazaki Municipal Recycling Plant building sustained a complete failure, as shown in Figure 5c. This tower is approximately 60 m tall. It has a hollow 4.5-m wide, reinforced concrete, square cross-section. The wall thickness varies from 370 mm at the bottom to 80 mm at top. This industrial facility was constructed in the 1980's using modern Japanese reinforced concrete design. The tower sustained complete fracture at approximately one-third of its height. This is the location of the lap splice for longitudinal reinforcement. The likely cause of failure is the inadequate splice length for the lapped reinforcement.

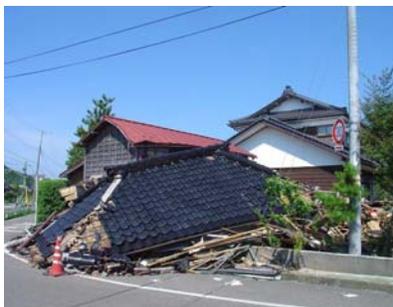
Approximately 1,000 houses totally collapsed because of the earthquake. Most of the collapses were the older, traditional Japanese wood structures (Figure 6) or buildings with soft stories (Figure 7) at the first floor created by a garage or storefront. The damage to modern residential buildings was not extensive. Traditional Japanese wood-frame construction is of post and beam construction, no shear walls, or braces are provided, and, as a result, these structures have been severely damaged in every significant earthquake.

Figure 6. Collapsed house

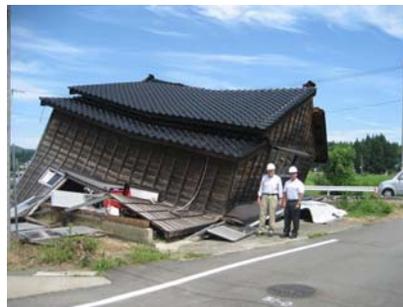
Figure 7. Soft-story failure

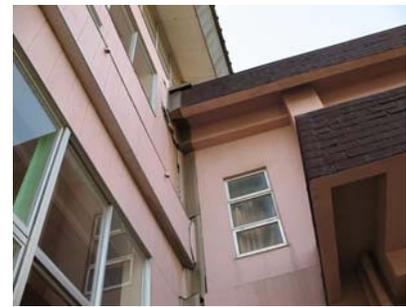
School buildings in the affected region did not have major structural damage. This outcome was true especially for buildings retrofitted with shear walls. One type of observed damage was pounding of buildings against adjacent units. This type of damage was worse when adjacent structures had floor slabs located at different elevations (Figure 8). This type of pounding can damage building columns and compromise a structure's gravity and lateral-load capacity. Following the current building code recommendations and providing either an adequate seismic gap or continuity between adjacent buildings can mitigate pounding.

Figure 8. School building

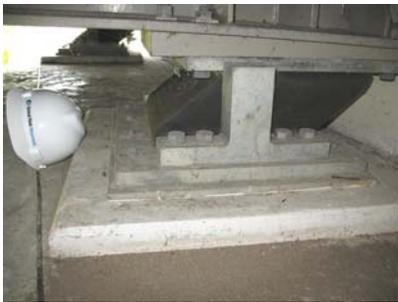
The most significant damage to bridges occurred on the Toyota Bridge. This three-span concrete structure is supported on isolation bearings at abutments and piers. Following the earthquake, the isolation system

experienced large longitudinal and transverse inelastic deformations, as shown in Figure 9. The deformations resulted from soil failure that caused large movement of abutments. For the Nagomi Bridge, the reinforced expansion joint at the abutments closed, and the joint filler material was extruded. Niigata Airport temporarily closed its runways immediately after the quake to check for damage, according to airport officials. Bullet trains stopped services in northern Japan temporarily after the earthquake. East Japan Railway Company temporarily halted train service on the Tohoku, Joetsu, and Nagano Shinkansen lines. Derailments of local and freight trains occurred, but no one was injured. Many cracks and ruptures were detected on the Hokuriku Expressway and other local roads (Figure 10). The road failures are attributable to the poor underlying soil conditions.

Figure 9. Toyota Bridge

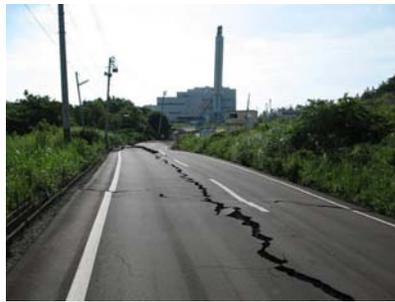
Figure 10. Ruptured roadway

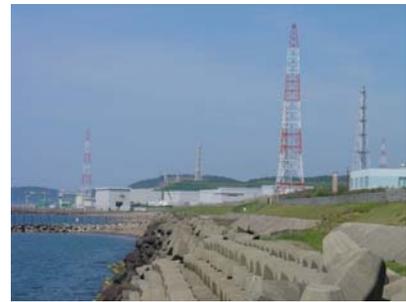
Figure 11. KKNPP Power Plant

The quake halted gas, electricity, and water service, and it interrupted telephone service. Substations generally fared well during the earthquake, the transformers, bushings, and other components performed well. Earthquake damage to substations and distribution towers was typically caused by the settlement of underlying soils. The Kashiwazaki-Kariwa Nuclear Power Plant (KKNPP) is the world's largest nuclear power generation facility. It is along the coast of the Sea of Japan, which is used to obtain the plant's cooling water, see Figure 11. The plant is owned and operated by the Tokyo Electric Power Company (TEPCO), the world's third largest electric utility company. The plant consists of seven reactors and the electric output of the plant is more than 8,200 MW; sufficient for approximately 30 percent of Japanese households. The earthquake was the largest seismic event ever to hit a nuclear power plant. During the earthquake, the strong-motion sensors recorded peak rock acceleration of over 0.5 g nearly twice the ground shaking considered in design. The only observed damage was nonstructural. It consisted of the following: damage to equipment systems outside the safety-related areas of the plant; one of the transformers caught fire, which was quickly extinguished; damage to a ceiling crane in the No. 6 nuclear reactor building; and damaged suspended ceilings in one of the office buildings. TEPCO had initially reported that there was no radiation leak, but later the company said that contaminated water reached the Sea of Japan, with no effect on the environment. The amount of contaminated water was estimated at 1,200 liters. The company also said that a small amount of radioactive matter had been emitted into the atmosphere.

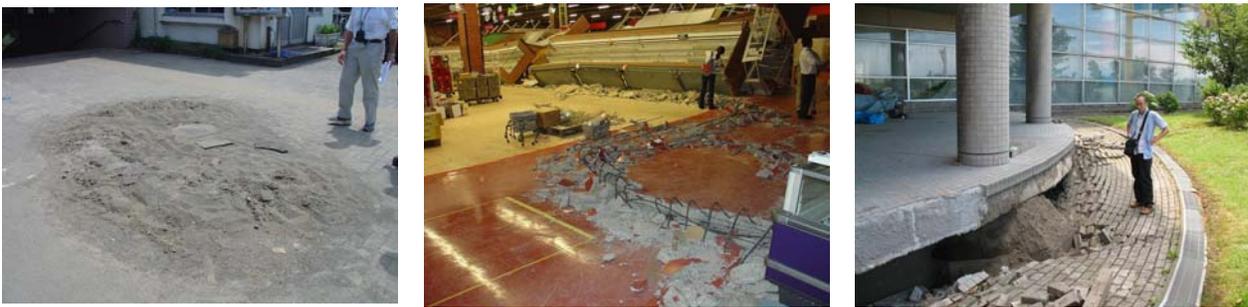
Figure 12. Geotechnical and foundation damage

Much of this region of Japan is situated on poor, liquefiable, sandy soil. Major liquefaction in earthquakes in both 1964 and 2004 led to extensive damage. The poor soil condition also caused damage during the 2007 event. Figure 12a shows liquefaction boil. The landslide was extensive and affected residential buildings as well as a major roadway. Slope instability caused damage to and closure of a major transportation artery in this area. The largest building in the affected area had an unusual concrete mat foundation that was severely damaged; see Figure 12b. Differential soil settlement caused structural damage to many buildings. In many cases, there was no major superstructure damage, but the underlying soil had settled significantly. Figure 12c shows a building supported on a pile foundation. Note that the building columns supported on piles have not settled. The adjacent area, however, experienced settlement of 300 mm or more.

a. Soil liquefaction and boil

b. Abutment sliding

c. Soil settlement

accelerations experienced. However, there was significant damage to the ground around typical buildings, including some stunning failures of surrounding fills and backfills. The damage caused extensive business interruption for commercial buildings. Given the poor and liquefiable soil in this area, two options are feasible for important structures: either use pile supports that extend to competent soil below, or the underlying soil should be strengthened to avoid this type of damage. The nonstructural damage can be mainly attributed to lack of adequate bracing and anchorage. Adding proper anchorage is a cost-effective mean of reducing damage and the resulting BI.
