## LESSONS LEARNED FROM THE OCTOBER 15, 2006 HAWAII EARTHQUAKE AND THE AUGUST 15, 2007 PERU EARTHQUAKE

Qisong “Kent” Yu<sup>1</sup> and David Gonzalez<sup>2</sup>

<sup>1</sup> Associate Principal, Degenkolb Engineers, Portland, Oregon, USA

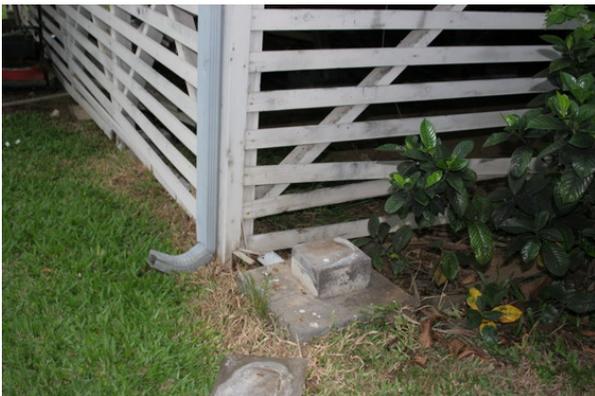
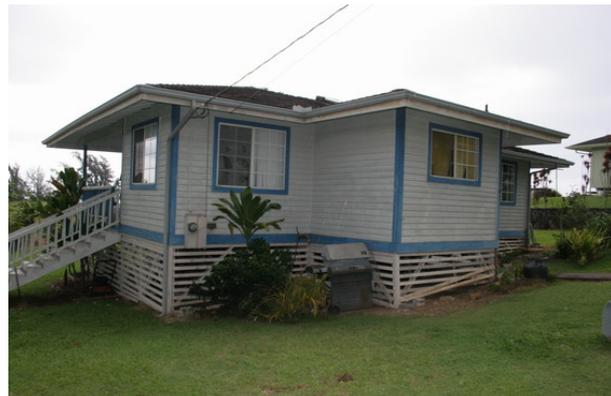
Residential construction in the rural part of North Kona normally consists of wood construction very similar to that used in the mainland United States. However, due to termite problems, the first floor is elevated from the ground a few feet. The first floor is normally supported on a wood beam and post system founded concrete blocks colloquially referred as "tofu blocks". Most of the structural damage observed in residences consisted of "soft-story" deformation and the displacement of the wood posts off the concrete blocks. Figures 2 and 3 show typical residential construction and damage.

Figure 2 – Typical residential construction

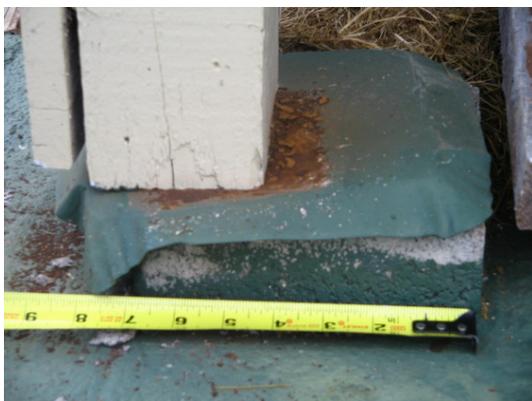
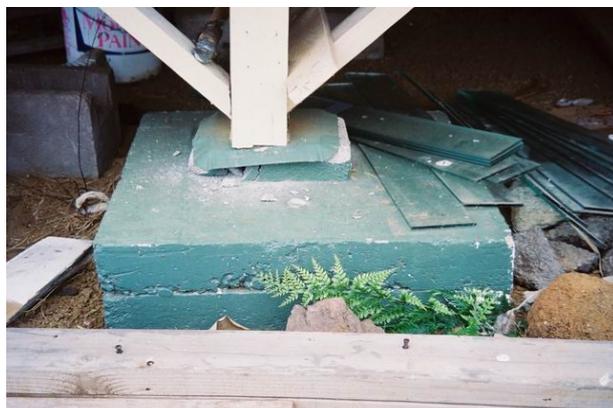
Figure 3 – Wood posts displaced out of "tofu blocks"

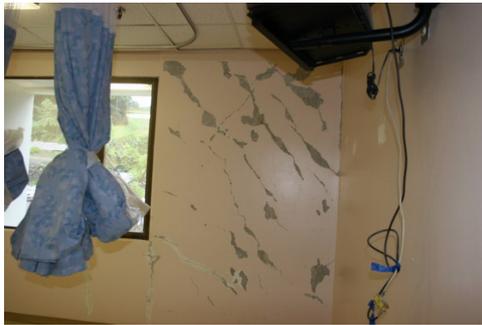
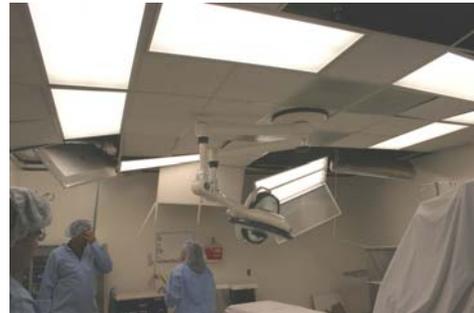
Engineered structures also suffered structural and nonstructural damage. Modern hospitals like Kona Community Hospital, North Hawai`i Community Hospital and Hale Ho`ola Hamakua experienced minor structural damage and moderate nonstructural damage. Kona Community Hospital is a 94-bed hospital was constructed with concrete frames and reinforced concrete and masonry shear walls. Although it does not appear the hospital was detailed to perform in a similar manner to those medical facilities located in California and Western, the construction type is commonly used in many areas of the United States. The nonstructural damage consisted mostly of fallen ceiling, lights and some partitions as shown in Figure 3. Hale Ho`ola Hamakua is a nursing care facility with several one-story reinforced concrete and masonry shear wall buildings. The building was constructed in the mid-1990's and suffered minor structural damage and moderate nonstructural damage. Most of the nonstructural damage was due to the lack of seismic detailing of ceiling systems and bracing of heavy contents.

Figure 3 – Kona community hospital structural and nonstructural damage

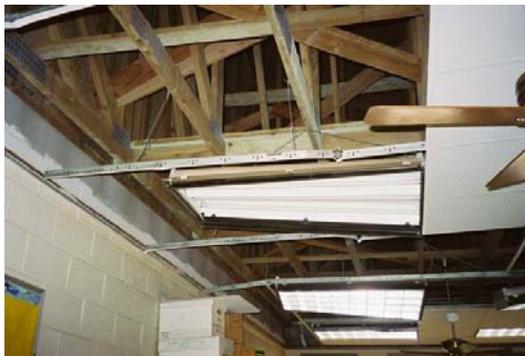
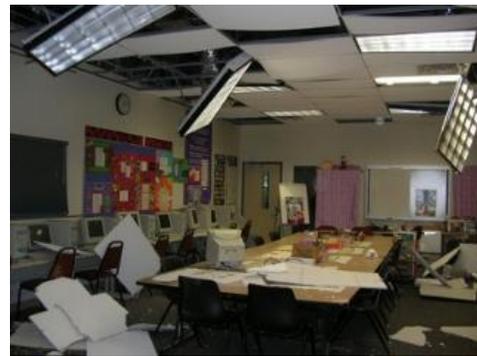
Schools in the North Kona area suffered minor structural damage and moderate to considerate nonstructural damage. Fortunately, there were only very few minor injuries and all the facilities were reopened within a few days after the seismic event. Kohala, Waikoloa and Honoka`a Elementary Schools were the closest to the epicenter and therefore sustained most of the damage. The nonstructural damage consisted of fallen ceilings and light fixtures, broken pipes and toppled heavy furnishings (see Figure 4).

Figure 4 – Waikoloa elementary nonstructural damage

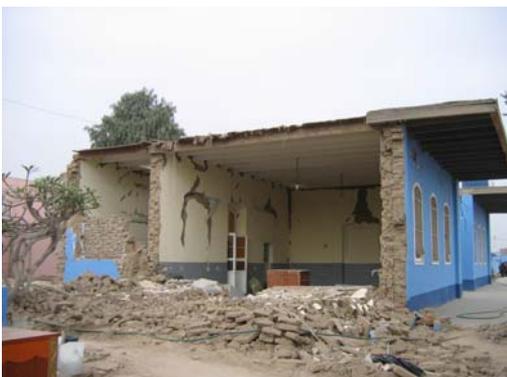
Figure 5 Collapsed building in San Jose Hospital of Chincha

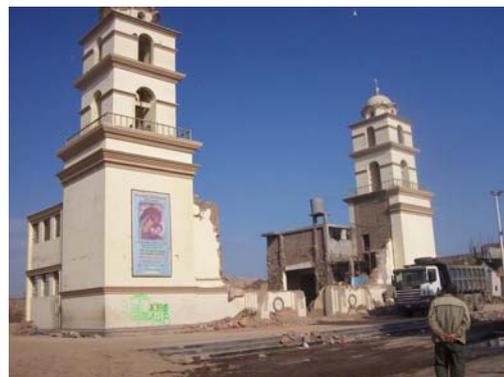
In Pisco and Chincha areas, almost all the adobe buildings suffered at least partial collapse. The adobe construction has been a traditional construction in Peru for more than 200 years. The building of this type is one-story high with rectangular configuration in plan. The adobe walls are made of adobe blocks laid in mud mortar, and range from 12 inches to 30 inches in thickness. The roof framing is typically made of timber beams and timber planks covered with a mud mortar overlay. In some cases, bamboo tubes are used in lieu of timber beams for supporting bamboo sheets covered with a mud mortar overlay. The adobe walls have limited out-of-plane resistance. Furthermore, the roof diaphragm provides little bracing at the top of the adobe walls. Thus, this type of construction is seismically vulnerable and prone to collapse (see Figure 5). Many historic church temples, as old as 400 years, made of adobe block walls experienced complete or partial collapse. Figure 6 shows that a historical church in Pisco downtown collapsed and killed more than one hundred and forty people.

Figure 6 Collapsed church in Pisco Downtown

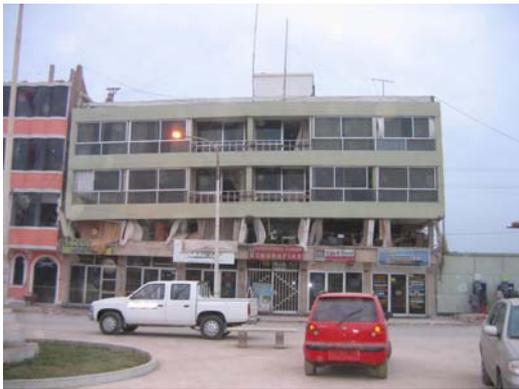
Figure 7 Torsional response and weak story leading to the failure of this building in Pisco

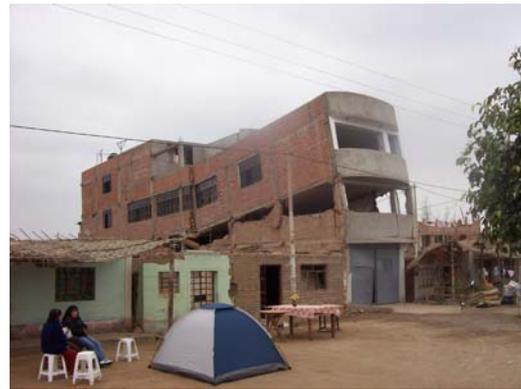
four types, the concrete moment frame with isolated brick infill and the concrete shear walls tended to perform very well. However, we observed several buildings of the first two categories suffered severe damage and dramatic failure. The failure is typically attributed to (1) torsional response due to the window openings at street sides (see Figure 7), (2) torsional response due to shifting of the center of mass from irregular floor addition, (3) torsional response due to the irregular plan configuration, (4) captive columns, (5) concrete frame joint failure due to inadequate joint shear reinforcement, (6) inadequate masonry walls, and (7) foundation failure due to the unconsolidated landfill (see Figure 8).

Figure 8 Structural collapse of this “Titanic” building due to failure of the unconsolidated landfill

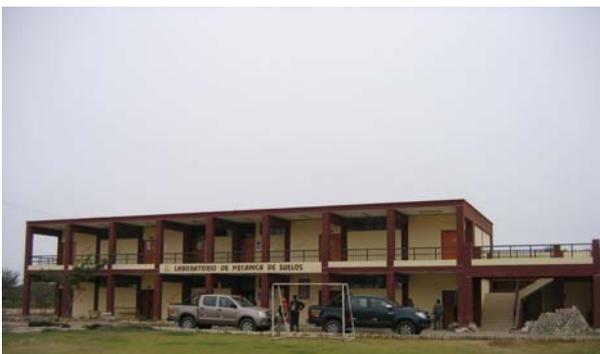
The ‘Laboratorio de Mecanica de Suelos’ is located at the south side of Universidad Nacional San Luis Gonzaga De Ica campus. It is a two-story rectangular concrete frame structure with masonry infill (see Figure 9a). The construction of the building was completed in 2000. Each masonry infill, either partial height or full height, was confined with a secondary concrete frame made of a pair of concrete columns and a beam atop the wall. The column reinforcement was anchored in the supporting concrete floor beams, which makes the walls act as cantilever walls to provide out-of-plane support of the infill. A 1-inch wide isolation joint filled with some elastomeric material was created between the concrete framing and the infill masonry (see Figure 9b). The isolation joint helps avoid creating the short column condition. Several infill walls were found out of plumb. A couple of full-height masonry infill walls experienced some minor to moderate damage of the plaster cover at the corners. However, the concrete frames did not experience any damage. Overall this building performed very well, although the building experienced a base shear of at least 70% its self-weight.

(a) A University laboratory

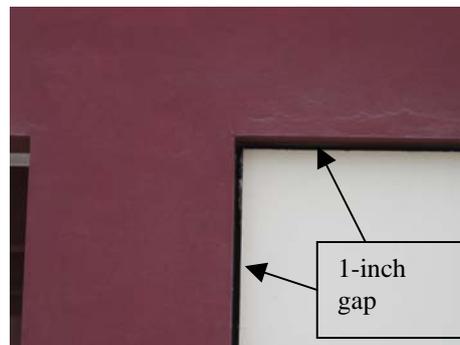
(b) A gap created around infill for isolation

Figure 9 Brick infill isolated from surrounding concrete moment frame

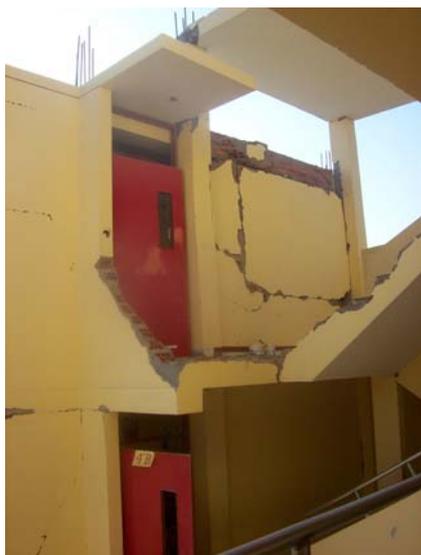
The classroom complex consists of four two-story buildings, including two classroom buildings, a stairwell and a restroom/storage building. The buildings were designed in 1995. The buildings are typically separated with a 2-inch seismic joint at both levels. The joint was somehow reduced to less than one inch at the second story between the classroom building and the restroom building. This resulted in pounding damage. Each classroom building has two identical classrooms at each level. It consists of concrete frames with masonry fill with floor and roof concrete slabs. In the transverse direction, it has five lines of reinforcement concrete frames. Both the two end frames and the middle frame have two bays with complete masonry infill. The other two frames are one-bay moment frames without any infill, and columns orient in the strong wall. In the longitudinal direction, there are two lines of concrete frames with partial height masonry infill. The brick infill in the front is about one and half times higher than that in the back, resulting in an aspect ratio of about two and four for the columns in the front and back, respectively. This resulted in severe shear failure of the columns in the front, which were on the verge of losing gravity carrying capabilities (see Figure 11). The windows next to the short columns fractured and fell on the floor. The front masonry infill in the first-story also experienced the moderate diagonal cracking.

Figure 10 Extensive masonry wall damage

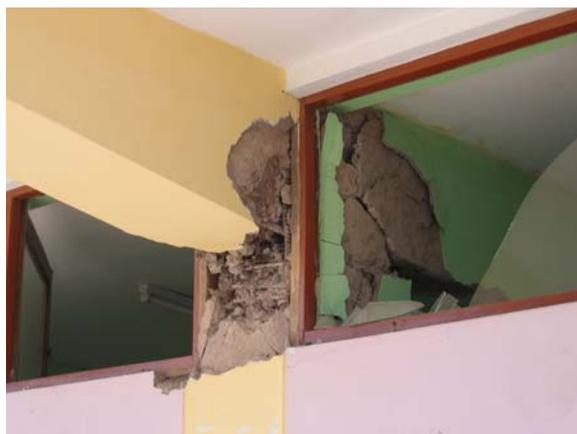
Figure 11 Shear failure of corridor columns

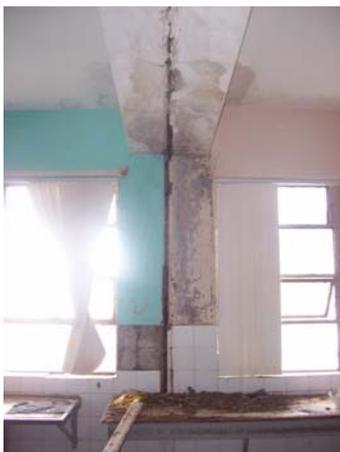
Figure 12 Pounding due to seismic Joints partially filled with grouting in Ica Hospital

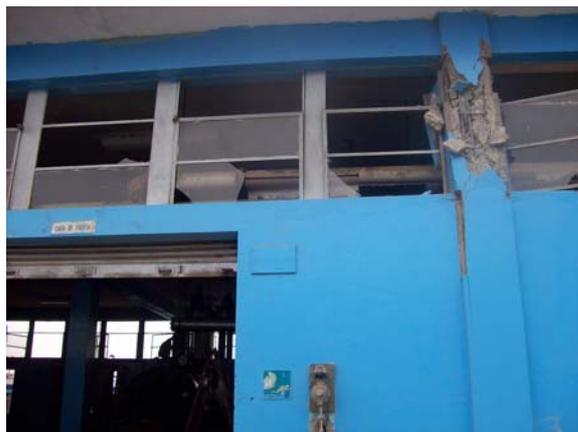
The Hospital Regional De Referencia Ica is the largest hospital in the region. It consists of approximately 16 buildings, most of which were designed and constructed in 1964. The main hospital consists of three four-story wings in a T configuration and a five-story elevator tower in the center, separated with a 2-inch seismic joint at all levels. The typical lateral system of each wing is made of four lines of concrete moment frames in the longitudinal directions with brick infill mostly at each side of the corridor, and seven lines of concrete frames in the transverse direction with brick infill partitions. The elevator tower has a concrete shear wall core as its lateral force system. Exterior moment frames of each wing typically showed no sign of stress except significant pounding between the wings and the elevator tower. The infill walls at the corridor experienced extensive damage of architectural finishes. Significant pounding occurred at the seismic joints between the wings and the elevator tower, and was partially attributed to the use of grouting to infill the seismic joints at the top and bottom of the floor edge beam (see Figure 12). Mechanical pipes and medical equipment and supply racks were not seismically braced, resulting in extensive nonstructural damage. As a result of extensive damage to architectural and mechanical components, the main hospital was abandoned. Next to the main hospital, there is an emergency power/mechanical building. It is a one-story concrete moment frame structure with brick infill in both directions. The exterior brick infill in the longitudinal direction created short column conditions. This resulted in severe shear failure of the exterior columns, which were on the verge of losing gravity carrying capabilities (see Figure 13).

Figure 13 Emergency power building Short column failure in Ica Hospital

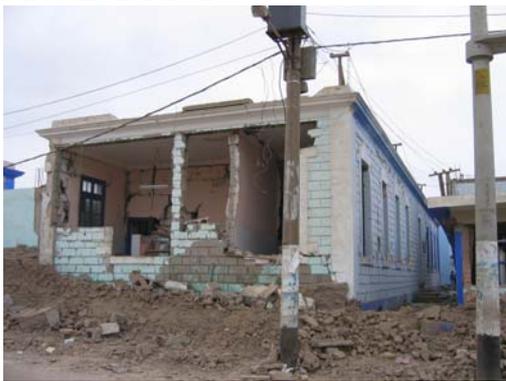
The Pisco Hospital has about 18 structures, two of which were reinforced concrete wall buildings and near the completion of construction. The majority of the original hospital buildings were one-story rectangular buildings constructed about 74 years ago. The transverse direction of these buildings typically consists of two interior and two exterior lines of CMU walls. The exterior walls have either a door opening in the center or two window openings. In the longitudinal direction, they have two lines of exterior CMU walls with window and door openings. Extensive cracks were observed between window openings, causing spalling of the plaster cover. The only original construction that did not experience any structural damage is the Kitchen/Mechanical Equipment Building. This is due to its lateral force system consisting of multiple lines of concrete shear walls in each direction. After the earthquake, the hospital salvaged medical beds and medical equipment and supplies and moved them into the newly constructed buildings. Figure 14 shows the structural damage of an original building with window openings at one end and a door opening at the other end. Significant torsional response of this building caused the wall piers adjacent to the windows to suffer more damage, resulting in the out-of-place collapse of the windows and the walls. Figure 15 shows structural damage of another hospital building that was originally a one-story concrete moment frame building having marginal joint shear reinforcement. Brick infill walls in each of the longitudinal exterior side created a captive column condition. A new addition was built on top of the southern half of the building. This irregular addition shifted the center mass, and created an undesirable torsional response. This building experienced short column failure in the longitudinal direction, joint shear failure in the transverse direction, as well as large twist with 10-in permanent drift in the transverse direction at the north end.

Figure 14 Structural damage of one-Story hospital building

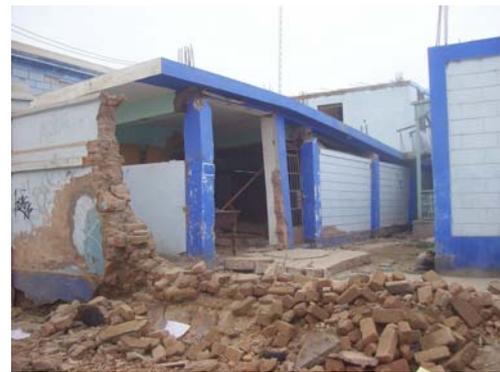
Figure 15 Torsional response, short columns and lack of joint reinforcement leading to the collapse of this building in Pisco Hospital
