PERFORMANCE OF BUILDING STRUCTURES DURING THE OCTOBER 15, 2006 HAWAII EARTHQUAKE

A. Gupta¹ and B.M. McDonald²

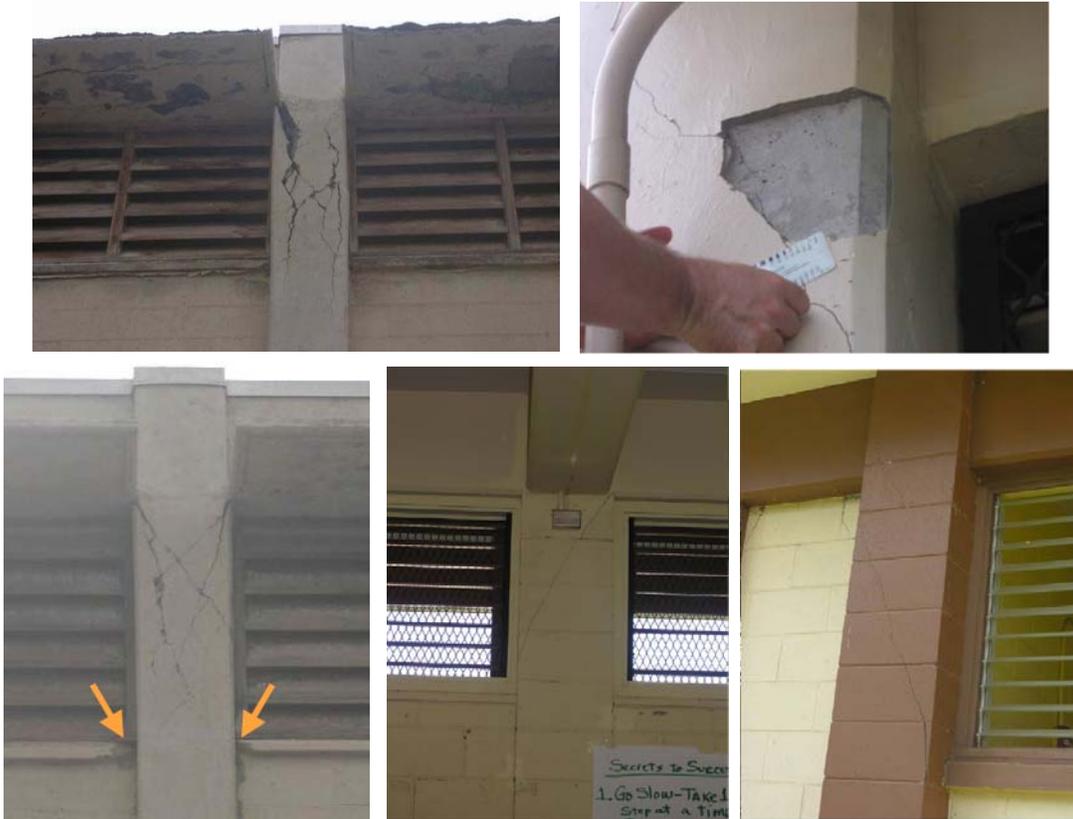
A large percentage of engineered building structures inspected exhibited a typical architectural detail wherein the infill wall (typically constructed using concrete masonry units) between the concrete-frame columns would stop short of the upper beam to leave space for windows. This detail, in effect, results in a classic short column situation wherein the irregularity in the strength and stiffness brought on by the infill wall results in the story deformation being essentially localized in the short columns spanning between the top of the infill wall and the beam above. Not surprisingly, shear cracking of such columns was observed at many structures. Examples of such damage are as shown in Figure 3.

Figure 3. Classical shear cracking of short columns.

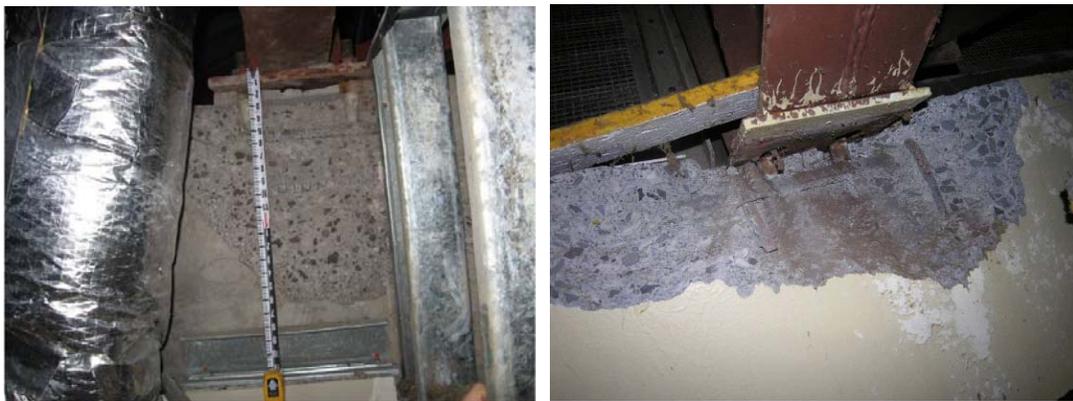
Another frequently observed condition consisted of failure (cracking and spalling) of a wedge of concrete under the bearing area of a beam or truss as seen in Figure 4. The exposed failure surface often exhibited corrosion of the embedded reinforcement indicating that the connection was in a compromised state prior to the earthquake and the additional earthquake loading was sufficient to aggravate the condition. In some instances, the beam/truss had to be temporarily shored until permanent repairs could be made.

Figure 4. Cracking/spalling at bearing area of beam/truss. Note corrosion of embedded reinforcement.

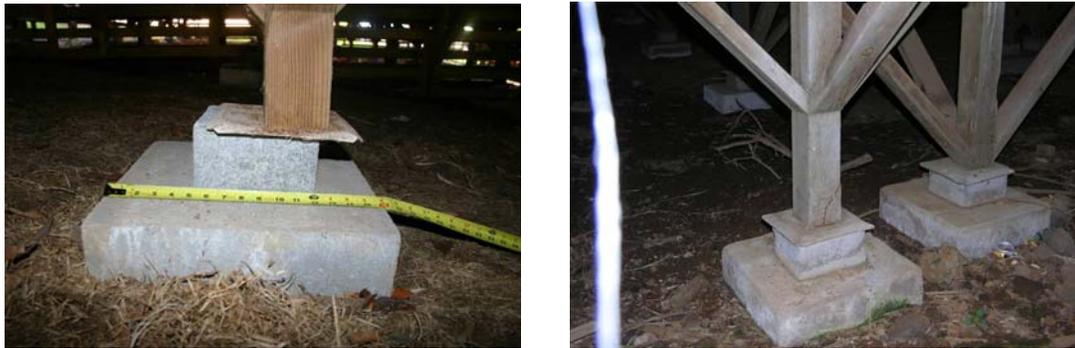
A significant percentage of low-rise wood-frame residential construction in Hawaii adopts a typical detail with the elevated first floor supported on a post-and-pier system, with the framing below the floor consisting of toe-nailed braces in two directions, and each individual post supported on a concrete block, which in turn is supported on a shallow concrete foundation block. There is often no positive connection between the post and the supporting blocks, and typically no shear walls exist in the foundation framing system. This particular detail is susceptible to sidesway and many instances of shifting/rotation of the post or foundation blocks were observed along with splitting of the posts and braces. In some cases, the structures had to be laterally supported to mitigate risk of additional damage during aftershocks or under sustained loads. Examples of such damage are as shown in Figure 5.

Figure 5. Shifting (left image) and cracking (right image) of foundation elements.

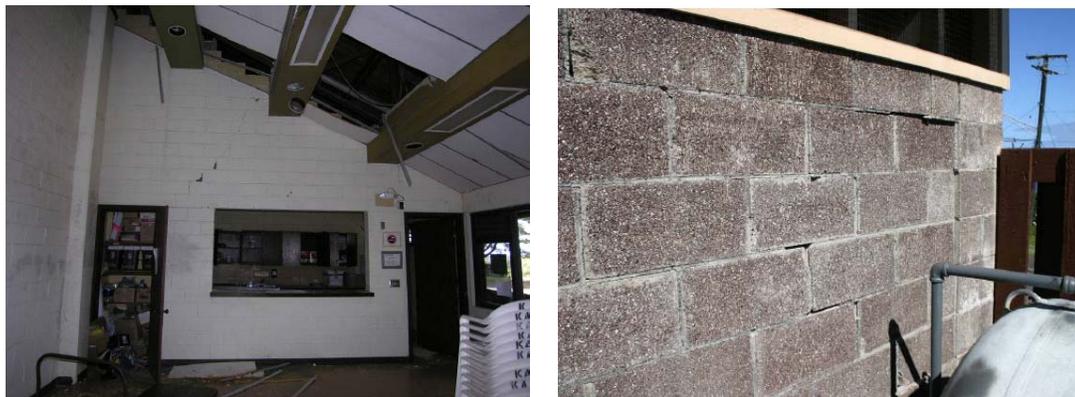
Concrete masonry unit (CMU) blocks are a preferred material of construction in Hawaii, often used as shear walls, infill walls (with or without grouting and reinforcement), and covers on concrete columns among other uses. Cracking and in-plane and out-of-plane displacement of CMU blocks was observed as seen in Figure 6.

Figure 6. Examples of cracking and shifting of CMU block walls.

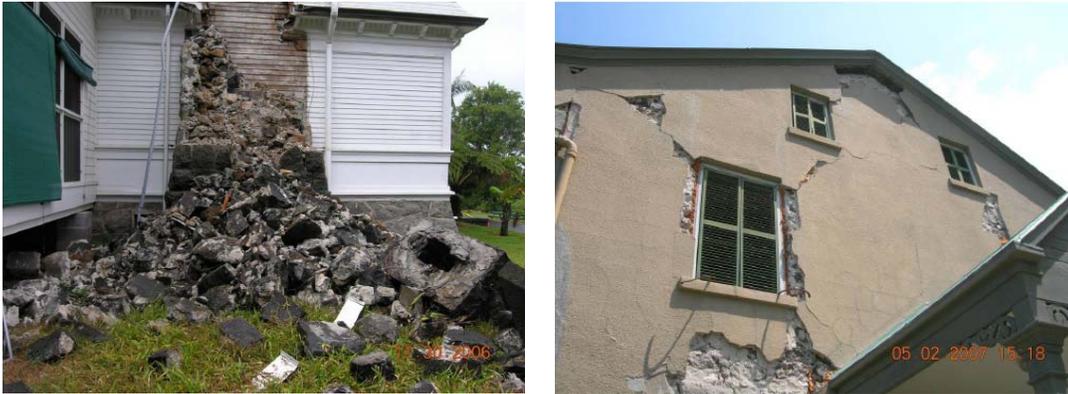
Some historical buildings and others exhibit the use of cemented rubble masonry (referred to as CRM and typically composed of local stone with mortar of widely varying quality). Typical uses include walls, columns, chimneys, and miscellaneous architectural features. A wide range of damage to such elements ranging from shifting of stones to partial collapse of walls was observed as seen in Figure 7. The Hulihee Palace experienced severe damage to its cement rubble masonry walls as seen in Figure 7 (right image).

Figure 7. Damage to cement rubble masonry elements.

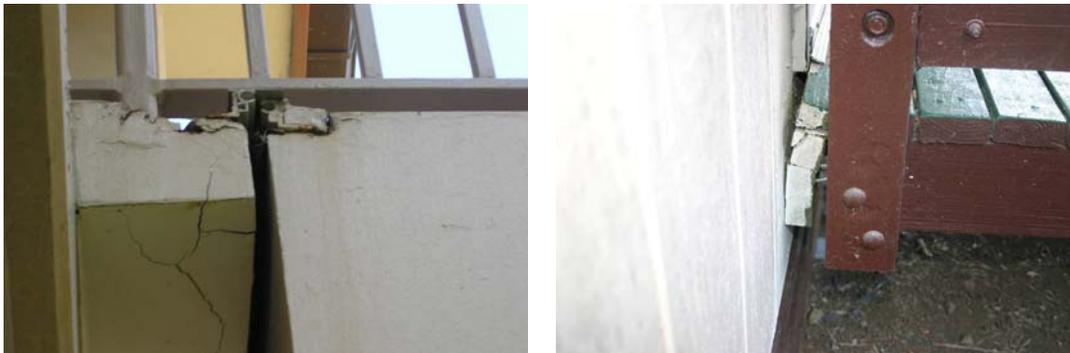
Differential movement between adjacent structural elements was observed at a few locations and typically manifested as damage to connections and expansion joints. Where appropriately designed, the expansion joints were able to accommodate the differential movement. Examples of typical damage are presented in Figure 8.

Figure 8. Damage due to differential movement of elements.

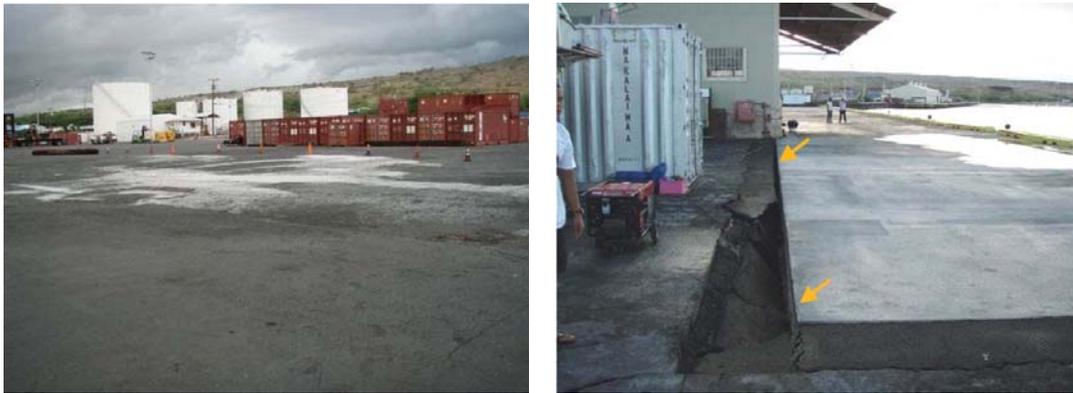
Isolated instances of structural damage were observed that were directly related to geotechnical failures in the form of liquefaction of the underlying soils. Figure 9 presents an example wherein liquefaction of hydraulically placed fill resulted in foundation movement and associated structural damage. Other instances of geotechnical failures, such as failure of steep banks or abnormal settlement of loose fill, were observed were structurally benign.

Figure 9. Evidence of sand ejecta (left), structural damage due to shifting of building foundation (right).

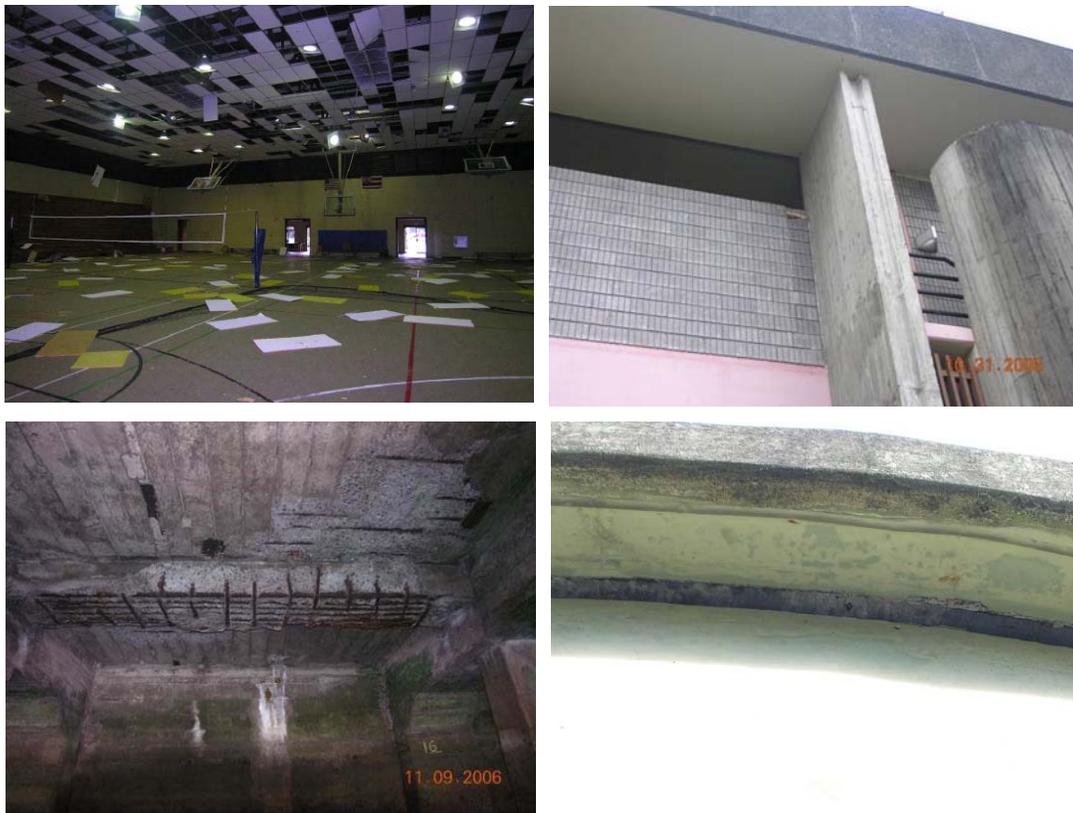
Nonstructural damage was common and consisted of damage to ceiling suspension systems; concrete masonry unit elements such as infill walls and column covers; cracking/spalling of concrete; and damage to brittle wall finishes. Figure 10 presents examples of some of the nonstructural damage observed.

Figure 10. (Top left) ceiling tiles and suspension system; (top right) infill wall damage; (bottom left) spalling of concrete cover over corroded rebar; (bottom right) lateral displacement of concrete water tank roof.

Damage to suspended ceiling systems with acoustic tile or drop-in panels was observed at many locations. The damage, in general, included shifting and dropping of tile and other ceiling fixtures, especially at the room

perimeter, as well as damage to the T-bar suspension system and perimeter closure angle. The damage, in general, resulted from lack of adequate seismic restraints for the suspension system (e.g., lack of diagonal bracing wire and compression struts, or inadequate connection between the T-bar framing and perimeter angles).

Damage to CMU nonstructural elements such as infill walls and column covers was observed at many locations. The damage, in general, included cracking of mortar joints between blocks, cracking through the face of the blocks and, in some instances, local spalling of the block. Damage to the perimeter mortar or flexible sealant joints between CMU infill walls and adjoining columns/beams was also observed at many locations.

Cracking and spalling of concrete elements was observed at many locations. The spalling typically resulted from long-term corrosion of the embedded steel reinforcement; the earthquake shaking dislodged the concrete cover and exposed the previously concealed pre-existing conditions.

Concrete water storage tanks exhibited a typical design detail wherein there is no positive connection between the tank wall and base pad or tank roof. Relative movement of the tank wall with respect to the base pad and tank wall was observed at many locations. While leaks were observed at a few locations, in general, the movement was not enough to impair the functionality of the tanks.
