# **RETROFITTING AND STRENGTHENING QUALITY EVALUATION FROM RIGIDITY VARIATIONS OF A DAMAGED BUILDING**

M. N. Farsi<sup>1</sup>, J-L Chatelain<sup>1,2</sup>, B. Guillier<sup>1,2</sup> and S-A Zermout<sup>1</sup>

The rigidity of a six-story shear wall building, damaged by the May 21, 2003 Boumerdes (Algeria) earthquake is evaluated before the event, in its damaged state, and after retrofitting, using the estimation of the frequency and damping factor of the structure. The pre-event parameters are estimated through a numerical analysis, based on the structure drawings complemented by a micro-tremor investigation of an identical non-damaged building located on the same site. The damaged and retrofitted parameters have been obtained using only micro-tremor recordings on the studied building. The variation of the frequency and damping factor during the three stages of the building went through allows to evaluate its rigidity changes, and therefore to control the quality of retrofitting and strengthening.

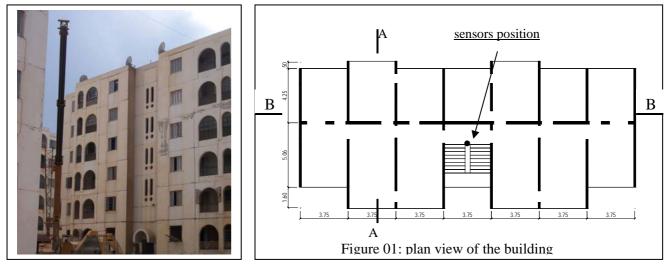
Photo N° 01: front view of the building

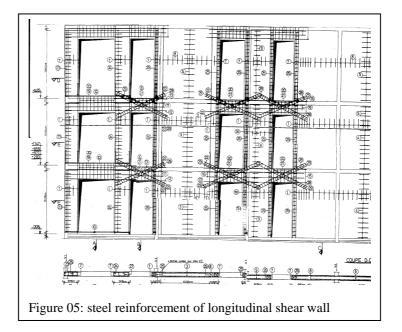
Photo 03: Steel reinforcement of longitudinal shear wall jacket

The jacketing technique was use to repair and to strengthen the damaged shear wall. This repair and to strengthen operation has concerned only the underground level and the ground level when the cracks have appeared. The jacket has 15 cm thick in the both sides of the wall with a steel reinforcement constituted by a 14 mm diameter bars forming a mesh of 20x20 cm (photo 03 and figure 06).

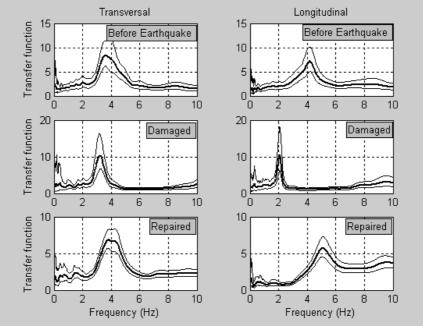
Damaged state: transversal direction 3.22 Hz, longitudinal direction 2.07 Hz

After repairing: transversal direction 3.80 Hz, longitudinal direction 5.10 Hz

In the longitudinal direction, the building had lost a significant part of its rigidity, about 50%, after earthquake occurrence. This is probably due to the coincidence between the building direction and the fault directional effect, i.e. the highest acceleration.

The repairing and retrofitting, as explained above, have strongly rigidified (5.1 Hz) the longitudinal direction but more than the initial state (4.20 Hz). Based on these results we can admit that the repairing and retrofitting operation has been a success and the choice technique is good. However, looking on the modal shapes (figure 11 a and b) we can note that, if on the first level the building is more rigid than on the other levels (that is normal because of the retrofitting), on the third level exists a "fracture" which is probably due to no detected microcracks.

Figure 10: frequency in longitudinal and transversal directions of non-damaged, damaged and repaired building
