Experiment on Seismic Disaster Characteristics of Underground Cable

ABSTRACT :

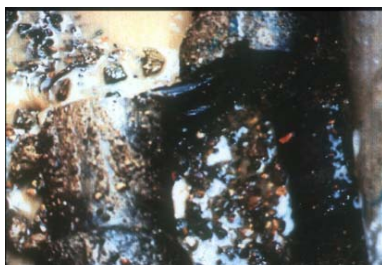
In many cases so far reported about seismic underground cable damage, a conduit was fractured and disengaged under local shear by land subsidence at a quick change of stratum or the crossing of the conduit over another buried item. This damaged a cable inside the conduit by drastic bending or shearing. Therefore, conduit joints and manhole connections have been made flexible to improve the anti-seismic performance.

Cable damage by conduit fracture
Kushiro Earthquake

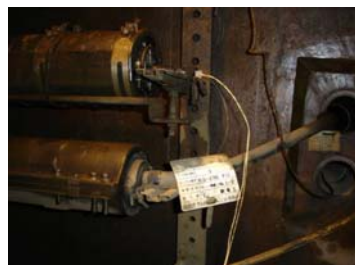
Cable cut in manhole The Niigata
Chuetsu Earthquake

At the Niigata Chuetsu Earthquake in 2004 and Niigata Chuetsu-oki Earthquake in 2007 when many optical communication cables were already laid, cables were pulled into manhole ducts at road collapses or land subsidences, as well as at conduit fracture and disengagement. This was reported to have increased the optical transmission loss and cut a cable by tensile force in some cases (Figure 2).

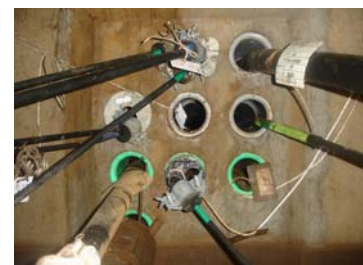
Cable displacement in manhole
Niigata Chuetsu-oki Earthquake

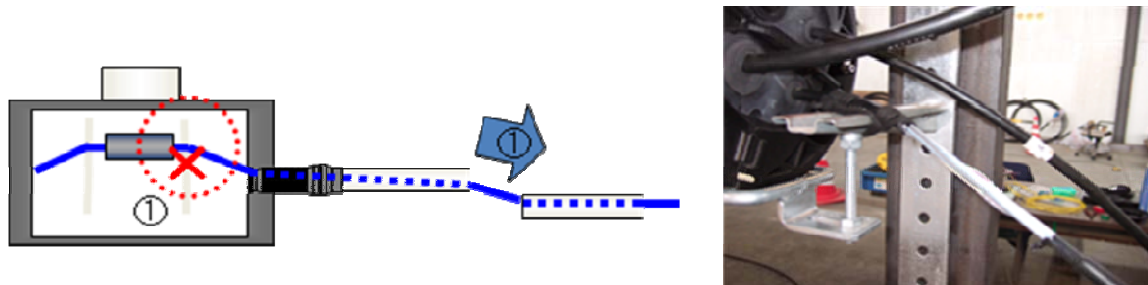
Figure 5 Disaster in a span with closure

- 1) The cable is pulled into the manhole due to conduit disengagement and tension is generated throughout the cable.
- 2) A conductor strain is generated throughout the optical fiber. (Similar strain in all slots)
- 3) The tension member bracket in the standard closure is damaged and the tension member is extracted.
- 4) Tensile force rapidly works on the sheathing and conductor and cuts the cable. The disaster at the Niigata Chuetsu Earthquake in Figure 2 could be reproduced. (Figure 5)

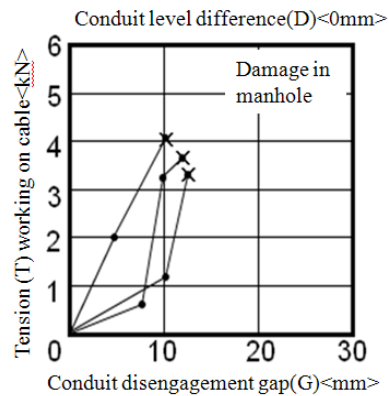
Figure 6 ① Conduit disengagement gap and tension

Figure 6 shows the relationship between the conduit disengagement gap (G) and the tension working on the cable. \times in the graph indicates a point where the optical transmission loss and strain on the optical fiber exceed the criteria. Since the cable is secured by binding, the tension is not uniform. However, the tension causes damage about when the conduit disengagement gap exceeds 10 cm.

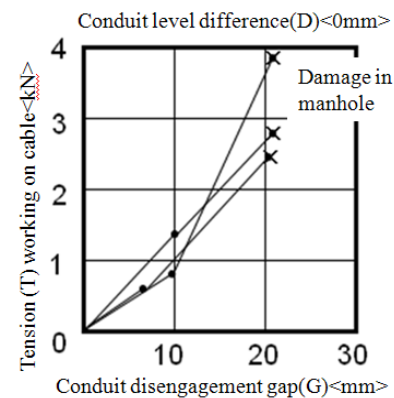
Figure 7 ② Conduit disengagement gap and tension

Figure 7 shows the relationship between disengagement gap (G) and tension (T). As in the previous section, the tension is not uniform but causes damage about when the disengagement gap exceeds 20 cm.

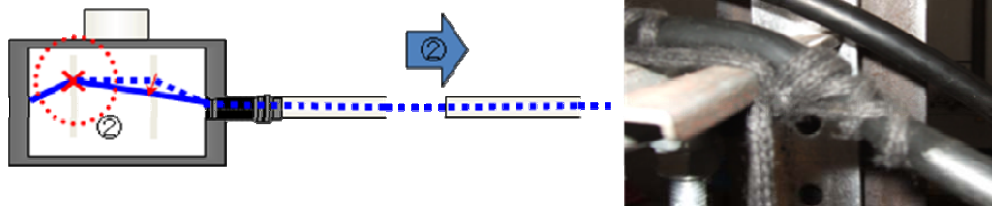
Figure 8 Disaster in a manhole in a span with no closure

- 1) The cable is pulled into the manhole due to conduit disengagement and tension is generated throughout the cable.
- 2) The cable comes off from the bracing near the duct and tension works on the far bracing.
- 3) A conductor strain is generated throughout the optical fiber. (Similar strain in all slots)
- 4) The strain increases the optical transmission loss or the biting string cuts the conductor. (Figure 8)

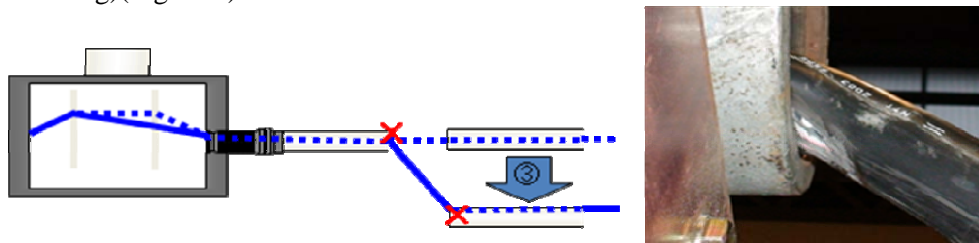
Figure 9 Damage at conduit disengagement in a span with no closure

- 1) Same as 1) to 3) in ②
- 2) As the level difference (D) at conduit disengagement increases, side pressure works on and makes the cable cross section flat.
- 3) The side pressure by tension and the abrasion with the conduit edge damage the cable sheathing.
- 4) The cable slot is crushed and presses the conductor, increasing the optical transmission loss. (Almost simultaneous occurrence of excessive optical transmission loss, conductor elongation, excessive strain, and boring in sheathing)(Figure 9)

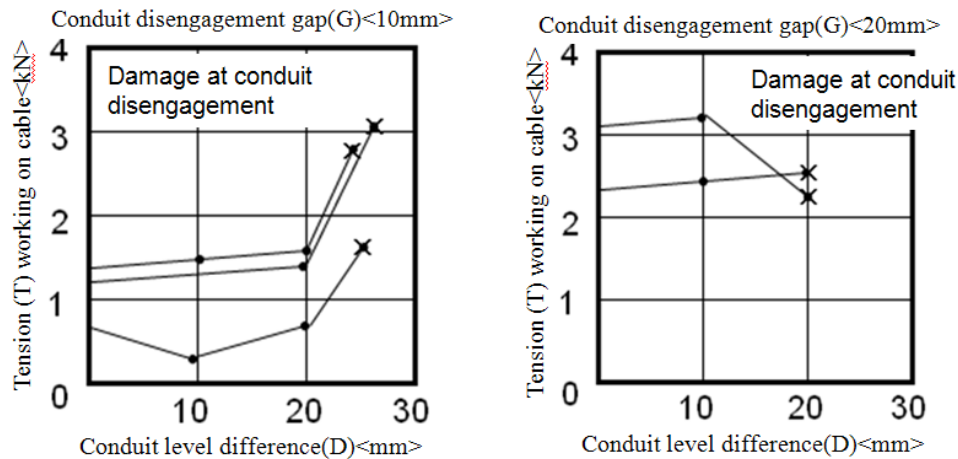
Figure 10 ③ Conduit level difference and tension

Figure 10 shows the relationship between the level difference (D) and tension (T) when the disengagement gap was 10 and 20 cm. Although the tension decreased when strings became loose, the cables were damaged almost uniformly about when the level difference exceeded 20 cm.

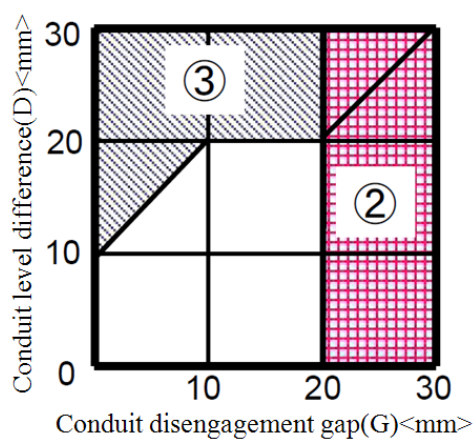
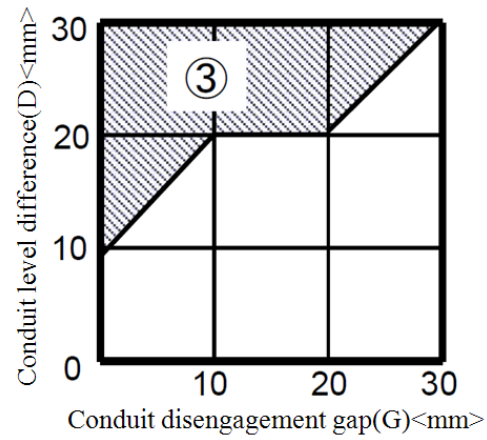
In a span with closure, a conduit disengagement gap of about 10 cm caused damage by the pattern of ①. In a span with no closure, fine cables suffered from damage of a combined pattern of ② and ③. Bold optical fiber cables suffered from damage of the pattern of ③. Figures 11 and 12 show the damage areas of fine and bold cables in a span with no closure.

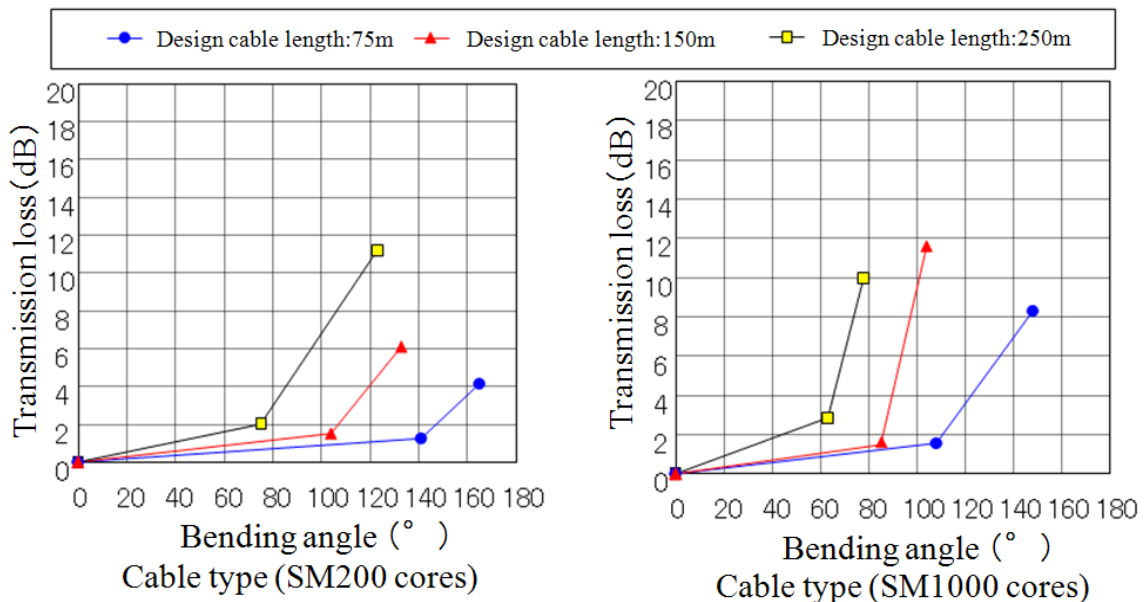
Figure 17 Relationship between cable bending angle and optical transmission loss

Figure 17 shows the relationship between cable bending angle and optical transmission loss about the two cases of SM200 and SM1000. A transmission loss tends to occur at a bending angle about over 60°, despite dispersion depending on the number of cores.

As the cores of the optical fiber cable are fewer, an optical transmission loss tends to occur at a greater bending angle. This is advantageous for a fine cable (small number of cores). As the design cable length is shorter, an optical transmission loss tends to occur at a greater bending angle. When the design cable length is 75 meters, an optical transmission loss occurs at a bending angle of about over 100°. At the design of a conduit

for a great bending angle, the conduit span should be reduced to suppress frictional tension on the cable.
