CYCLIC TESTING OF A FULL-SIZE STABILIZED, FLAX-FIBRE REINFORCED EARTH (UKU) WALL SYSTEM WITH OPENINGS

J.S. Cheah¹, T.K.K.B. Morgan² and J.M. Ingham³

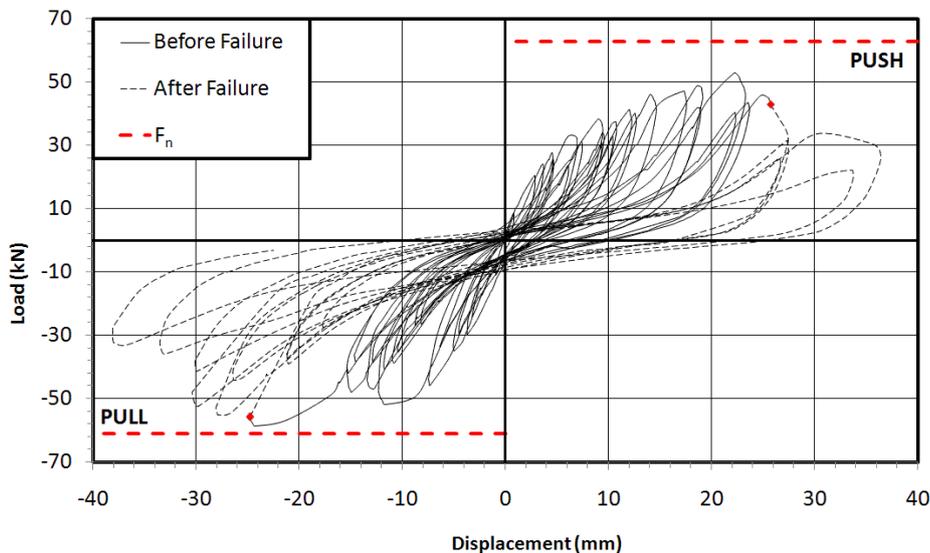
Figure 8 Lateral Force-Displacement History of the Uku Wall Assemblage

The lateral-force displacement history is plotted in Figure 8. The shape of the hysteresis loops before wall failure are similar to the hysteresis loops obtained from seismic tests of plywood sheathed timber shear walls (controlled by slip of sheathing nails) (Dean et al. 1986). The horizontal dotted lines indicate the calculated ultimate lateral load F_n . Due to the lack of symmetry in the wall line, the seismic performance in each direction was different. The maximum lateral forces sustained and the maximum available displacement of the wall is shown in Table 2 for both directions. The measured non-linear characteristics of the wall system were not due to the yielding of the vertical steel reinforcing bars but rather the sliding, rocking and crushing of the earthen panels. This is consistent with the wall exhibiting non-linear behaviour below the calculated ultimate lateral load. Due to the lack of steel yielding in this wall test the overall wall ductility could not be accurately and confidently evaluated. The results do show however, that the initial assumption of an elastic structure with a structural ductility of $\mu = 1$ was conservative.

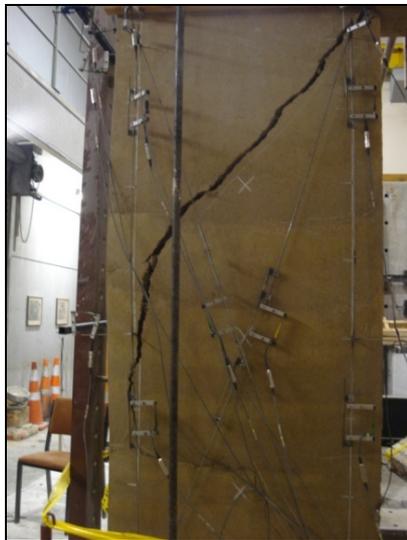
The wall system exhibited several failure mechanisms throughout the test. At a lateral displacement of 6 mm a fine crack formed at the corner of the window and at the control joint between EP2 and EP3. The nib wall on which EP1 was built had detached from the concrete foundation beam and rocked with EP1, with measured vertical displacements up to 2 mm. The top half of EP2 failed first with a 6 mm wide diagonal shear crack developing at a lateral displacement of -7 mm. A large shear crack developed on the opposing diagonal as the load was reversed. At a lateral displacement of 11 mm it was possible to see through the cracks in EP2. Up until a displacement of 21 mm EP1 showed minimal damage and was observably rocking on the concrete foundation beam. A sliding shear mechanism had developed between the concrete bond beam and the top of EP3 from an early stage in the test. EP2 continued to develop new shear and flexural cracks, and widened existing cracks. At a lateral displacement of 21 mm EP1 developed a large diagonal shear crack; by this point EP2 was severely cracked. Small shear cracks developed in EP3 as lateral displacements increased past 30 mm. Figure 9 shows photos of EP1, EP2 and EP3 at the end of the wall test.

Figure 9a EP1 at test end

All three wall panels exhibited non-ductile failure mechanisms. EP1 rocked initially and failed in shear, EP2 failed in shear, and the top layer of EP3 de-bonded from the 4 D12 vertical steel reinforcing bars connecting the earthen panel to the bond beam. Yielding of the vertical steel reinforcing at the base of the panels was the ideal failure scenario because this would create a ductile failure mechanism. Clearly this was not the mode of failure observed in the wall test. The sliding shear mechanism that developed between EP3 and the bond beam was unexpected. Post-test observations of EP3 revealed a weaker layer of earth at the top of the panel. It was also noted that before the test the top earth layer of EP3 was paler than the rest of the wall panel. A likely explanation is that the top layer of EP3, which had been curing for less than 24 hours, absorbed additional water as the concrete bond beam was cast in situ on the earth panels. The same problem is not expected to occur in the Rotoiti Uku house because there was a considerable length of time between the construction of the wall panels and the in situ casting of the concrete bond beam. EP3 represented 37% of the total effective wall length and was likely to have had an under-represented strength contribution in the test conducted.

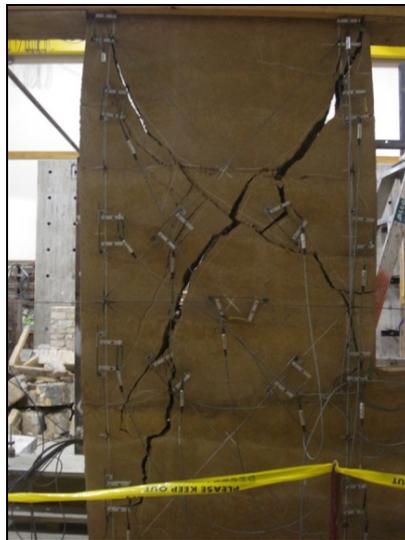
Figure 9b EP2 at test end

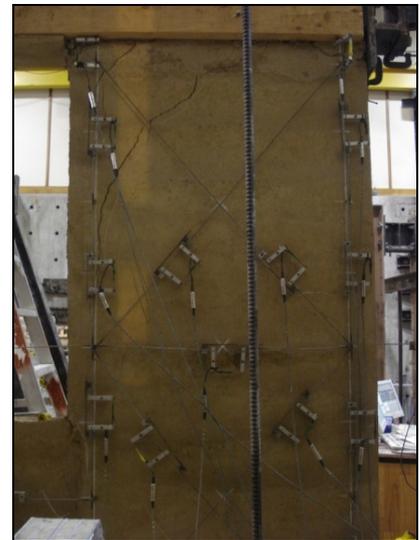
Figure 9c EP3 at test end

The wall test did not reach the calculated ultimate lateral loads required for an elastic design. The wall reached 84% in the positive direction (push) and 97% in negative direction (pull). The de-bonding failure at the top of EP3 is likely to have resulted from casting the insitu concrete beam too soon after ramming the earth panel. The strength contribution of EP3 would have decreased as a result and under-represented the actual strength capacity of the earth panel. All three wall panels exhibited non-ductile shear and de-bonding failure mechanisms which were contrary to assumptions that the panels would fail first in flexure.
