BEHAVIOR OF DWELLINGS DURING STRONG EARTHQUAKES IN ROMANIA

I. Vlad¹ and M. Vlad²

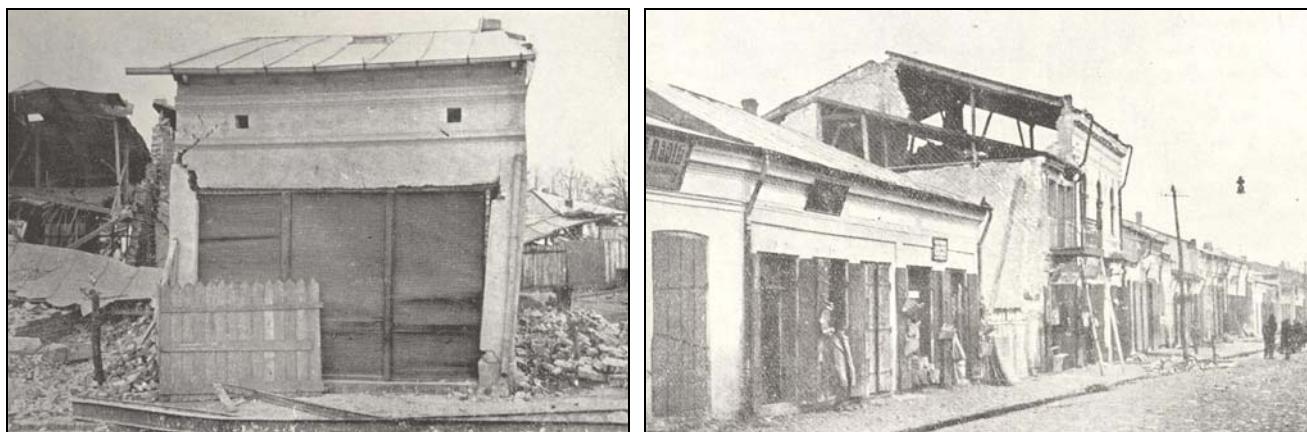
Figure 2. Damage of dwellings in Panciu and Adjud towns, 1940 (Niculescu, 1941).

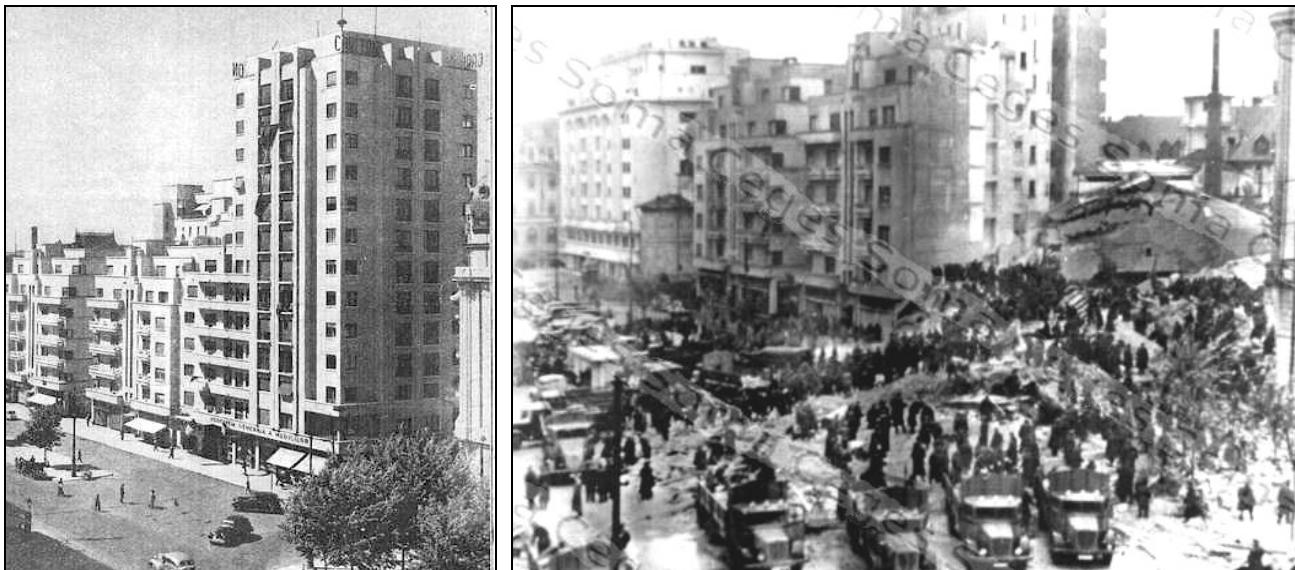
The essential cause of the complete collapse of the Carlton building was the structural conception on which the design of the reinforced concrete frames had been based. As there were shops at the ground floor, in order to get as big shop-windows as possible, some of the columns were reduced to transversal reinforced concrete walls only 22 cm in width, but 200 cm in length (Beles, 1960). Among other causes that may have contributed to the collapse were the unfavorable position of the 47 m high corner tower with respect to the direction of the earthquake motion, the possible amplification of earthquake effects due to the proximity of the foundation to the water table, the location of the building at the end of a row of tall buildings and the cantilevering of the first floor theater seats from the columns. Professor Cristea Niculescu was the first one who brought into discussion the *resonance phenomenon* in connection with the total collapse of this building.

Figure 3. "Carlton" building. General view before and after the November 10, 1940 earthquake.

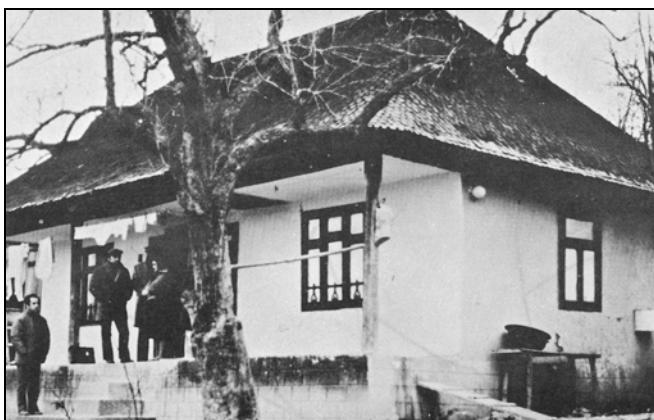
(a)

In the small village Vrancioaia, two kilometers West of the epicenter, the effects of strong ground shaking were less severe; superficial cracking of adobe/wood walls in one-story dwellings (Figure 4,a) was typical of observed damage. In the towns of Focsani and Buzau, located between the epicentral area and Bucharest, unreinforced masonry walls in low-rise buildings partially or totally collapsed, and movement between structural elements and adjacent masonry in-fill walls was observed in recently then constructed and engineered buildings. In the town of Galati, to the Southeast of the epicenter, about twenty older dwellings were seriously damaged (none collapsed) and numerous others sustained slight or moderate damage. In several small towns to the North of Ploiesti, at least one several-hundred-year-old building collapsed and other unreinforced

Figure 4 (a). Typical one story adobe/wood wall dwelling in Vrancioaia. (b). Typical old two-story unreinforced masonry wall dwelling, Bucharest, 1977 (Rojahn, 1977).
