## **THE ADANA-CEYHAN EARTHQUAKE OF 27 JUNE 1998: SEISMIC RETROFIT OF 120 R/C BUILDINGS**

**Haluk SUCUOĞLU<sup>1</sup>, Türel GÜR<sup>2</sup> And Polat GÜLKAN<sup>3</sup>**

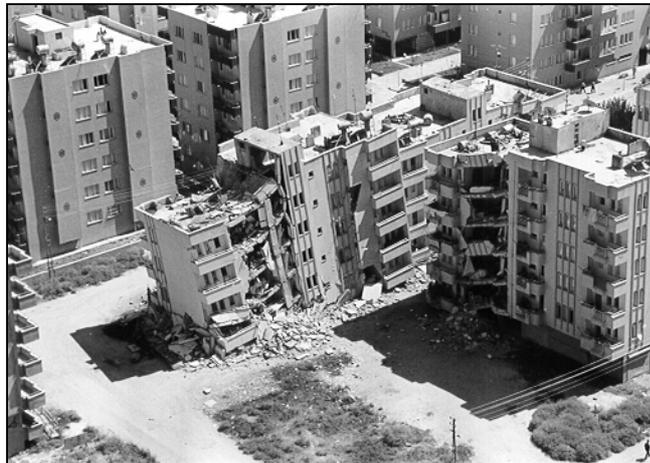
If the extremely poor masonry houses are excluded in Ceyhan, structural damage is entirely confined to multistorey reinforced concrete buildings which do not satisfy earthquake resistant design regulations in Turkey. The twelve collapsed, 30 heavily damaged and 120 moderately damaged apartment blocks were distributed randomly throughout the city. Figure 6 shows a collapsed and a heavily damaged block in the foreground and moderately damaged blocks in the background in Ceyhan after the earthquake. Since the difference in soil conditions are eliminated as a factor, the distribution in damage is expected to be in accord with the available seismic resistance of damaged buildings.

**Figure 6. Collapsed and damaged buildings in Ceyhan after 1998 earthquake**

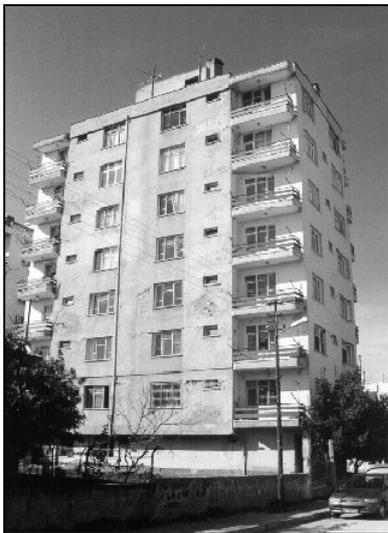
The building shown in Figure 9 is selected as a case study. It was constructed in 1984, its floor area is 245 m<sup>2</sup> and story height is 3 m. The structural system consists of reinforced concrete framing with columns and beams, strip foundation in both orthogonal directions, concrete slabs in the first six stories and joist slabs in the top two stories. There are structural walls around the elevator. Partition walls made of hollow factory bricks also contribute to the stiffness and strength of the building. The damage score for the building is calculated as 27

which places it into moderate damage category. In the structure, an extensive beam damage, especially between the first and the fifth floors, was observed.

**Figure 9. The photo of the 8-story apartment building**

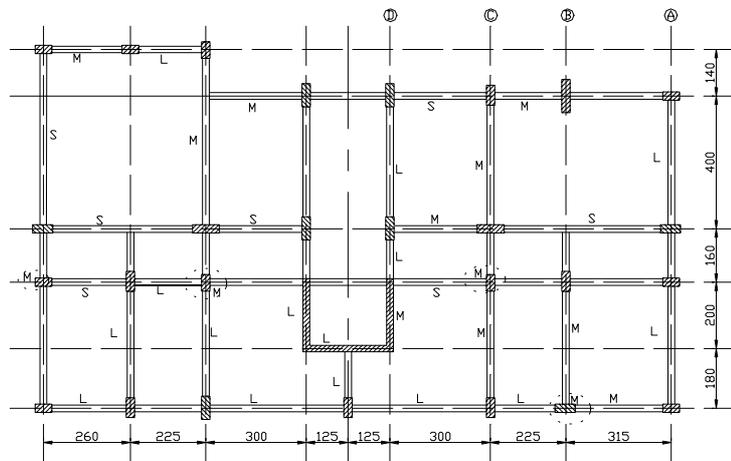
**Figure 10. Simplified plan of a typical story of the building showing the damage observed on the structural elements (L: Light damage, M: Medium damage, S: Severe damage)**

First, three dimensional models of the structure in three stages, as-built, damaged and repaired, are prepared for elastic analysis to estimate the vibration modes [Computer and Structures Inc., 1998]. The typical story structural plan of the model, simplified from the real structure, is given in Figure 10. The adopted retrofit scheme of the building is shown in Figure 11. In the selection of the seismic retrofit scheme, closing exterior window openings, intervention with the existing piping system and limiting architectural functions are avoided as much as possible.

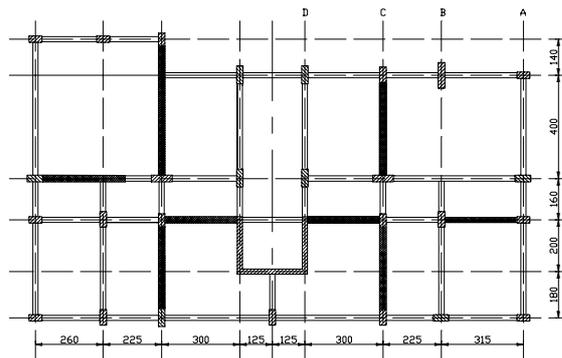
**Figure 11. Strengthening scheme applied to the building (Darker shadings show newly added R/C walls)**

The lowest mode vibration periods of the original (as-built) building are calculated as 0.85 s (torsion), 0.68 s (translation in the short direction) and 0.65 s (translation in the long direction). In the damaged state, these periods become 1.09, 0.87 and 0.84 s respectively. After adding the shear walls shown in Figure 11 with ratios of 2.4 % and 1.6 percent in short and long directions, respectively, with respect to the floor area, periods of the first three modes are reduced to 0.65 s (torsion), 0.50 s (translation in the long direction) and 0.43 s (translation in the short direction). The building satisfies code requirements with the adopted retrofit scheme.
