## **EARTHQUAKE SAFETY OF AN ARCH-GRAVITY DAM WITH A HORIZONTAL CRACK IN THE UPPER PORTION OF THE DAM**

### **SUMMARY**

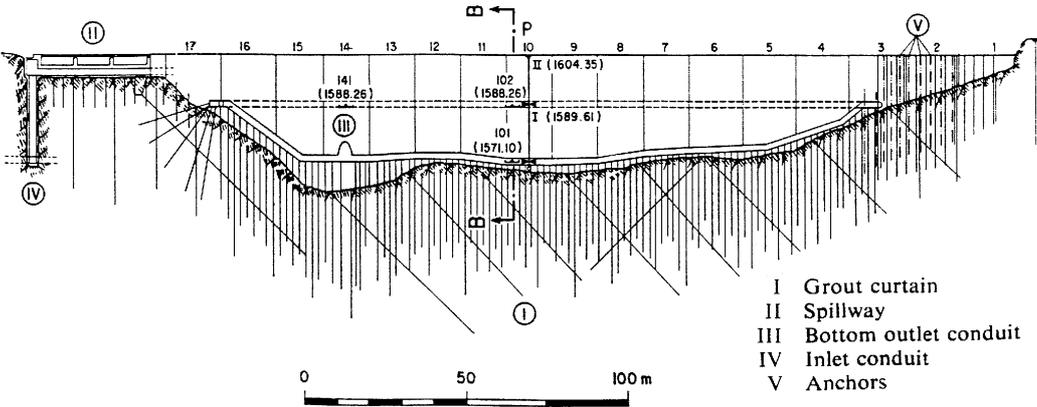
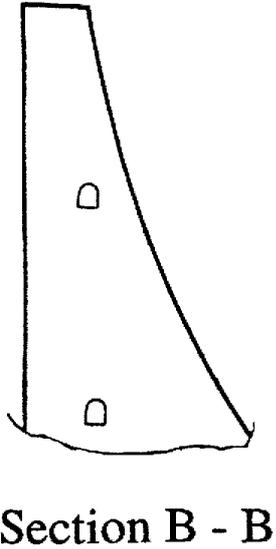
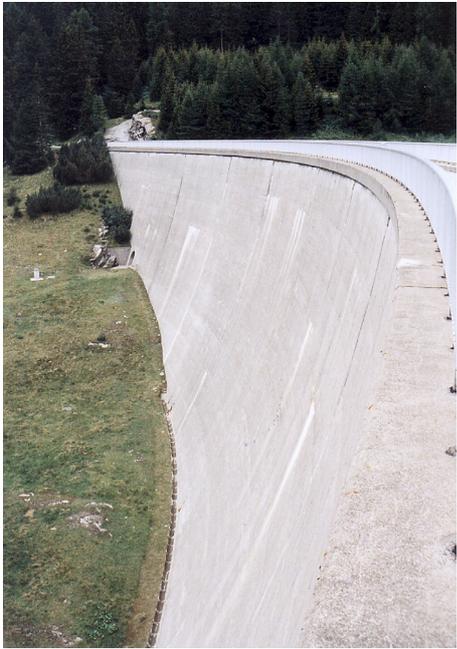
A continuous crack was observed along the downstream wall of the upper gallery of the 45 m high arch-gravity dam shown in Fig. 1 after 25 years of operation. The crest length of the dam is 290 m, the crest width is 5 m and the maximum base width is 22 m. The total volume of the mass concrete is 71,000 m<sup>3</sup>. The upper gallery is located about 15 m below the dam crest. The crack has already propagated along almost the whole dam length and the crack opening has been continually increasing at a rate of up to 0.1 mm per year. This has been accompanied by an irreversible displacement of the crest towards the reservoir by about 1.1 mm per year. A

similar crack has also been observed at the corner at the base of the upstream wall of the upper gallery. However, the crack opening of this crack is much smaller than that of the first crack.

Fig. 1 Layout of arch-gravity dam, central cross-section and photograph showing downstream dam face

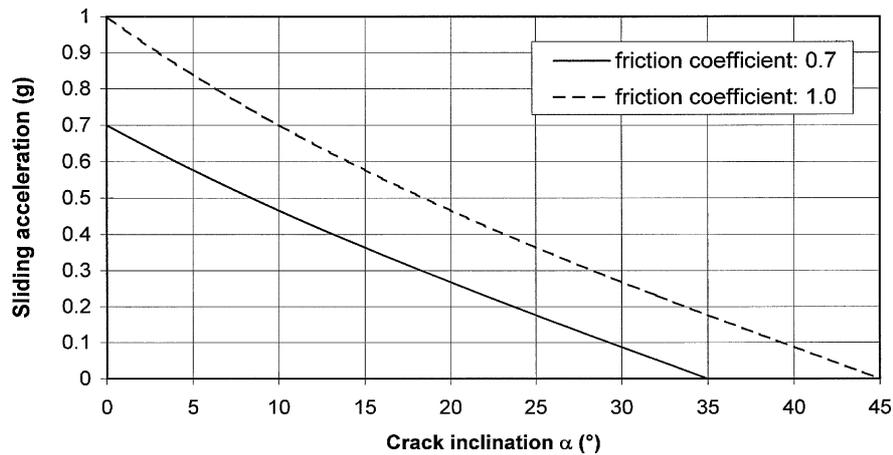
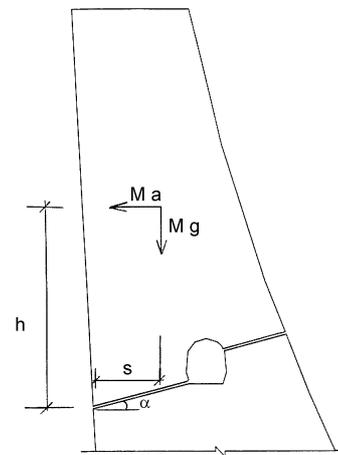
The critical sliding acceleration is a function of the crack inclination and the coefficient of friction in the crack, which is in the range of 0.7 to 1.0. It has to be pointed out that only a movement of the detached concrete block towards the upstream side is possible due to the geometry of the arch-gravity dam. For a crack inclination of  $15^\circ$ , the critical pseudostatic sliding acceleration is 0.36 g.

The critical pseudostatic acceleration which leads to the overturning of the upper portion of the dam is 0.32 g. This value is essentially independent of the crack inclination and the coefficient of friction. The results of the pseudostatic analysis would imply that the upper portion of the dam should overturn before it starts to slide for the case of a  $15^\circ$  crack. However, the results of the dynamic analysis, which are described in the following part, show that the earthquake shaking causes a sliding movement of the detached upper portion of the dam without producing an overturning instability.

**Fig. 2 Critical pseudostatic accelerations for sliding and overturning of detached upper portion of dam**

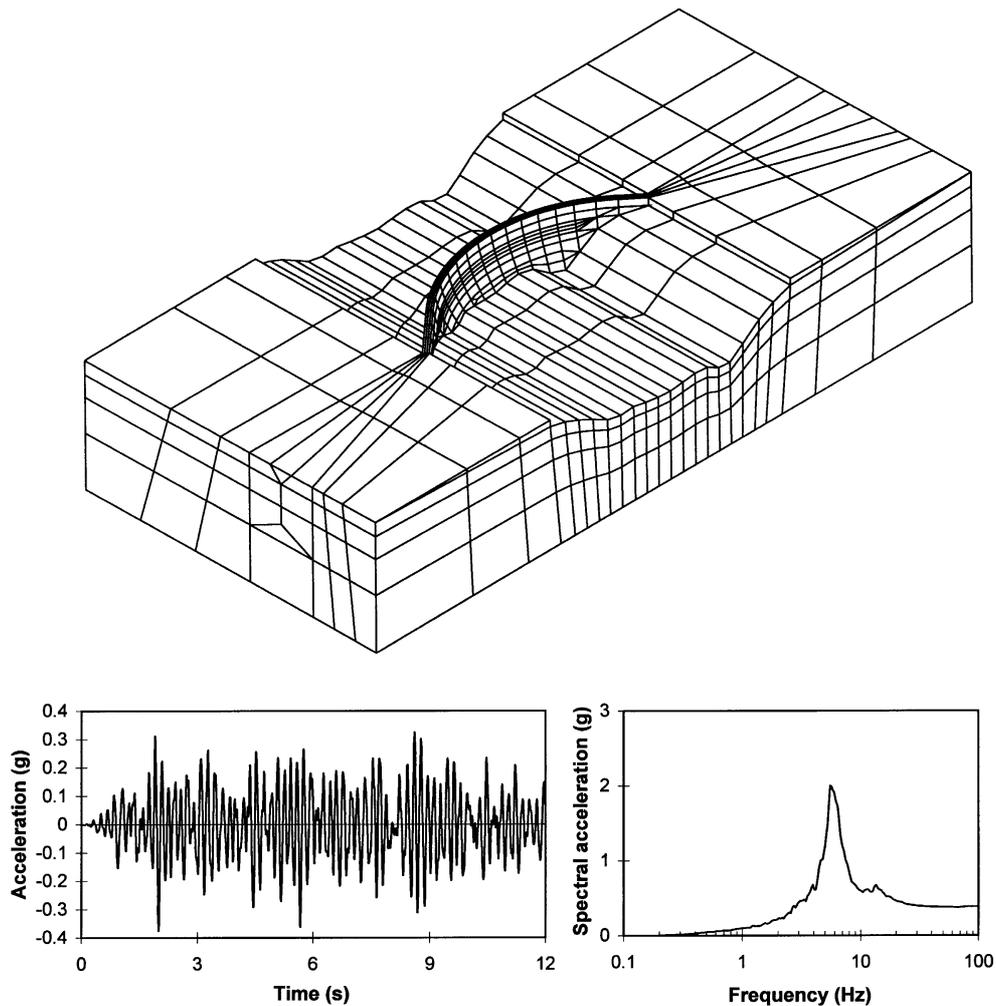
The time history of the radial acceleration at the base of the upper gallery for an earthquake with a peak ground acceleration (PGA) of 0.1 g is shown in Fig. 3 together with the corresponding floor response spectrum. The acceleration amplification factor with respect to the PGA is 3.8 at the upper gallery and about 8 at the dam crest.

**Fig. 3 Three-dimensional dam-foundation model (top) and time history of radial acceleration at base of upper gallery with corresponding floor response spectrum for PGA of 0.1 g (bottom)**

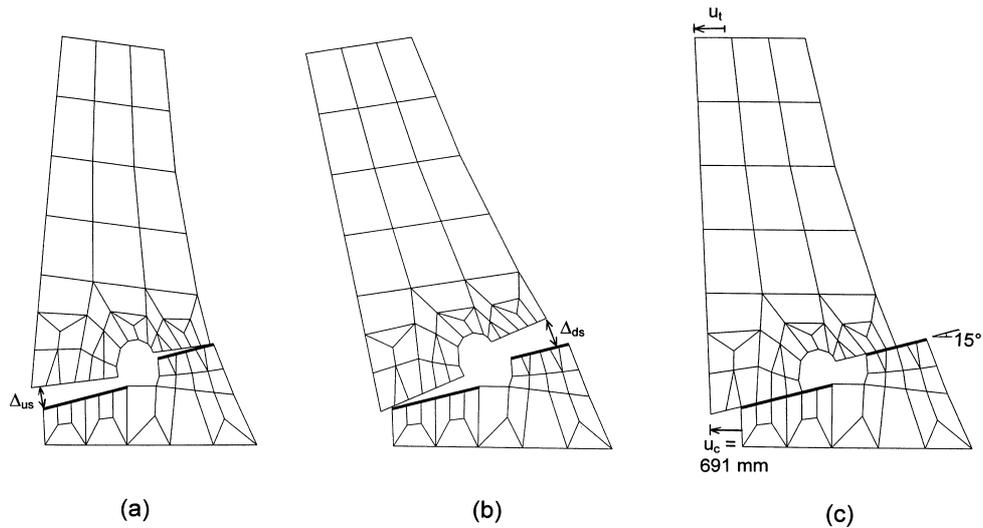
Typical results of the dynamic stability analysis are plotted in Figs. 4 and 5 for the coefficient of friction of 0.7 and the base excitation shown in Fig. 3 scaled up for a PGA of 0.5 g. During the rocking motion caused by the earthquake load, the maximum crack opening displacements at the upstream and downstream faces of the dam amount to 19 mm and 27 mm, respectively. After the earthquake, the detached upper portion of the dam will have moved in the upstream direction by 69 cm. For comparison, at the end of an earthquake with a PGA of 0.2 g, the sliding displacement is 3 cm.

**Fig. 4** (a) and (b) show the rocking of the detached upper portion of the dam during earthquake shaking, and (c) shows the final configuration with permanent sliding displacement after an earthquake with a peak ground acceleration of 0.5 g (coefficient of friction in crack: 0.7)

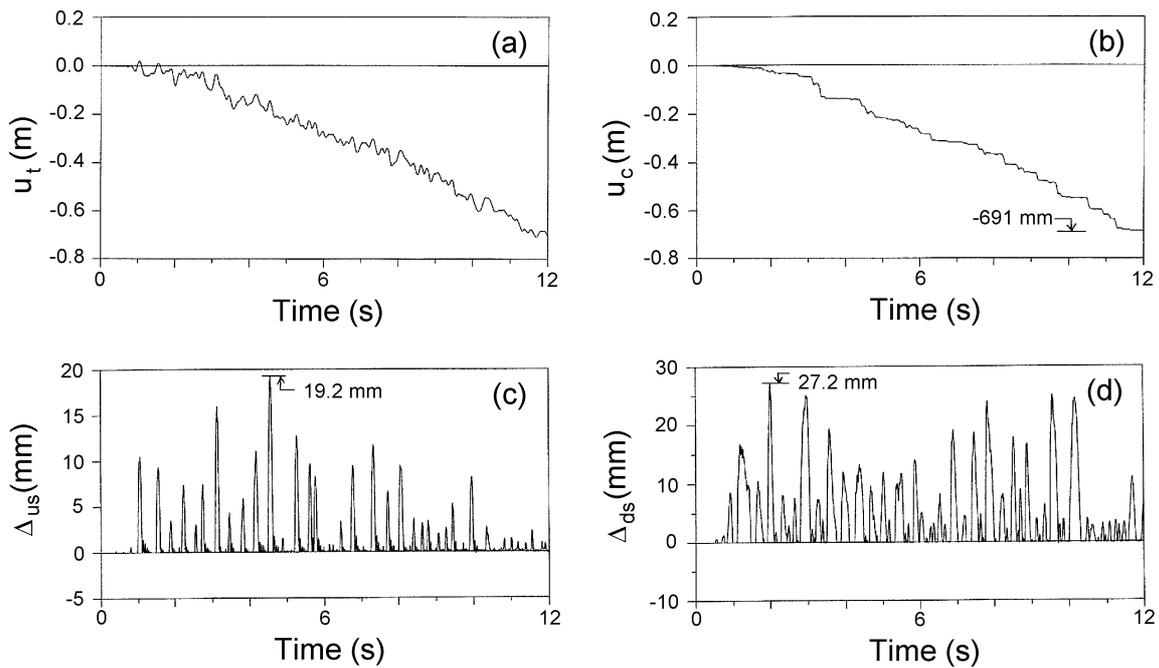
From Fig. 5, it is obvious that the final sliding displacement of the detached upper portion of the dam is proportional to the duration of the strong ground shaking. In the present study, the effect of water in the crack has not been considered. This could lead to a reduction in the frictional resistance in the crack. Moreover, it has been assumed that the mass concrete remains intact at the upstream and downstream rocking points, where very high local stresses are expected to lead to spalling of concrete. Spalling can also be the result of combined action of rocking and sliding motions. Such structural damage was, for example, observed at the Sefid Rud buttress dam, which was subjected to very intense ground shaking during the 1990 Manjil earthquake in Iran (Wieland et al., 1996; Wieland, 1999).

**Fig. 5** Time histories of (a) radial displacement of dam crest, (b) sliding movement towards upstream along crack surface, (c) crack opening at upstream dam face and (d) crack opening at downstream dam face for earthquake excitation with peak ground acceleration of 0.5 g (coefficient of friction: 0.7; crack inclination: 15°)

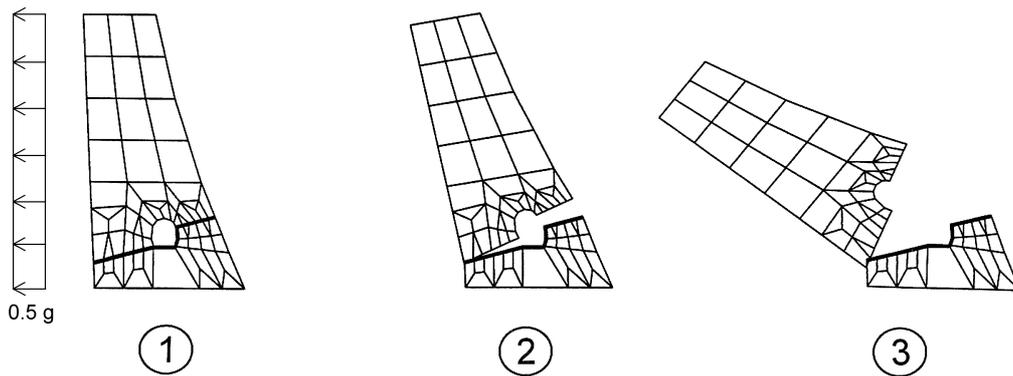
6. In a pseudostatic stability analysis, the upper portion of the dam would fail by overturning when subjected to a horizontal acceleration of 0.32 g. The failure mode for a pseudostatic earthquake loading is illustrated in Fig. 6. A dynamic stability analysis, however, proves that such a failure mode does not occur, as the failure will be due to sliding. The detached upper portion can, in fact, withstand a much larger ground acceleration without overturning than what one would expect on the basis of a pseudostatic analysis. The failure mode from a dynamic analysis of the detached upper portion of the dam under the earthquake loading is shown in Fig. 7.

**Fig. 6 Failure mode of the dam obtained from pseudostatic analysis (rocking failure)**

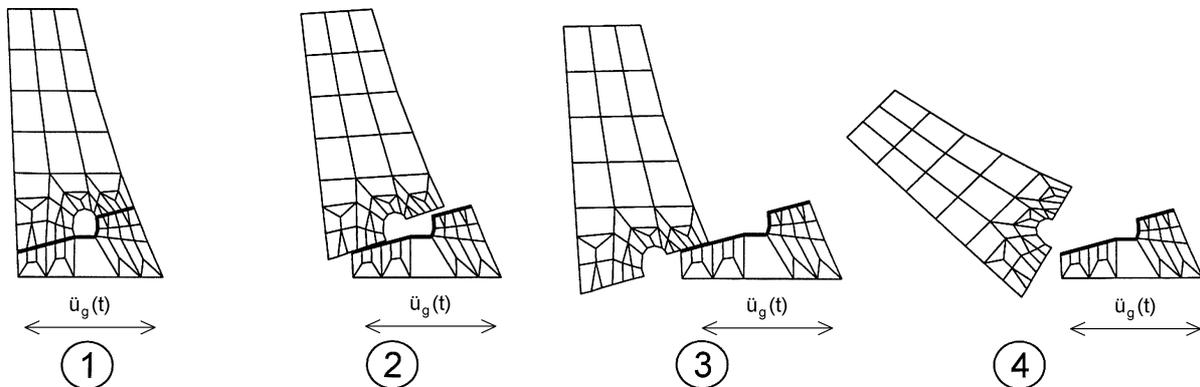
**Fig. 7 Failure mode of the dam obtained from dynamic analysis for earthquake excitation with peak ground acceleration of 2 g (sliding failure)**
