IN SITU TESTS FOR THE ASSESSMENT OF SEISMIC RESISTANCE OF OLD STONE-MASONRY HOUSES

Miha TOMAŽEVIČ¹, Iztok KLEMENC² And Marjana LUTMAN³

SUMMARY

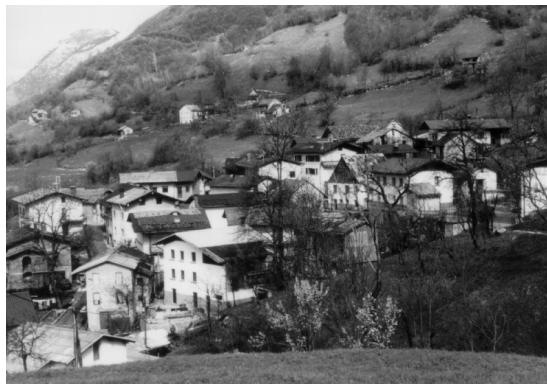
Typically, stone-masonry houses are 2 - 3 storeys high (Figure 1). Floor structures and lintels are traditionally wooden, without any wall-ties provided to connect the walls. Wooden floors and lintels have been replaced with reinforced-concrete slabs in the cases where houses have been remodelled to meet the demands of the growing tourism in the region in the last decades. However, wall-ties have been installed only in the case of a small number of buildings after the earthquake of 1976. Roof structures are wooden. They are covered with ceramic tiles, sometimes laid in mortar. As a rule, the buildings are built without any foundation, and foundation walls are of lesser quality than the walls of the structure above the ground level.

Figure 1. Typical village in the earthquake-damaged area

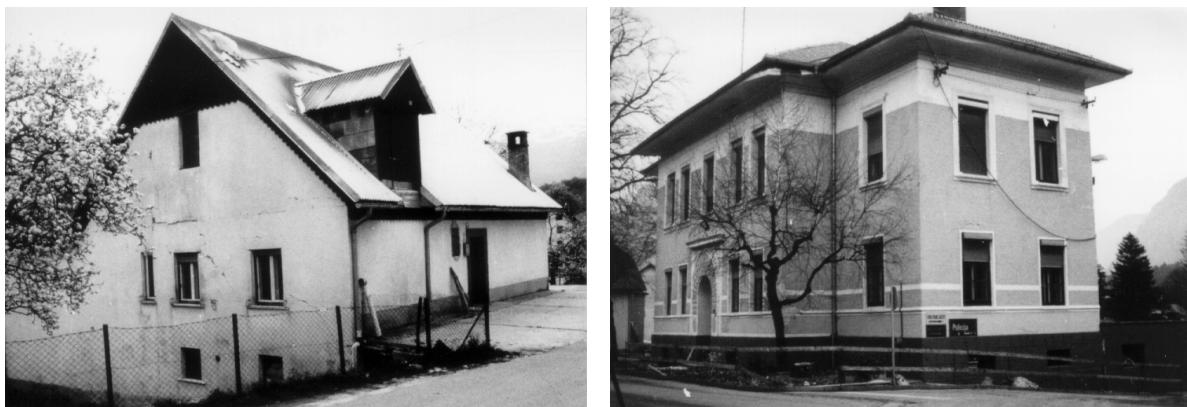
Figure 2. Typical (left) residential and (right) public building, where the in-situ tests have been carried out

Taking into consideration the observed differences in the quality of existing masonry and structural configuration, tests have been carried out on traditional residential houses in villages as well on the public buildings in towns. Since many owners of buildings did not permit to use their houses for testing, it has not been possible to carry out tests in the most damaged part of the zone. A suitable building has been found in the village of Kal-Koritnica near the town of Bovec, which also suffered damage during the earthquake (building A - Figure 2, left). In the category of public buildings, however, the walls of two buildings have been tested (elementary school building in the village of Soča - building B, and Bovec Police station building - building C, Figure 2, right).

When selecting the suitable buildings for testing, attention has been paid that, for the specimens tested in the existing condition, a sufficiently large part of the masonry at a suitable location in the structure has not been damaged by the earthquake. As regards the cement-grouted walls, however, the masonry walls, from which the specimens in buildings A and B have been cut, have not been damaged before the grouting, whereas in the case of building C, the masonry suffered minor cracks during the earthquake.

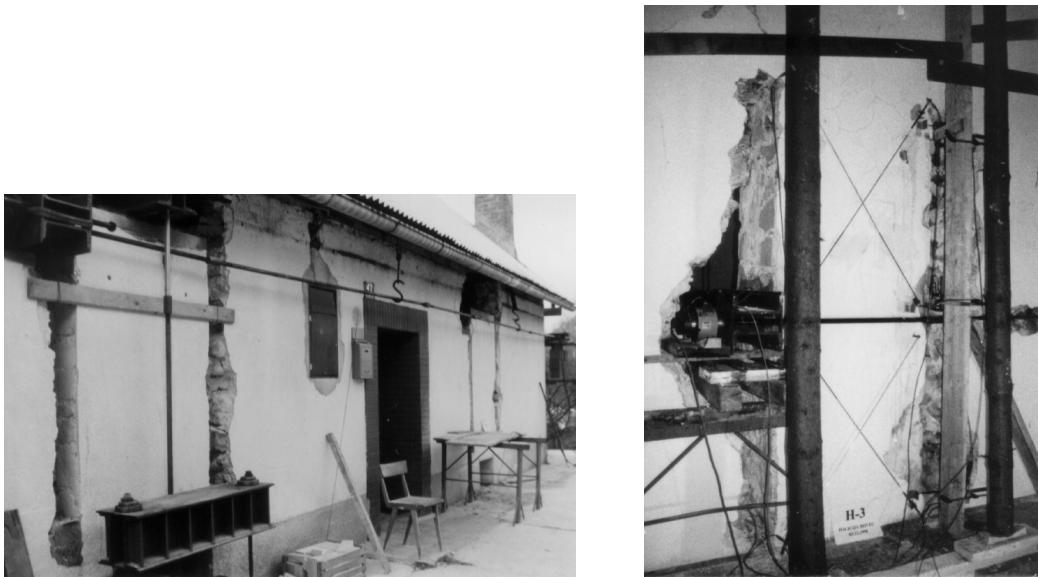
Figure 3. (Left) Arrangement of test - building A and (right) crack pattern in a tested cement-grouted wall at ultimate state - building C

As expected, all walls, existing and cement-grouted, failed in shear. Diagonally oriented cracks developed, beginning at the point where the lateral load has been applied and directed to the opposite corners of the wall at the top and bottom of the specimen. Typical crack patterns for the case of the fixed-ended specimen, tested in building C, are shown in Figure 3, right. Except in the case of building A, tests have been terminated before the final collapse of the specimens.

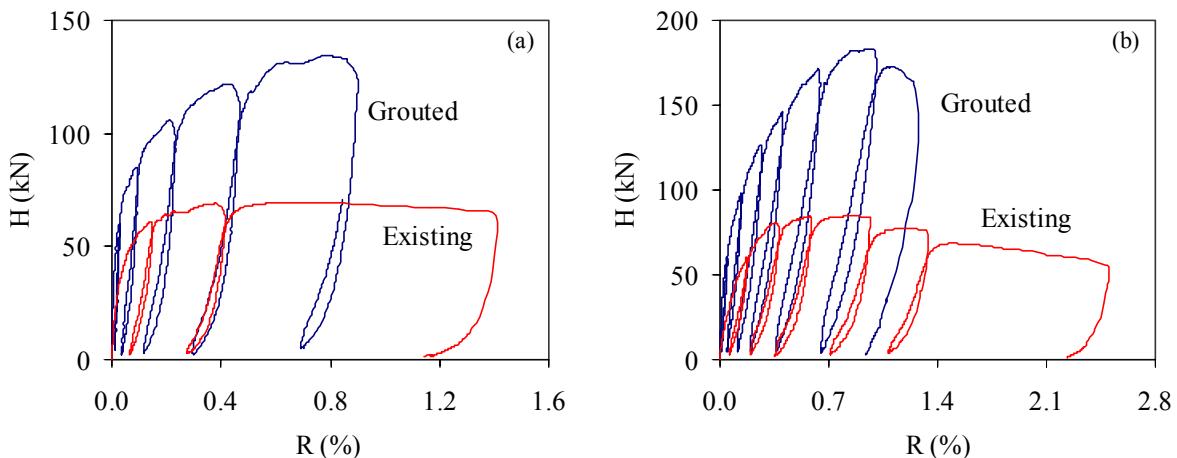
Typical relationships between the lateral load and rotation angle (displacement/half-height of the wall ratio), obtained by testing the existing and cement-grouted specimens in buildings B and C are shown in Figure 4a and 4b, respectively. The dimensions of the specimens and test results are summarised in Table 1, where the ratios of improvement of the tensile strength in increase in shear modulus due to cement-grouting are also indicated.

Figure 4. Lateral load - rotation relationships obtained by in situ lateral resistance tests of existing and strengthened walls in (a) building B and (b) building C

As can be seen, by cement-grouting, the tensile strength of the stone-masonry, which determines the shear resistance of walls, is significantly improved. It can also be seen, that the values of shear modulus, which determine the stiffness of the walls in the particular case of stone-masonry, is also increased. Taking this into consideration, it can be concluded that changes in distribution of seismic loads onto the walls may take place if only single walls in the plan of a storey are strengthened. This may result into an unexpected behaviour of the partially strengthened building during earthquakes. In order to avoid this, it is recommended that cement-grouting of stone-masonry walls, if needed, be executed uniformly over the entire floor area.
