EVALUATING CURRENT PROCEDURES AND MODELING FOR SEISMIC PERFORMANCE OF REINFORCED CONCRETE BUILDINGS

SUMMARY

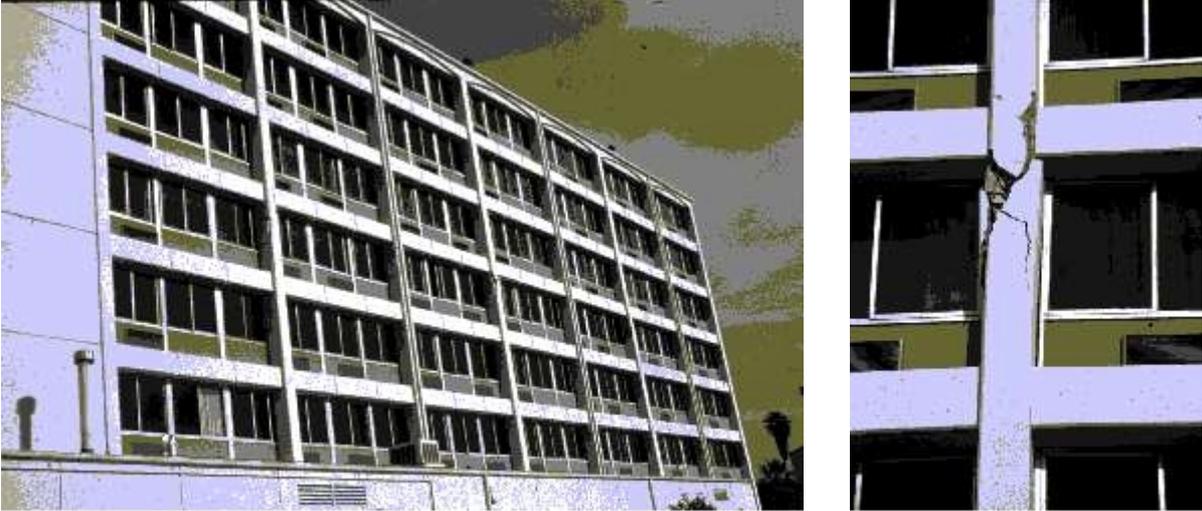
Observed structural damage was concentrated in the bottom floor and the top of the fourth floor columns (Figure 2). Horizontal cracking at the column bases of the north face was also observed. The failures at the tops of the south face exterior columns at the fourth floor show inclined cracking, buckling of longitudinal steel, and splitting of the concrete along the longitudinal reinforcement (Figure 2). The damage suggests distress due primarily to shear and bond splitting.

Figure 2: South face of structure (left), and detail of damaged column (right) - damage after the 1994 Northridge earthquake [EERC 1994]
