STRUCTURAL BEHAVIOR DURING THREE MODERATE MEXICAN EARTHQUAKES.

SUMMARY

This paper summarizes the experiences obtained by the Grupo Interuniversitario de Ingeniería Sísmica (GIIS), of three epicentral Mexican areas during three important earthquakes in 1995: September 14th, in Ometepec, Guerrero; October 9^h, in Manzanillo, Colima; October 21st, in Villaflores, Chiapas. Different types of failures are analyzed and discussed in adobe, masonry, concrete and steel structures.

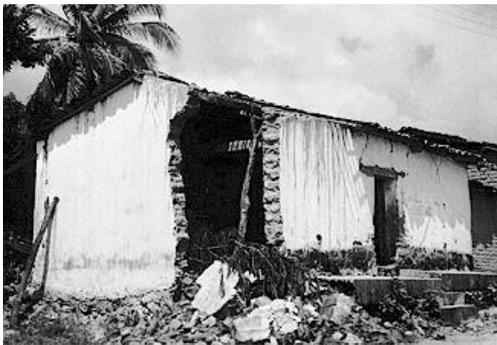
- 1) The first was the lack of adequate connection in the corners that led to the outward failure of the walls, (figure 1).
- 2) The second was the failure due to excessive stress concentration at the corners of doors and windows, (figure 2).

Figure 1. Outward failure of walls due to inadequate connection of corner walls.

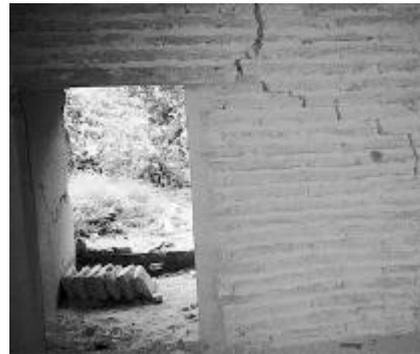
Figure 2. Stress concentration at the corners of doors and windows.

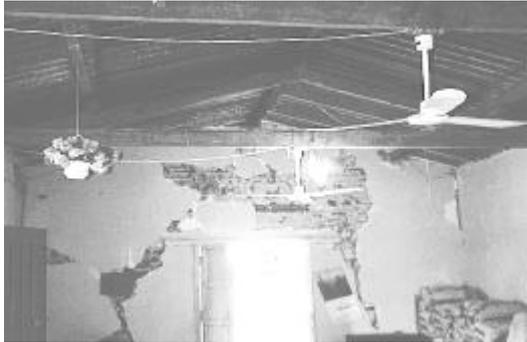
- 3) The third one was associated to the roof system (figure 3), which is made of wooden girders that support the roof tiles. Two slopes are presented in the roof system, there is a large wooden girder in the center of the slopes. The ground motion provoked inertial forces that struck the main central girder, provoking the outward failure of walls due to flexure, (figure 4). During the earthquake the roof tiles were thrown from

Figure 3. Typical roof system in the epicentral region of Ometepec.

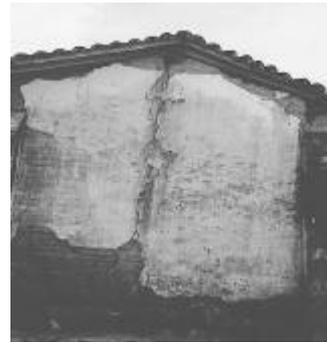
Figure 4. Flexural failure provoked by the roof system.

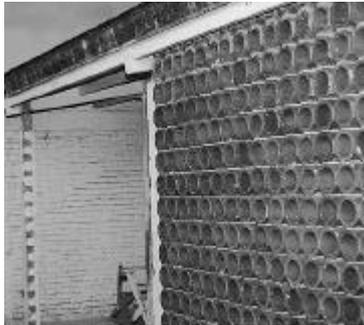
elements, exhibiting good seismic behavior. The only failure reported, occurred in the tile bricks used as walls, due to the inadequate connection between the tile bricks and the steel structure, and this provoked the outward collapse of the walls, (figure 7).

Figure 7. Outward failure of walls due to inadequate connection.

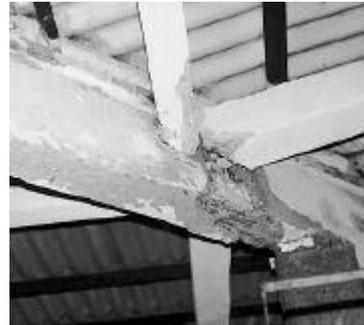
The reinforced concrete structures of the epicentral region were found in the town of Ometepec, and only three of them were reported with slight damage. The damages were provoked because of the poor structural configuration, such as short columns, or inadequate position of structural elements, (figure 8).

Figure 8. Inadequate position of structural elements.

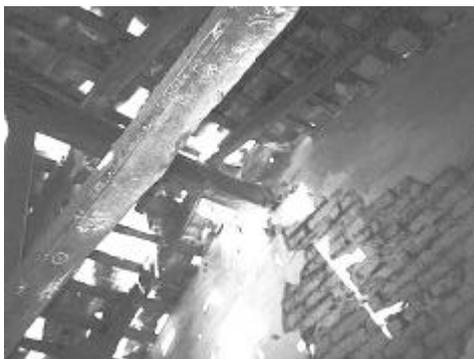
Figure 9. Flexural failure provoked by the roof system.

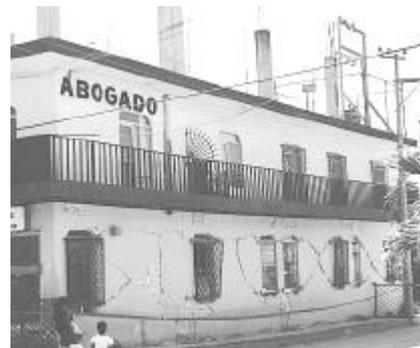
Figure 10. Stress concentrations at the corners of windows.

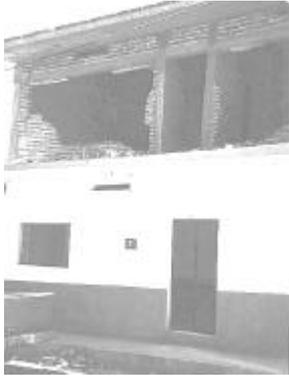
A poor response also resulted from inappropriate connection between stories, (figures 11 and 12), generally in old houses where a second story was added to an older pre-existing single story house, damages were found in the second story. In these cases, the first story was often made of unreinforced masonry walls, usually exhibited inadequate anchorage and overlapping of the longitudinal bars of castillos and dalas of the second story.

Figure 11. Inadequate connection between stories.

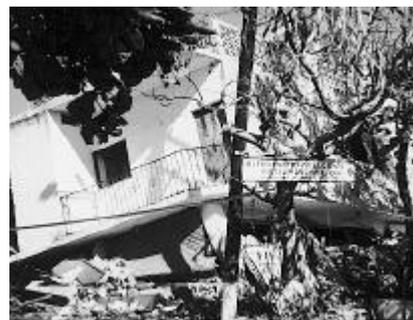
Figure 14. Weak first story failure.

Inadequate structural configurations led to poor behavior of structures, in figure 14 and 15 the irregularities in plan and elevation, the poor amount of longitudinal and transversal bars in the dalas and castillos provoked the collapse and heavy damage of the first story.

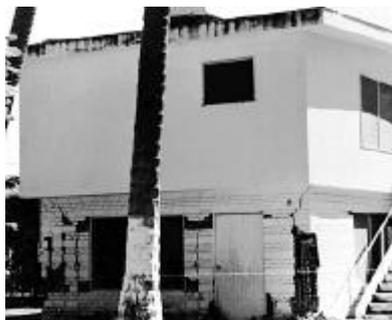
Figure 15. Weak first story failure.

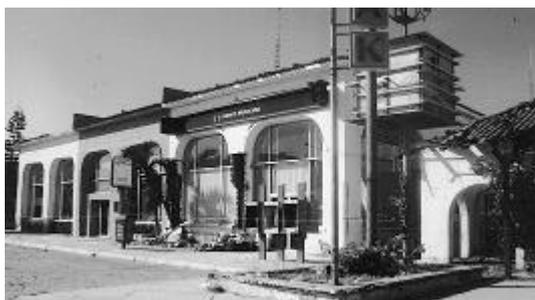
Steel structures, in general, performed well during the earthquake, but a shopping mall in Manzanillo did not have an adequate performance. Four separate steel buildings comprised this shopping mall complex. A light steel-framed structure was the backbone of each of the separate square-shaped structures. Corridors of reinforced masonry walls surrounded each structure on two or three sides. Many plan and elevation irregularities, with structural elements having great differences in stiffness, resulted in heavy damage. The poor anchorage and overlapping in reinforcing bars in the corridors of the shopping mall allowed partial collapse, and ten people were reportedly killed, (figure 17).

Figure 17. Failure of corridors in the shopping mall complex.

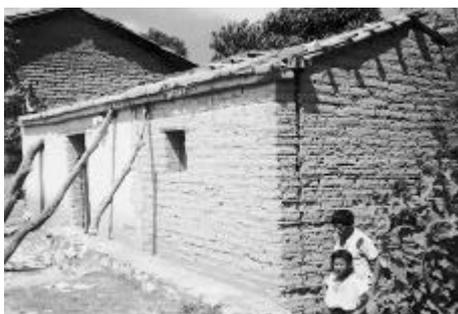
Figure 19. Inadequate connection in the corner walls.

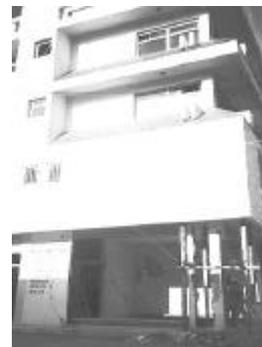
These types of structures performed well during the Villaflores earthquake, even though wooden poles were used as dalas and castillos, (figure 22). In figure 23, a reinforced masonry structure presented no damage, while this adobe structure was completely collapsed. Those structures that performed poorly during the earthquake were because of the poor structural configurations, irregularities in plan and elevation, weak first stories, (figure 24), and inadequate lateral reinforcement.

Figure 24. Weak first story failure.

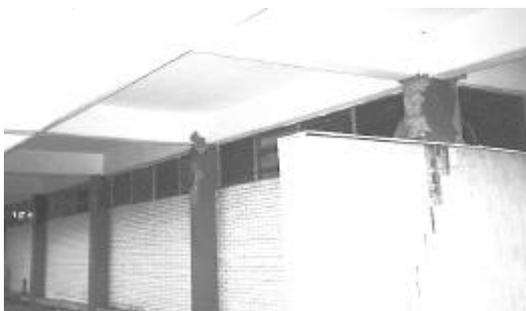
In general these structures performed well during the earthquake, but some of them were reported as damage. The poor seismic behavior was because the lack of engineering advice, and these two problems were detected: short columns with inadequate stirrup spacing, (figure 25); and inadequate disposal of longitudinal bars, package of bars with inadequate stirrup spacing, (figure 26). No damages were reported on steel structures.

Figure 25. Short column configurations led to poor behavior.

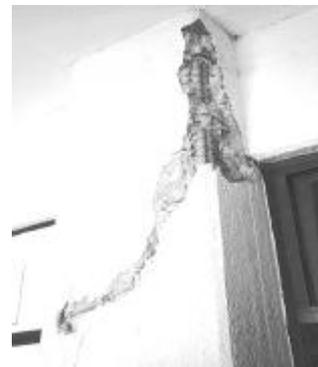
Figure 26. Inadequate stirrup spacing.
