HOSPITALS BEHAVIOR DURING THE SEPTEMBER 1997 EARTHQUAKE IN UMBRIA AND MARCHE (ITALY)

SUMMARY

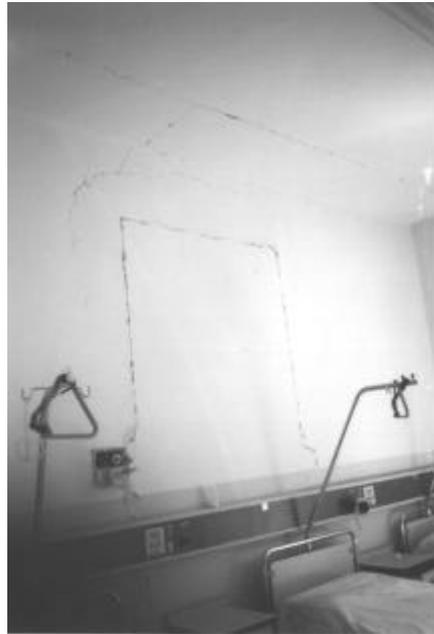
Fig 6: Foligno - small cracks in interior wall

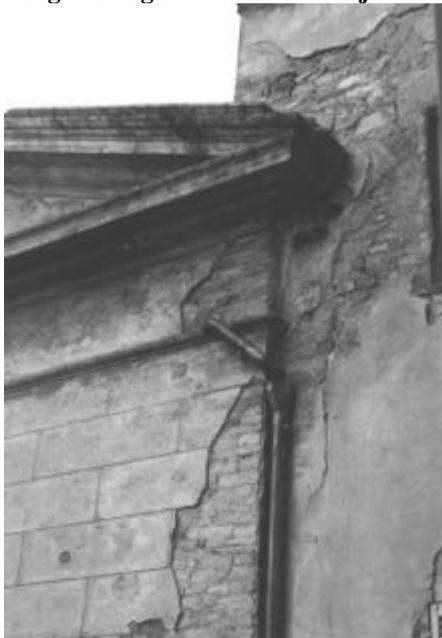
Fig 7: Foligno - interaction with the adjacent roof

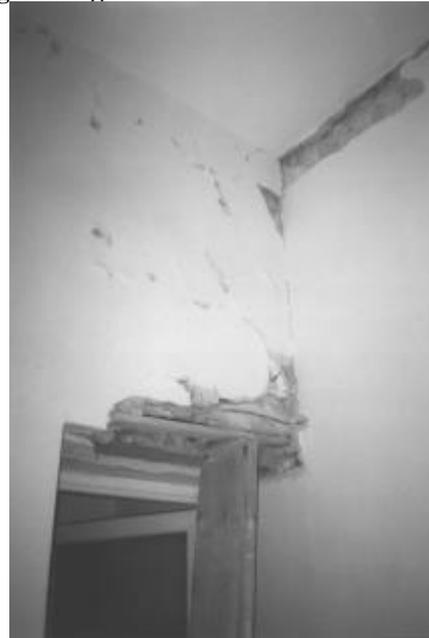
Fig 8: Foligno - collapse of a beam

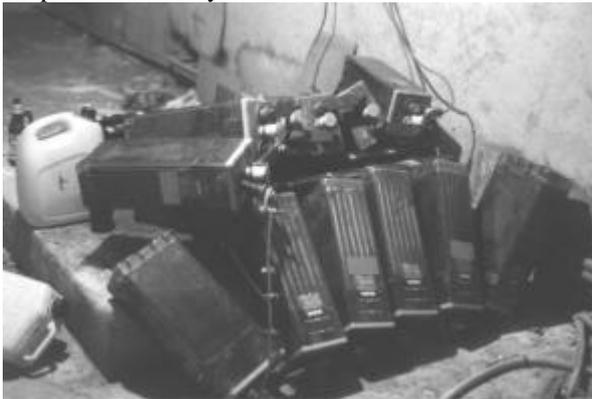
place; this caused, beyond the derailing of the elevator, the fall of the light batteries from the racks (Fig.9). This has been confirmed also by the readings taken by the accelerometers installed in building 1 by the Servizio Sismico. During the earthquakes after September 26, at the second level an acceleration peak more than three times the PGA was recorded. Some losses of oxygen from the pipelines were also observed.

Fig 9: Foligno - fall of the batteries from the racks

- (1) The anchorages of the equipments and cabinets having stability problems should be improved, particularly at the higher levels, where an amplification of the ground motion up to 3 in terms of accelerations was recorded. This meant for a VII local macroseismic intensity that the acceleration exceeded 0.5 g.

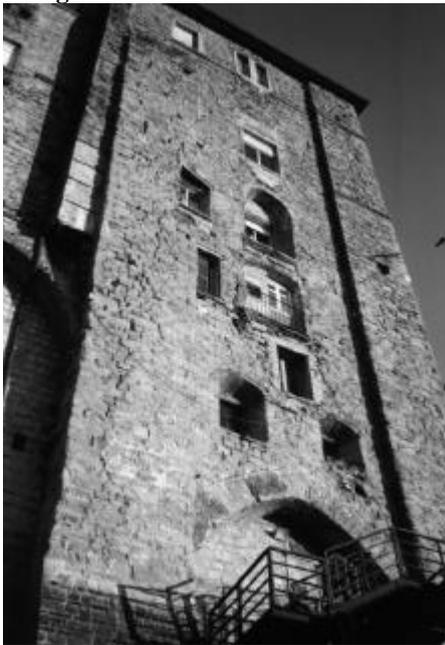
Fig 11: Camerino - cracks in the S-W corner wall

The facility was externally in good state, particularly the newer two buildings, where a light pounding in correspondence of the joints was only visible. The situation, due to the localization of the complex, was different and heavier with many dangerous stone falls on the narrow street, which gets at the hospitals. The 14th century building showed cracks also externally particularly in the S-W corner and in the N facade (Fig. 11). The former namely is the point of higher fragility of the complex whereas the two modern buildings showed damages only in correspondence of the joints because of the pounding (Fig. 12). In the E side important damages are present in the whole 14th century building. Cracks on the walls and on the floor are visible. The whole area, which looks toward the Camerino town, particularly the areas in the S-W corner, was particularly damaged. The whole W facade looked separated from the floors; some E-W chains looked damaged; one of the S facade chains was broken and partially expelled by the walls, whereas the chimney that goes beyond the roof showed a clear fracture in correspondence of the last level, with a displacement of some centimeters. The particular plan distribution of the different buildings and the abrupt stiffness variation due to the interruption of the building showed clearly the seismic sensitivity of the S-W part.

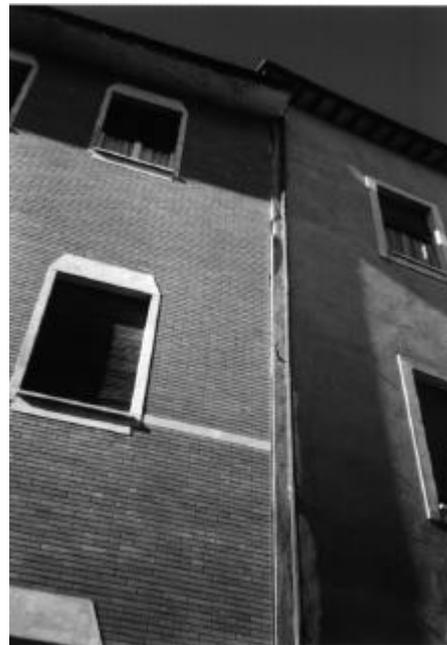
Fig 12: Camerino – pounding
