## **1994 NORTHRIDGE EARTHQUAKE: DAMAGE TO A FOUR-STORY STEEL BRACED FRAME BUILDING AND ITS SUBSEQUENT UPGRADE**

**Dominic J KELLY<sup>1</sup>, David R BONNEVILLE<sup>2</sup> And Stacy J BARTOLETTI<sup>3</sup>**

### **SUMMARY**

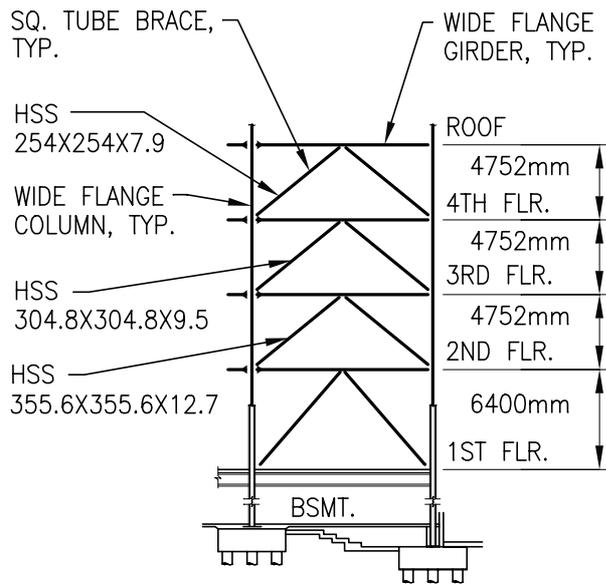
**Figure 3: Typical Chevron Braced Frame**

The floor framing consists of concrete fill on metal deck that is supported by composite steel beams and girders. The steel structure is supported on precast concrete pile foundations. Seismic forces are resisted in each direction by six bays of Chevron-configured tube steel braces for a total of 12 braces in each direction in each story. The locations of braced frames are indicated in Figure 1 and a typical braced frame elevation is shown in Figure 3. The braces were slotted at their ends and welded to the gusset plates, and the gusset plates were welded to the beams and bolted to the column flanges through double angles. Beams within a bay of bracing generally had welded beam flange-to-column connections, and the web was bolted with double angles.

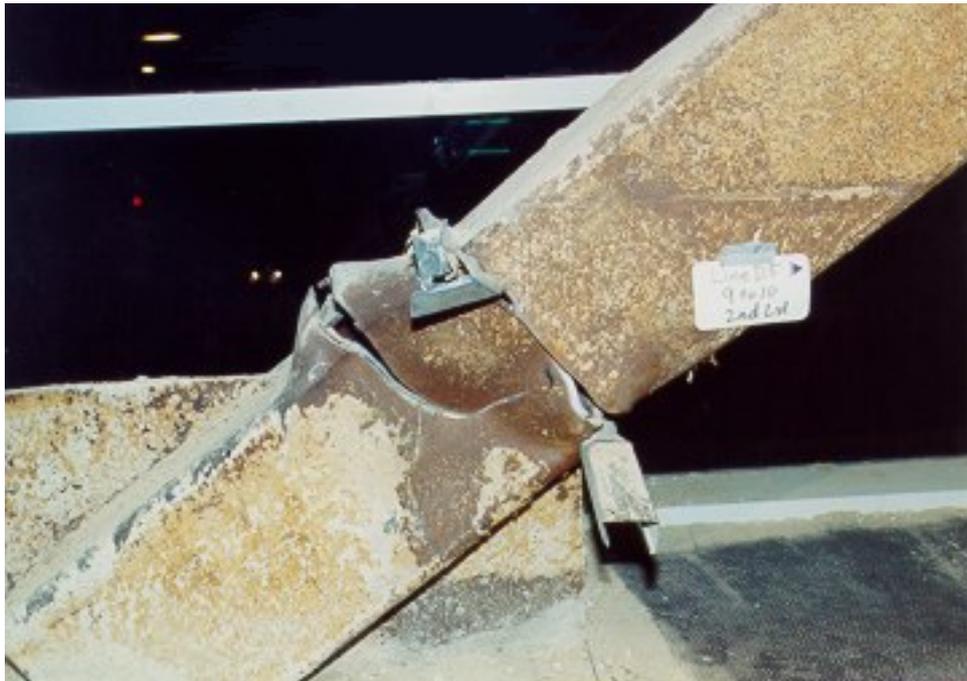
Eventually, the team came to a location in a stairwell with a large bulge in the wall at the second level. Because a bay of bracing was located behind this wall, it was decided that the braces be exposed to view the cause. The braced frame damage concealed by the walls consisted of the following: the bottom flange of the supporting overhead beam twisted out-of-plane, the end connection of one of the braces failed and the other brace fractured. The intense level of structural damage in this particular frame warranted further investigation of the other braced frames. The additional investigation into the remaining braced frames concluded that every second level brace oriented to resist north-south forces lost all or most of its capacity.

The loss of capacity was primarily due to premature fracture of the tube steel braces initiated by local buckling of the thin walls. The width to thickness (b/t) ratio of these braces was 29. Fractures were located at the middle of the brace length and immediately adjacent to the gusset plate connections at the ends, locations most affected by overall brace buckling (Figure 5). Tang and Goel predicted such fractures in 1989 based on laboratory tests, but up until Northridge, post-earthquake investigations of buildings with tube steel braces did not indicate a problem with thin-wall buckling.

**Figure 5: Brace Fracture**

HP chose to upgrade the lateral force resisting system to the provisions for a special concentric braced frame in the Uniform Building Code, 1994 edition, and the requirements of the Los Angeles Building Code, 1992 Edition. A principal reason for this decision was that there were indications that the City of Los Angeles was going to require a building with more than 10 percent loss of strength in its lateral force resisting system to be upgraded to the current building code. There was confusion as to whether the City would require all levels of the building to be upgraded or just the second level since substantial damage only occurred in the second level. HP, with the guidance of its structural engineer, chose to address the whole building.

Therefore, proposed provisions and recommendations made by Goel, et al (1989, 1991) were used for the upgrade design. The design team considered the advantages and disadvantages of using a two-story X configuration, a modified chevron configuration that had a zipper column in the centre of the bay of bracing in all levels above the first floor, and a tied column in the centre of the chevron at all levels. These configurations are described in greater detail in a report by Khatib, Mahin, and Pister. The modified chevron with a zipper column was chosen for the upgrade, because it distributed buckling over the height of the building better than the other configurations considered. An example of this configuration is shown in Figure 4. Instead of using tube steel braces, wide flanged members were used. Connections were designed for the member tension capacities rather than the force requirements of the Los Angeles and Uniform Building Codes. The lowest levels of several of the columns were strengthened with steel side plates in order to avoid buckling of the columns. In accordance with what Goel (1991) espouses, relatively slender braces were used. The expected behaviour of the upgraded system is further described in Bonneville and Bartoletti (1995) and in Bonneville, et al (1995).
