JANUARY 25TH 1999 EARTHQUAKE IN THE COFFEE GROWING REGION OF COLOMBIA: DAMAGE DESCRIPTION IN THE AREA AND EMERGENCY RESPONSE

Omar D CARDONA¹

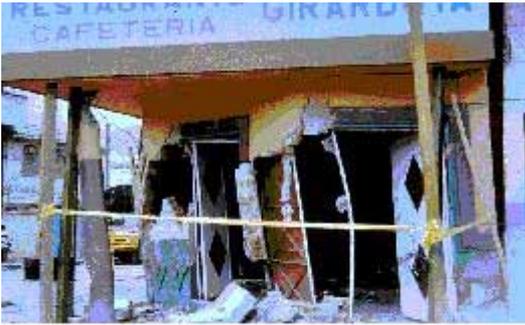
Damages were concentrated mainly in older buildings, unreinforced masonry buildings without confinement in elements of reinforced concrete and in buildings designed and constructed before the first national earthquake resistant construction code was introduced (Photos 1 - 4). The first nationwide code was legislated in 1984 as a positive product of the 1983 earthquake that affected the city of Popayán. A majority of more modern structures, constructed after development of the nationwide seismic code of 1984, only sustained non-structural damage to walls, partitions, ceilings, architectural finishes, etc. However, this type of damage was expected in case of a very strong earthquake. Consequently, in 1997 the Asociación Colombiana de Ingeniería Sísmica convinced the

Photo 1: Seriously damaged non earthquake resistant brick masonry building

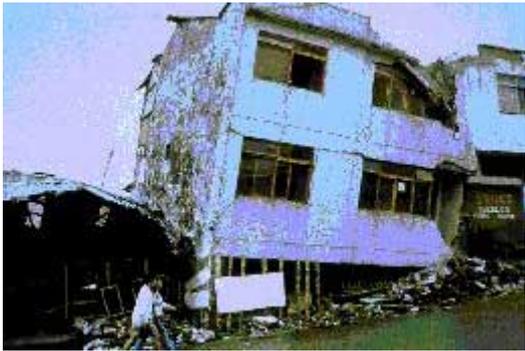
Photo 2: Collaps of unreinforced, non earthquake resistant brick masonry building

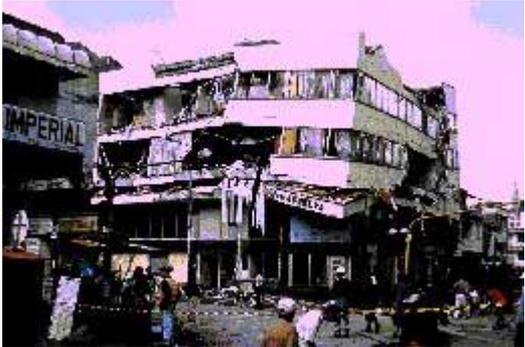
Photo 3: Collapse of old non earthquake resistant building.

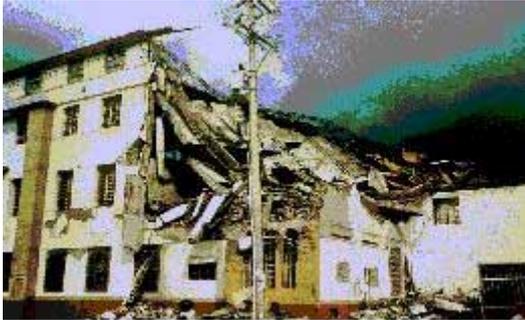
Photo 4: Partial collapse of old reinforced concrete building

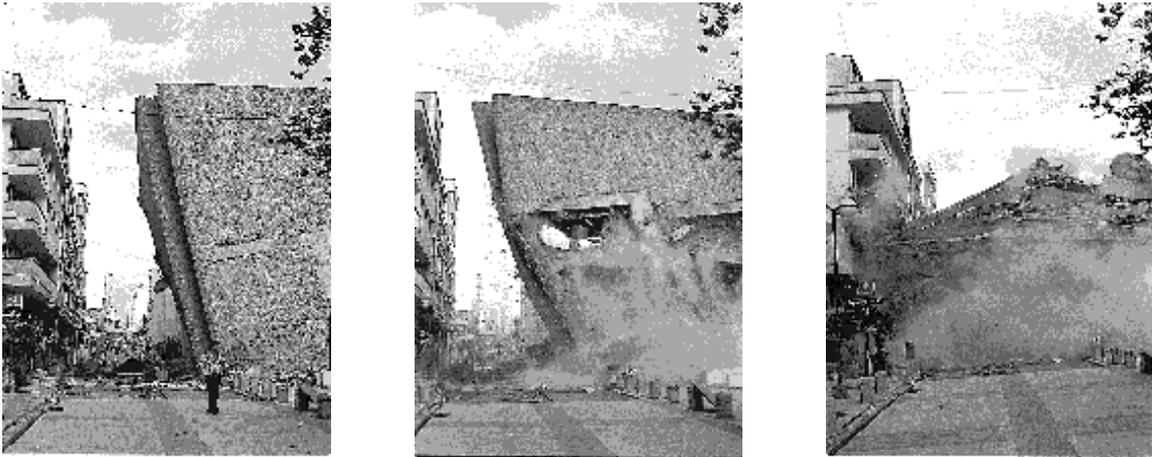
Photo 5: Photographic sequence of the collapse of modern building during the 5:40 p.m. aftershock.

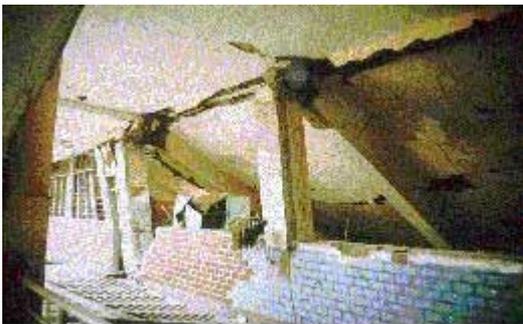
Photo 6: Failure of beam-column joint due to lack of transversal reinforcement

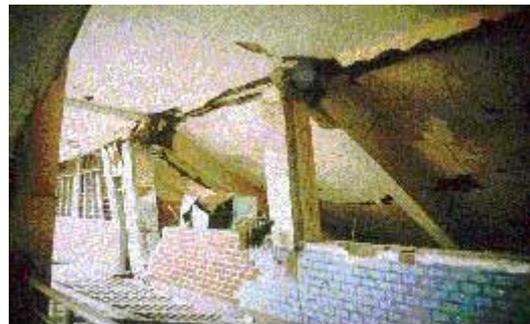
Photo 7: Column failure due to lack of stirrups and confinement

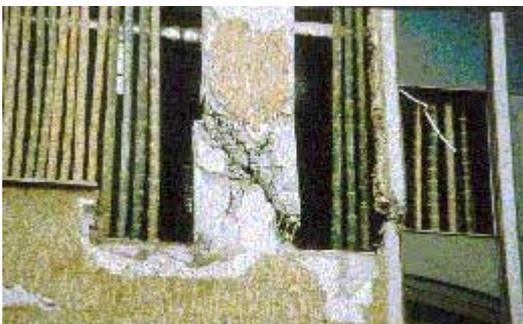
Photo 8: Fragile failure of a column due to insufficient transversal reinforcement

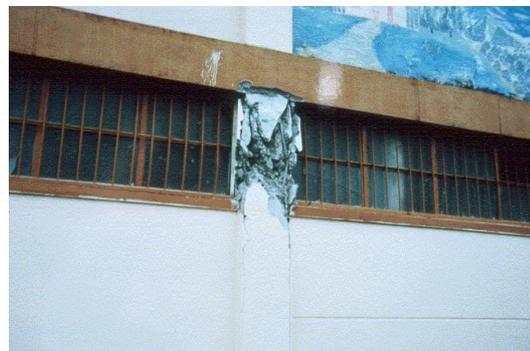
Photo 9: Short column effect due to adverse interaction of brick masonry walls

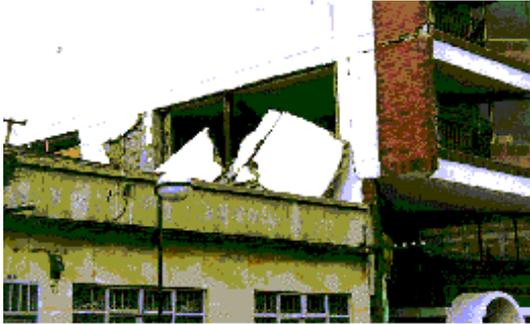
Photo 10: Brick masonry infill walls failure because lack of connection

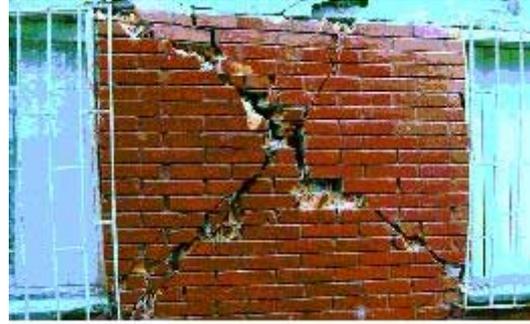
Photo 11: Shear failure in brick masonry infill wall of a reinforced concrete frame

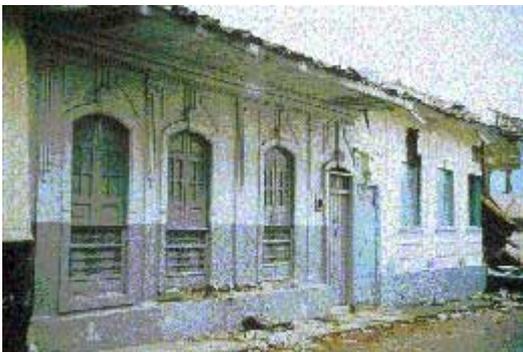
Photo 12: Bahareque de guadua (bamboo) structure, "temblorero style"

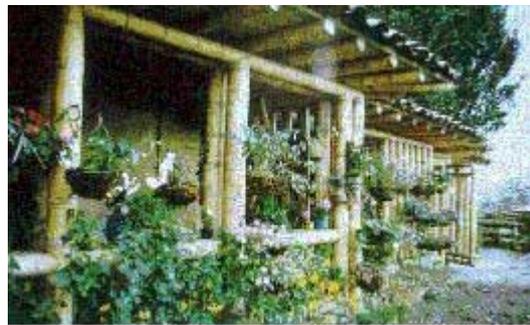
Photo 13: Guadua structure displaying satisfactory, seismically resistant behavior

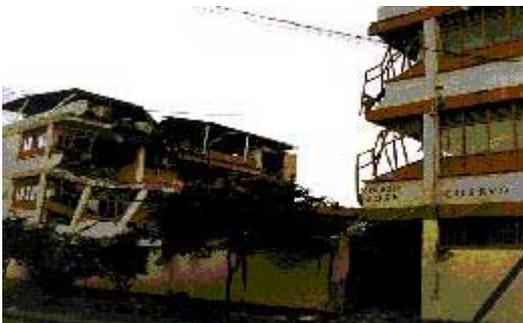
The structures of a large number of schools and colleges were greatly affected. It is estimated that nearly 80% of the educational buildings in the zone suffered moderate to severe damage (Photos 14 -15). Many health facilities serving small populations had serious damages; Armenia's main hospital had to be partially closed due to non structural damage that impeded its function. It is important to note that this hospital was in the process of being seismically retrofit but the intervention had not yet been completed. The main buildings of the National Police and the Fire Department both collapsed, killing a significant number of police and firemen; personnel critical to emergency response (Photos 16 - 17). The majority of the churches of the city and of the villages surrounding the epicentral zone suffered serious damage and some roofs suffered total collapse.

Photo 14: Collapse of structure belonging to educational sector due to short columns

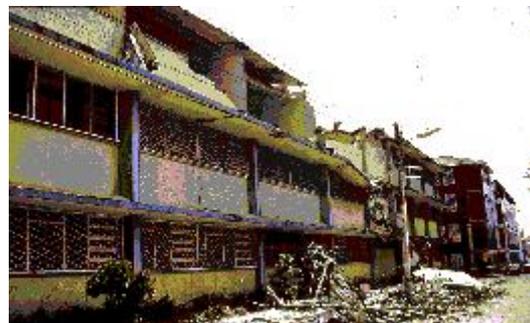
Photo 15: Collapse of school building of reinforced concrete frame system

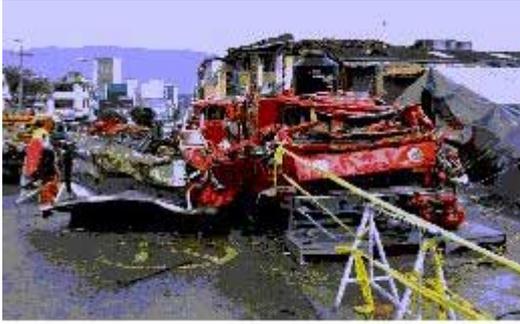
Photo 16: Condition in which fire trucks remained after the collapse of the fire station

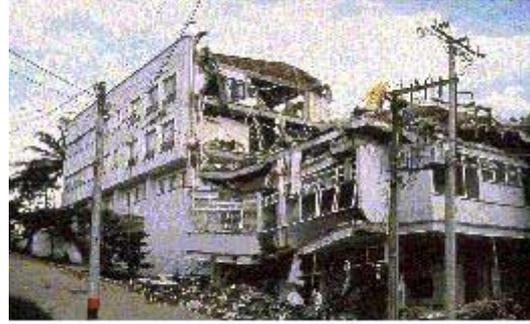
Photo 17: Older structure housing police station, in which many policemen lost their lives

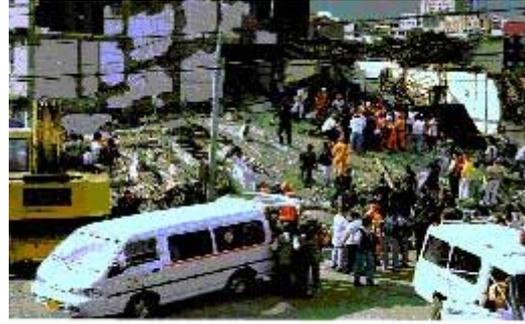
Photo 19: The collapse of buildings blocked some streets impeding the moving of rescue teams
