## PERFORMANCE OF INDUSTRIAL FACILITIES IN THE AUGUST 17, 1999 IZMIT EARTHQUAKE

Mohsen RAHNAMA<sup>1</sup> And Guy MORROW<sup>2</sup>

### SUMMARY

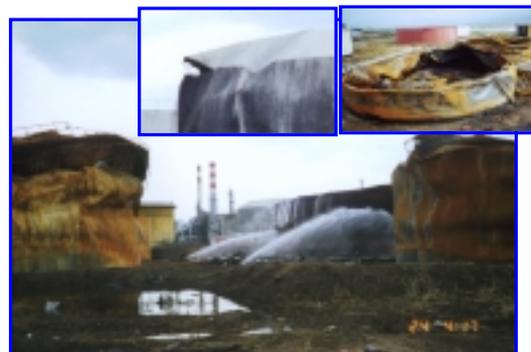
The tank farm has more than 110 tanks of varying sizes containing water, crude oil, and other oil substances. Sizes range from 1,200 m<sup>3</sup> to 135,000 m<sup>3</sup> and roofs are both floating and fixed. Table 2 shows geometric information of the six tanks that were damaged due to ground shaking and fire. It appears that ground shaking caused oil leakage and vertical movement of the floating roof created sparks which led to the fire ignition. Shell buckling at the base of tanks and resulting oil leakage may have contributed to spread of the fire. Additional investigation will be needed to verify how the fire started and spread to the nearby tanks. The extreme heat caused the steel to melt and tanks to experience a significant amount of deformation. Figure 5 shows the

Figure 5: State of damage to tanks

burned floating roof tanks and buckling of the wall and roof of tanks with a fixed roof.

Tanks No.	Dim. (m)	Height (m)	D/H	Roof Type	Damage
202	36.5	16.42	2.22	Floating	Collapsed
203	36.5	16.42	2.22	Fixed	
241	13.7	12.80	1.07	Floating	
242	21.30	14.6	1.46	Floating	
221	27.4	14.6	1.88	Fixed	Buckling of wall & Roof
222	27.4	14.6	1.88	Fixed

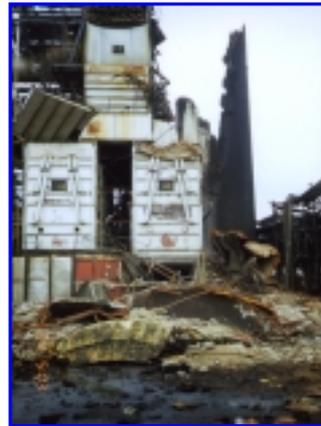
**Figure 6: Stack collapsed in Crude Unit**

The collapse of a 115-meter tall, 10.30-meter diameter reinforced concrete stack was a separate source of fire and destruction at the crude oil processing unit. This crude oil unit was the most recent addition to the refinery, built in 1983 as the third phase of expansion. Part of the collapsed stack fell on the boiler and crude oil processing unit, which caused significant damage to the processing unit, boiler, pipeway and surrounding facilities. The release of fuel from piping systems was the primary cause of the fire at the crude oil unit. Figure 6 shows the collapse of the stack in the processing unit. Figure 7 shows damage to the piping system due to collapse stack and fire. In the Crude Unit, columns supporting the furnace were exposed to extreme heat due to the fire and buckled. Figure 7 shows the buckling of the steel column which supports the furnace. Similar types of failure mode have occurred in past events, which could be prevented if steel elements were covered by fire proofing materials.

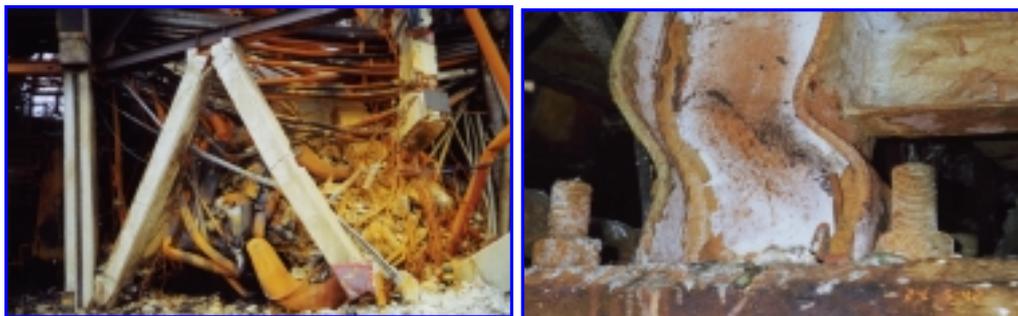
**Figure 7: Destruction of the piping system and buckling of steel columns supporting furnace**

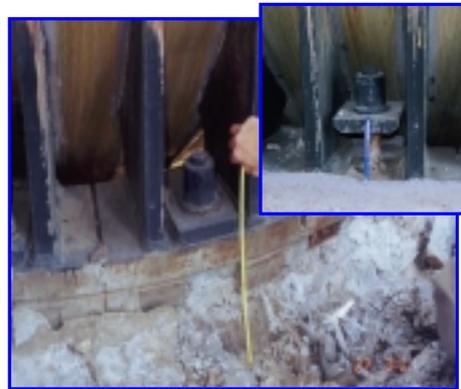
The ammonia building is a tall concrete frame-wall structure, which houses heavy processing equipment, storage tanks, pipes, a boiler, and a tall cylindrical reactor vessel. This structure experienced extensive damage at the upper levels, especially at beam-column connections. A two inch wide concrete crack extended one-third of the column height at the top levels of the structure. The concrete column lacked adequate confining steel reinforcement to resist the seismic loads to which the structure was subject. A thick concrete slab at level four of the processing unit building, which supports a reactor vessel, cracked and was severely damaged due to rocking and uplift of the reactor. A steel stack was attached by horizontal angles to the top of the exterior wall of the processing unit building. The connections of the angles to the wall failed. However, the stack remained standing without the lateral support provided by the angles.

**Figure 8: Damage at the base of reactor vessel**

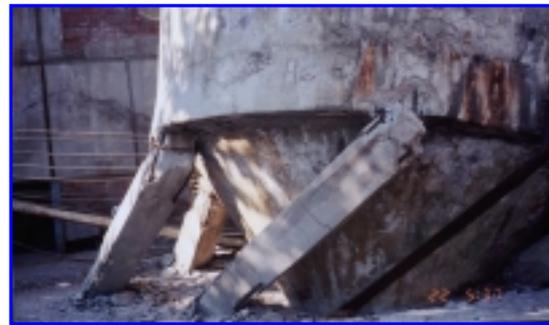
At the #1 paper plant, three concrete silos containing wastewater completely collapsed. The diameter of the silos was 6 meters and they had a capacity of about 200 m<sup>3</sup>. The silos were supported on six 40cm square concrete columns. The reinforcement of the columns was less than 1% of gross concrete area and confinement was minimal. The failure of the columns occurred at the connection to the cylindrical wall. Two more recently constructed silos of similar dimension did not fail. These silos have larger support columns than the failed silos.

**Figure 9: Collapsed silo at Seka Paper Plant**

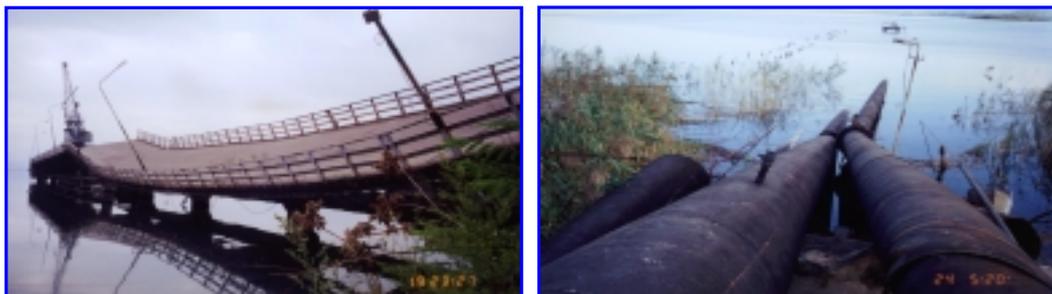
The #4 paper plant, a steel frame structure with steel roof trusses, had an inadequate lateral load resisting system. The roof is a 4-inch concrete panel system, supported by transverse steel beams. In few locations, the concrete roof panels dropped causing damage to the nearby equipment. At both paper plants #1 and #4, the main paper production machinery was anchored to concrete foundations and did not appear to have been damaged. The wharf facility at the Seka Paper Mill sustained extensive damage. A large portion of the wharf deck collapsed due to the failure of columns and piers. Again, a lack of adequate steel reinforcement led to significant damage to the columns and subsequent collapse of the concrete deck.

The Seka Pump Station at Sapanca Lake, about 25-km from the plant, provides water to this facility (as is the case with the previously discussed refinery and petrochemical facility). The pump station, a one story concrete structure, houses three electrical pumps and one-diesel pump. There was no damage to the building or pumps. Four 32-inch pipes with a length of about 300 meters bring the water from the lake to the pump station. These pipes were supported on a concrete platform deck with steel frames, which are supported by concrete piers. Due to strong ground shaking and fault rupture, several hundred meters of the platform sank and the pipes were separated at their connection. The pump station was visited one month following the earthquake and it was in the same condition as after the earthquake.

**Figure 10: The collapse of wharf deck at Seka paper plant and collapse of pipeline at pump station**

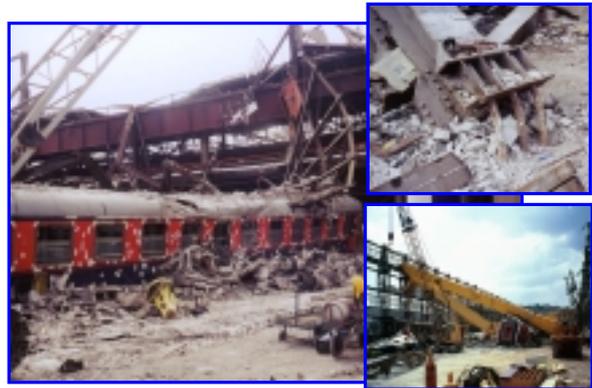
The Wagon Factory, located outside of the city of Adapazari, is the main production and maintenance facility for train cars in the country. It employs approximately 1,750 people. Structural damage to the facility was extensive. One of the large maintenance buildings suffered total collapse and numerous other structures suffered partial collapse and are likely a total loss. Additionally, the supporting structure for a large crane collapsed.

The structural systems of the damaged buildings consisted of high bay steel frames with steel roof trusses and a 3 1/2" thick concrete roof deck. Lateral bracing was not present at the facility and therefore seismic loads were resisted by trusses and columns acting as moment frames, although assuredly they were not designed to resist the seismic loads to which they were subject.

The main source of damage consisted of failure of the roof truss to column connections and failure of the column anchor bolts, both of which contributed to full or partial collapse of the buildings. Of particular interest at this site was the condition of the two-story administration building adjacent to the collapsed production facility. This building is the typical concrete frame and hollow clay tile wall building found in the region and had no signs of appreciable damage on the exterior of the building.

**Figure 11: State of damage to wagon factory**

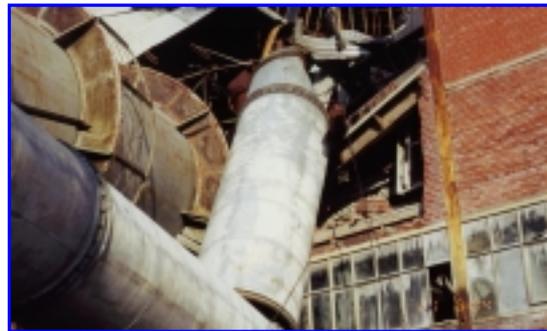
The plant sustained extensive damage due to high ground shaking in the Adapazari area. The power generation plant building is a steel frame structure with brick infill walls. The building was severely damaged and has a permanent offset. Outside of the processing plant, two steel stacks and one elevator pipe with heights of 36m failed at their base and completely collapsed. One of the stacks and the elevator pipe fell into the sugar processing unit building and severely damaged a portion of that building, causing extensive damage to the equipment inside. An elevated pipeline outside of the processing plant, which is connected to the finishing product building, failed at several locations. In addition, a concrete frame

**Figure 12: Steel stack collapsed into processing unit**
