Building in Resilience for Remediated Residential Housing

J.R. Leeves & T.J.E. Sinclair

Tonkin & Taylor Ltd, Auckland, NZ

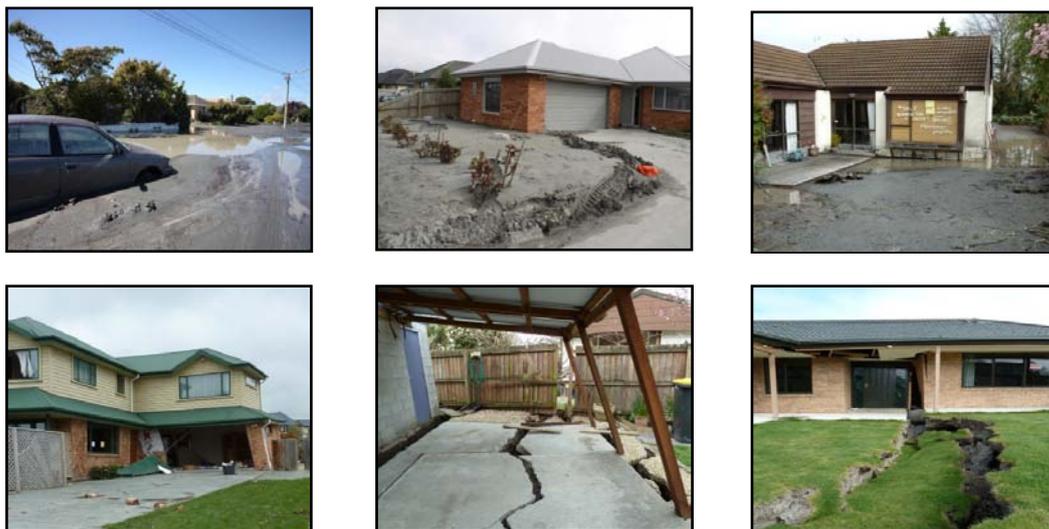
Most of Christchurch occupies a flood plain, with deep deposits of alluvial/fluvial origin. For much of the area (particularly in the east of the city), the near-surface soils comprise liquefiable sands and silts, and the land is low-lying with meandering rivers. The liquefaction that occurred has been well documented (Geotechnical Land Damage Assessment Reports – T&T 2010a and T&T 2010b). Damage to land was manifest in several ways, including lateral spread near waterways, sand ejection and ground cracking due to phenomena other than lateral spread (e.g. oscillation damage) and variable settlement. Figure 2 shows examples of these effects.

Figure 2. Examples of land and building damage

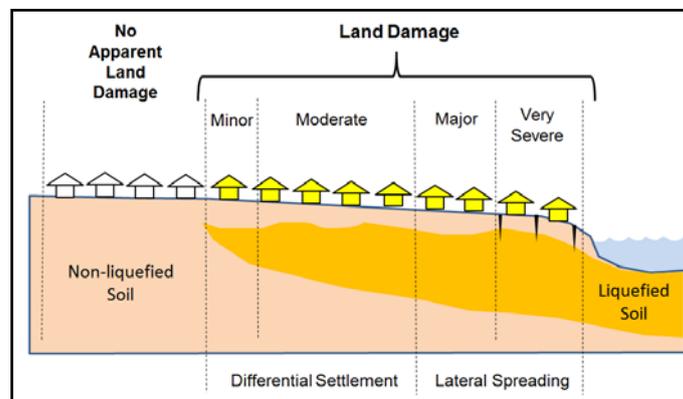
Figure 3 illustrates how the observed land damage generally related to topographic features.

Figure 3. Land damage relationship to topography

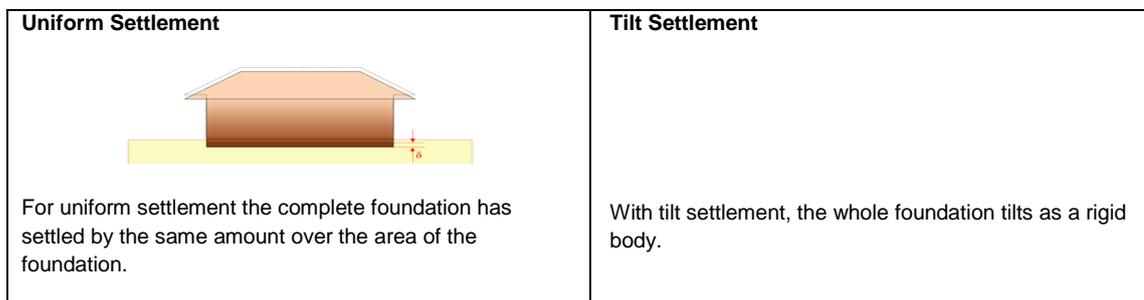
Liquefaction-induced ground movement has caused stretching, hogging, dishing, racking/twisting, tilt, differential settlement, differential displacement or any combination of the above to residential buildings. The severity of the damage is dependent on the damage type, the type of building damaged, the building geometry and the amount of foundation movement that has occurred.

Figure 4(a). Simple settlement cases

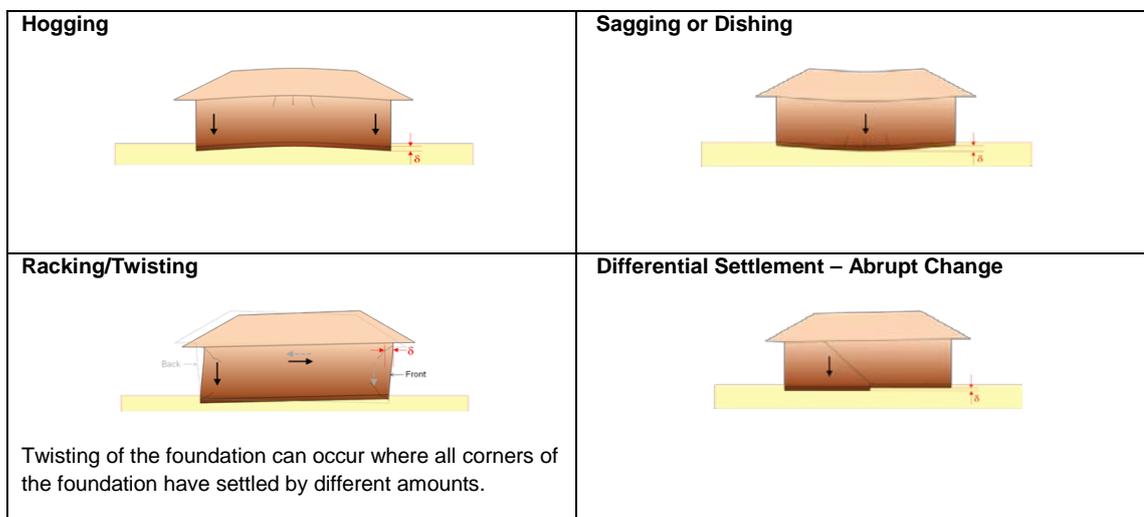
Figure 4(b). Differential settlement cases

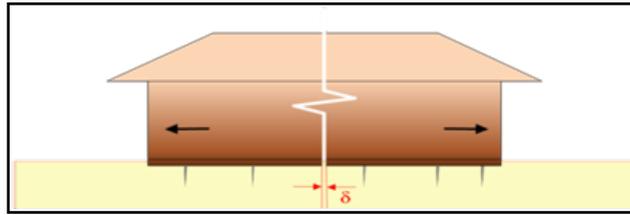
Figure 4(c). Lateral stretching

- Many of the existing houses did not have tensile reinforcement in the footings (Type B housing) or floor slab (Type C housing). This resulted in stretching of the building due to lateral ground spreading.
